**REPORT FOLLOWING  
TECHNICAL INVESTIGATION  
into the collision (and resulting fire)  
between a coach and a HGV  
that occurred on October 23rd 2015  
on Departmental Road No 17  
near the town of Puisseguin  
(South-West of France)**

**Land Transport Accidents  
Investigations Bureau**

Case n° BEATT-2015-014

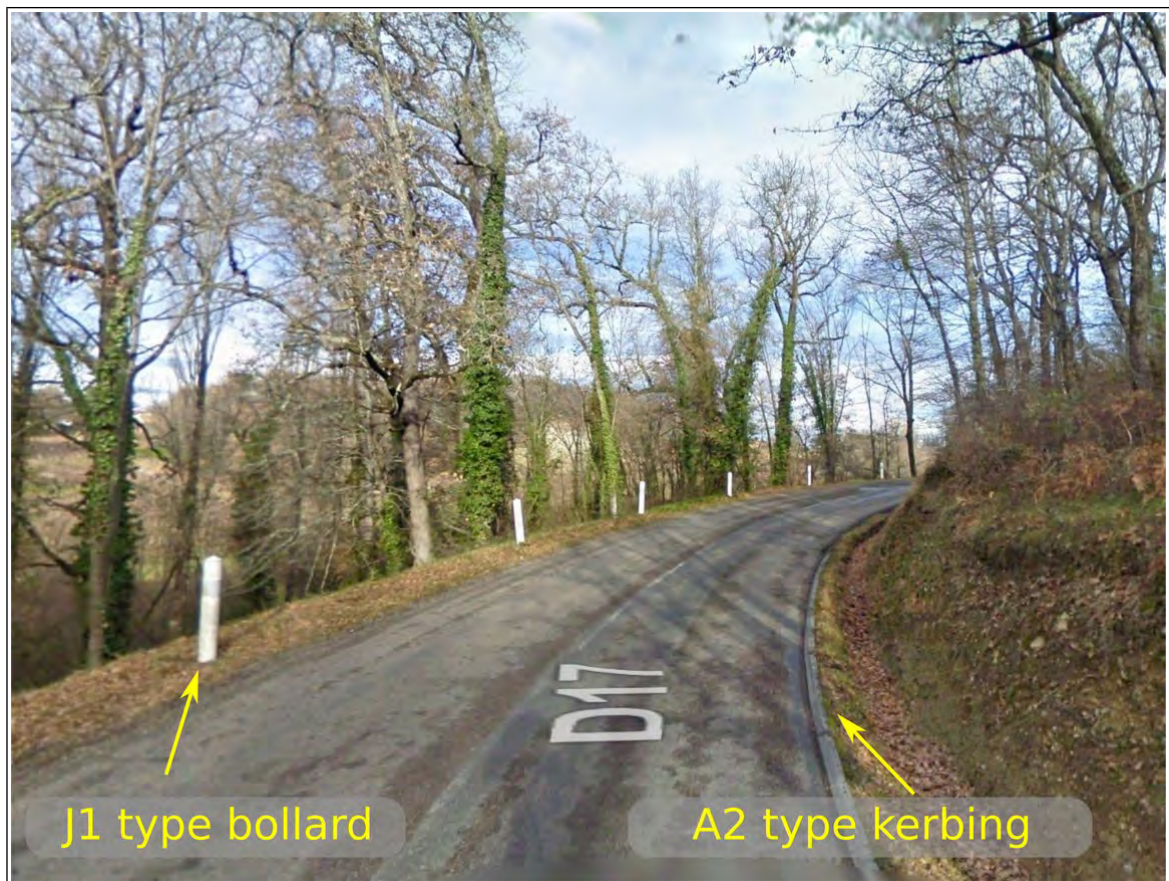
**Fig. 3: View of the bend where the accident occurred from the perspective of the lorry.**

The two lanes are demarcated via a "T3" broken white line running along the middle of the road, which is faded and not easily visible.

The bank running along the inside of the bend makes it more difficult to read the bend, while also limiting the visibility of oncoming vehicles.

This section of the road has slight ruts and the surfacing is worn in places due to the impact of vehicle wheels.

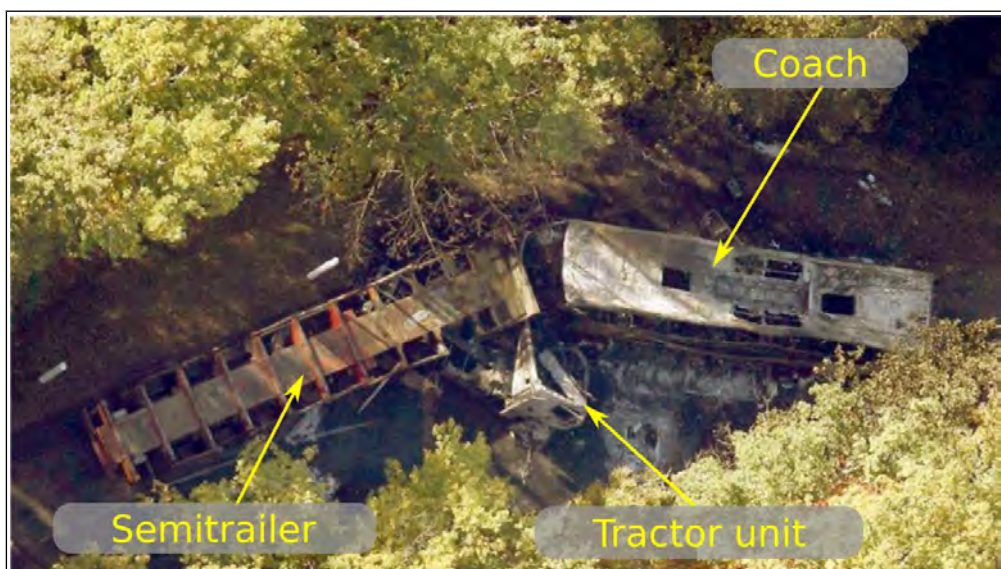
**Figure 5: Aerial view of the position of the vehicles following the collision**

The diagram and photographs in figures 4 to 7 below indicate the respective positions of the vehicles involved in the October 23rd accident, as they were found by emergency services arriving at the scene.

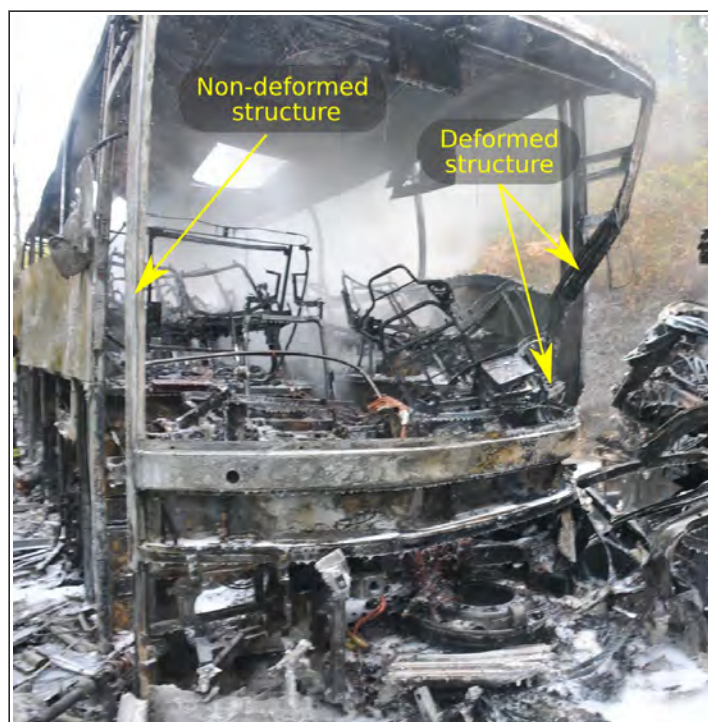
**Figure 29: Wider view of coach**

The vehicle suffered a frontal collision with the lorry on its left-hand side, causing its solid structures to be pushed back. The deformations to the vehicle's structure were mostly concentrated in the areas indicated in figures 28 - 31 below.

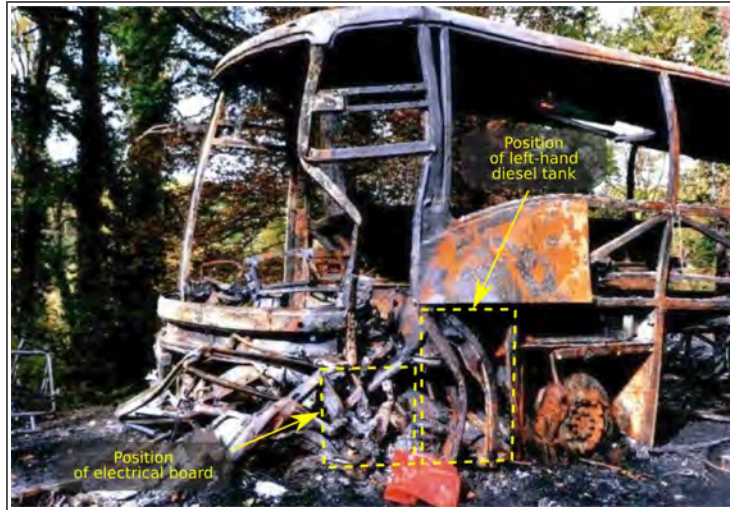
**Figure 30: View of the front left-hand side of the coach involved in the accident**

The electrical board situated on the front left-hand side of the coach, as well as the structure protecting the left fuel tank were heavily deformed by the impact with the tractor unit. The space between the exterior stanchions for the fuel tank compartment was reduced by around 65%.

The BEA-TT investigators have surmised that the left-hand side fuel tank located within the impact zone was most likely also crushed, which may have led to its rupture during the collision.

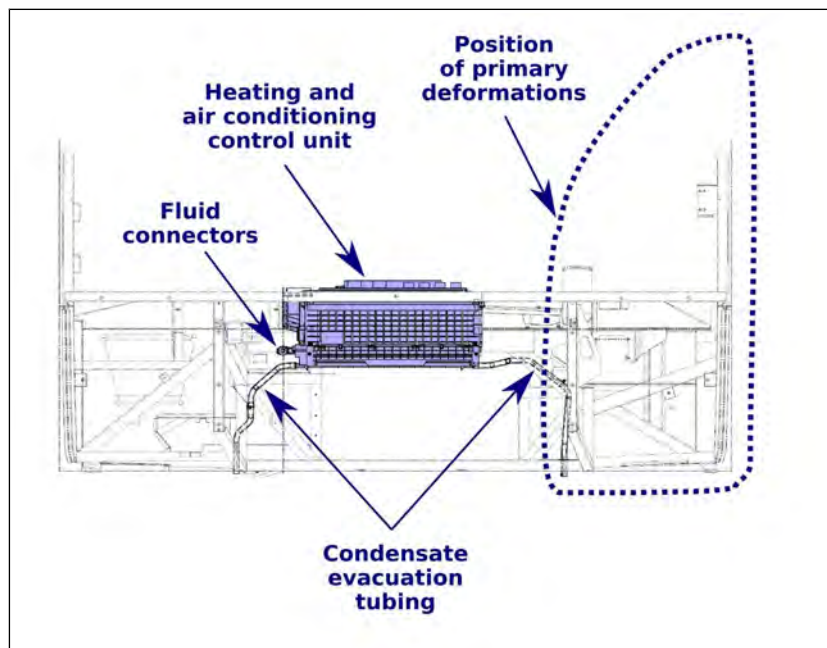
**Figure 33: Position of the heating and air conditioning control unit and areas of structural damage on the front of the coach**

The coach's frontal heating and air conditioning control unit was partially destroyed in the fire. The radiator and evaporator installed in this control unit were not destroyed by the fire, and were lying on the ground. They showed no visible signs of being crushed.

In light of these observations, the BEA-TT investigators have ruled out the hypothesis that a direct impact with the frontal heating and air conditioning control unit was what led to the sudden rupture of the heating and air conditioning circuits. Their role in causing the two vehicles to be consumed by fire can therefore be dismissed.

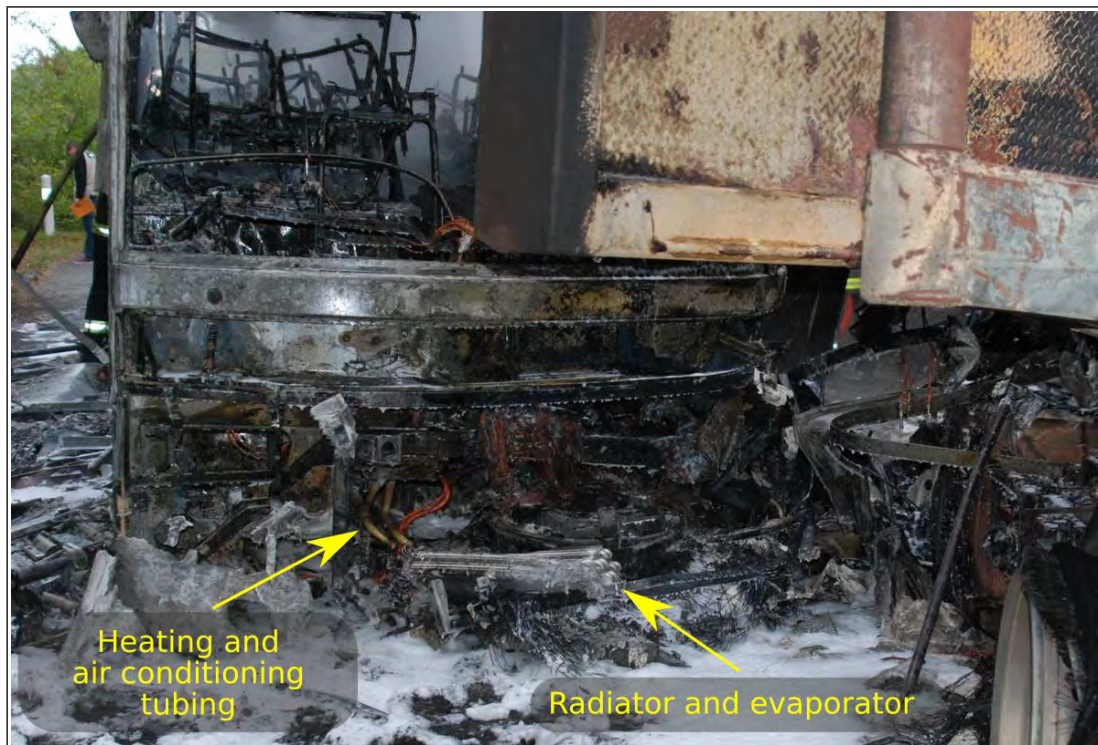
**Figure 34: View of the front of the coach involved in the accident**

Figure 34 below provides a view of the front of the coach, the radiator and the evaporator as well as the tubing to which they were attached as they were found by the judicial investigators once the blaze had been quelled by the firefighters.

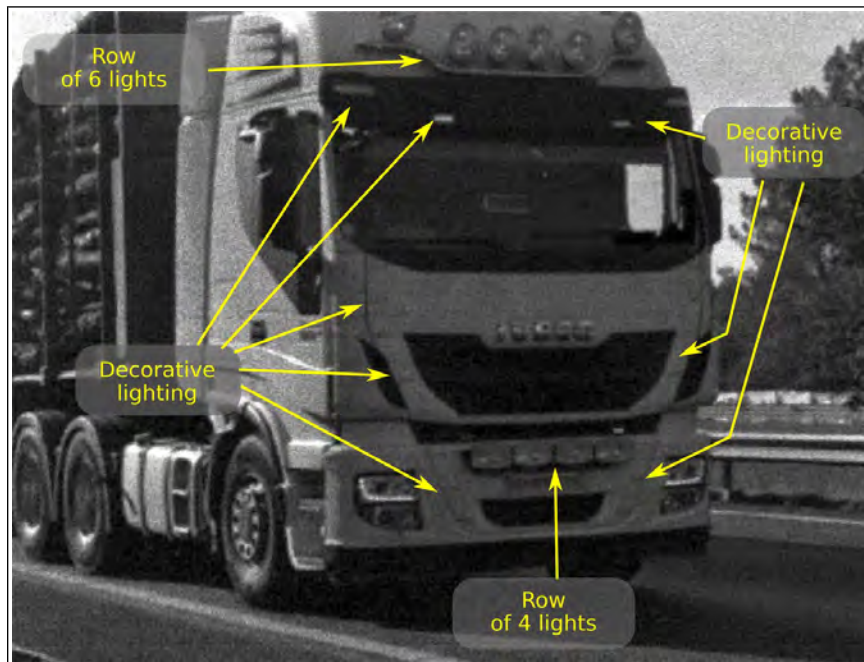
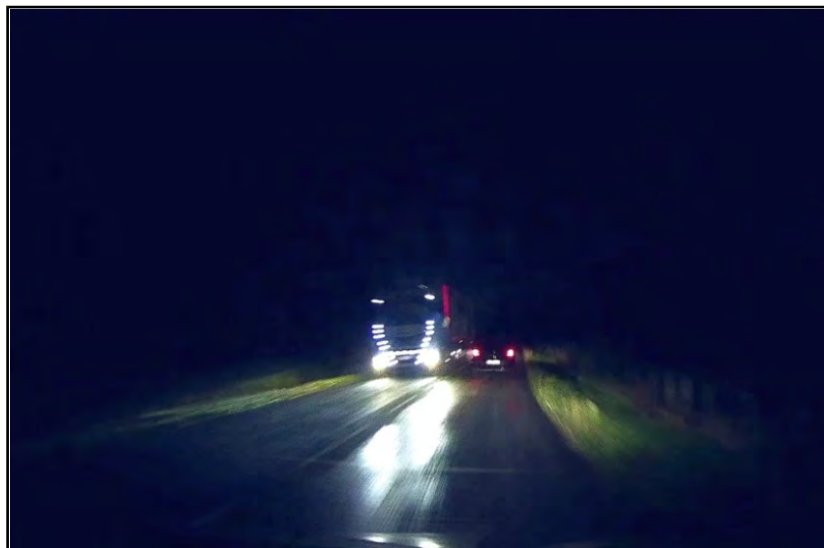
**Figure 45: View of the headlights and decorative lights on the tractor unit**

**Figure 46: View of the tractor unit using dipped headlights with the decorative lights switched on.**

The lights installed on the tractor unit were therefore not compliant with existing regulations, but nor did they have any influence on the cause or consequences of the accident.

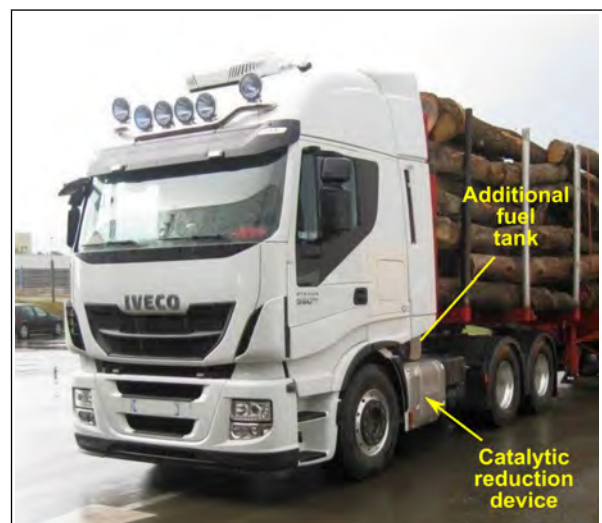
**Figure 52: View of the additional fuel tank on the IVECO tractor unit involved in the accident**

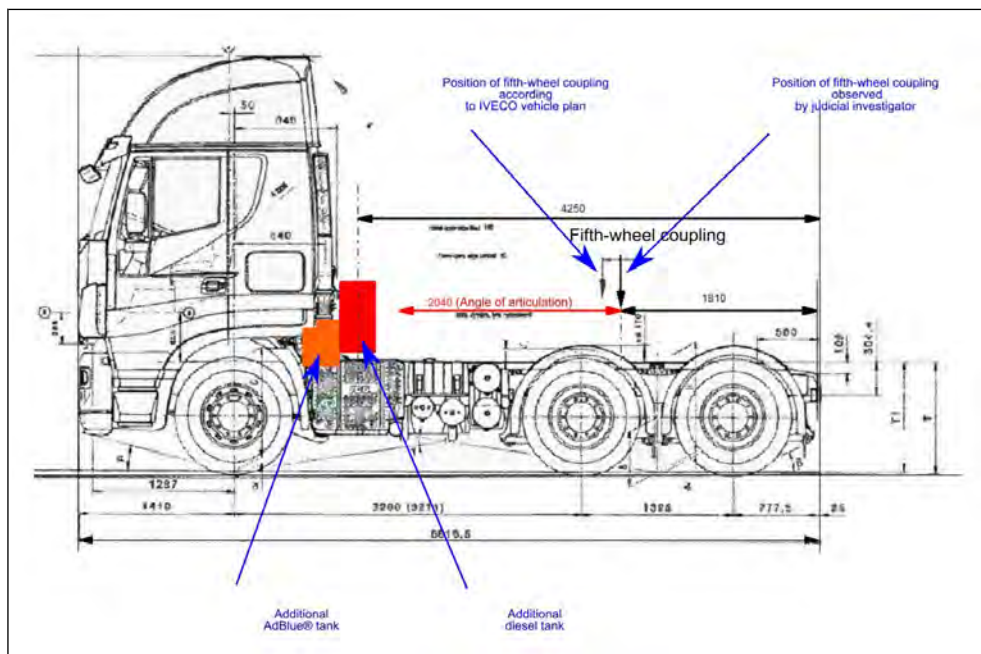
The original position of the fifth-wheel coupling was determined by the judicial expert in charge of vehicle assessments, with the aid of the tractor unit's technical design plans provided by its manufacturer (IVECO). The position of the fifth-wheel coupling on the wreck of the tractor unit allowed the investigator to estimate it had been moved backward by around 18cm.

**Figure 54: View of the fifth-wheel coupling positioned in accordance with the distance measured**

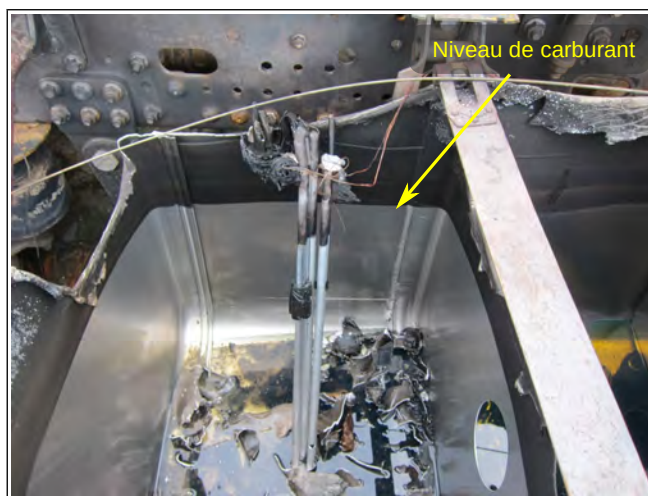
The primary fuel tank was partially melted. Traces indicating the level of liquid the tank contained were visible on the tank's interior after the fire had been extinguished. They were situated around 3/4 of the way up the tank.

**Figure 62: View of the traces of liquid on the interior of the primary fuel tank of the tractor unit involved in the accident**

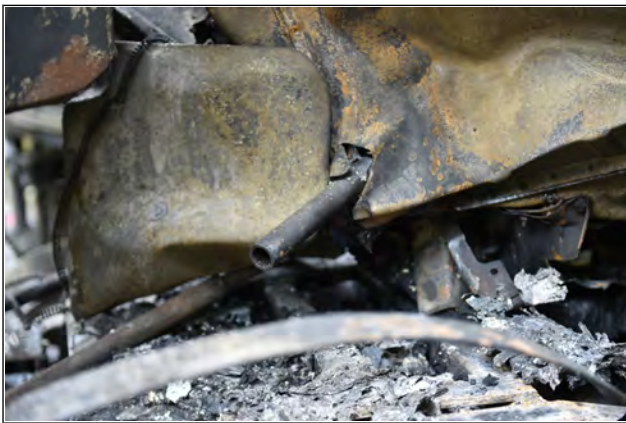
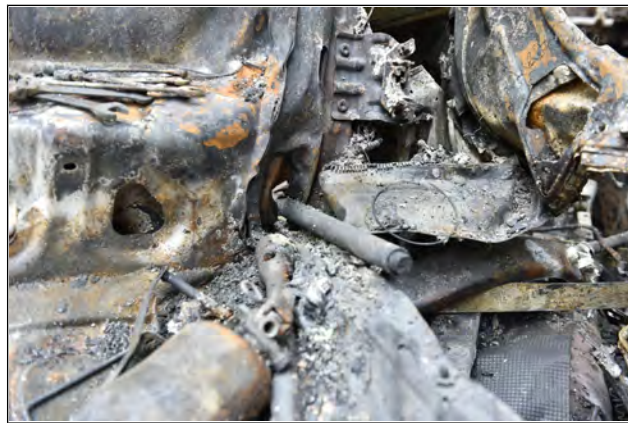
A metal rod, which had been stored in a boot space on the left-hand side of the driver's cab, perforated the rear of the cab; one end of the rod was found where the additional fuel tank had been, in a position that led investigators to surmise that it had partially perforated the tank.

**Figure 65: Close-up view, from the rear of the tractor unit, of the metal rod that passed through the rear wall of the cab**

**Figure 66: Close-up view, from the front of the tractor unit, of the metal rod that passed through the rear wall of the cab.**

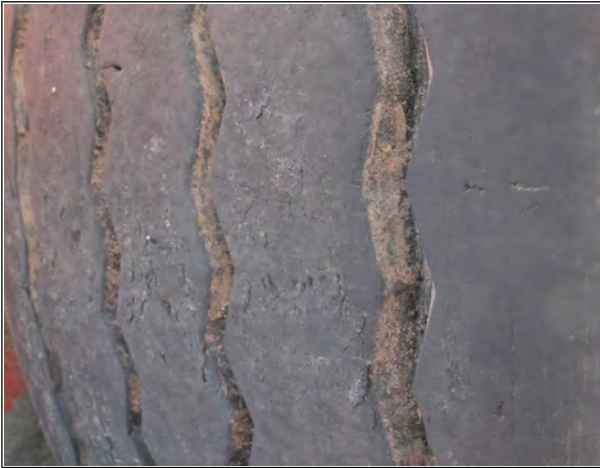
Isolated abrasions on the tyre treads were observed on tyres 1D and 2D, whose shape corresponds approximately to the area where the tyre met the road surface. The abrasions on these tyres can be matched with the tyre tracks caused by slippage observed on the road surface (cf figure n° 9).

**Figure 68: Abrasions on the tyre treads of tyre 2D.**

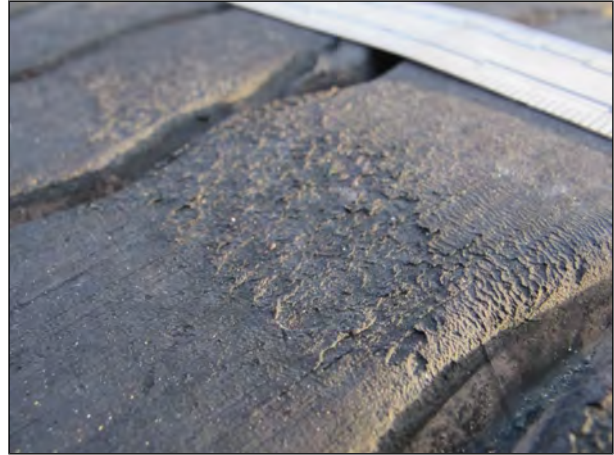
**Figure 69: Abrasions on the treads of tyre 1D**

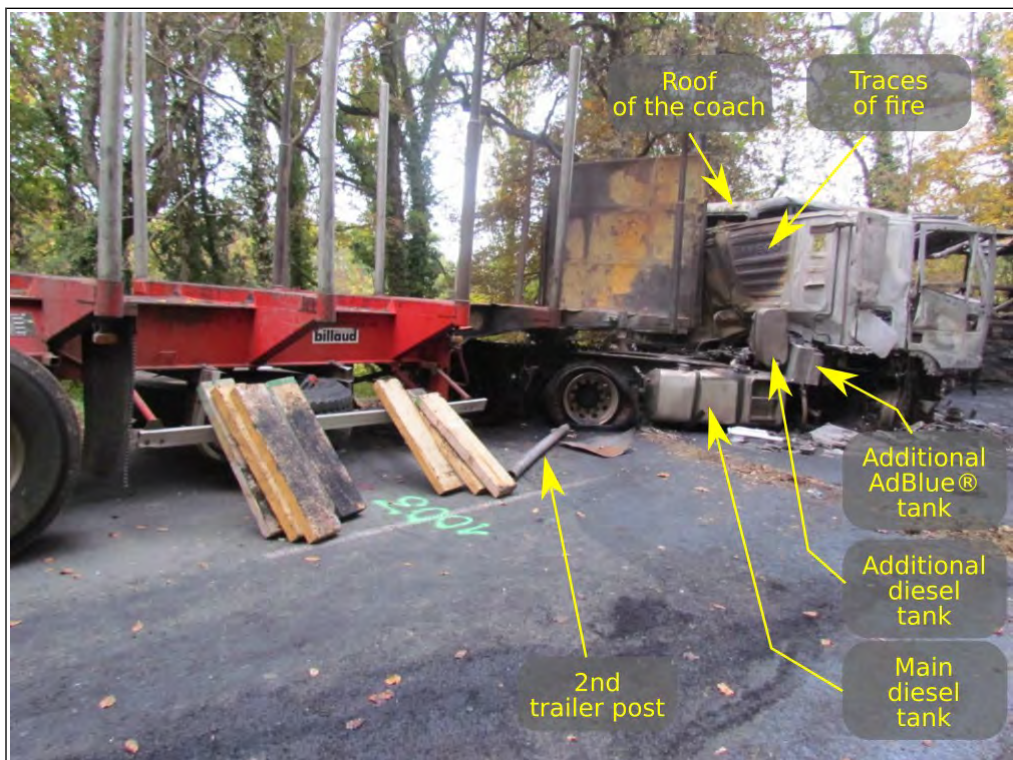
The second trailer<sup>17</sup> post on the right-hand side of the vehicle fell onto the road, as a result of its support structure giving way.

**Figure 70: View of the right-hand side of the semitrailer involved in the accident**

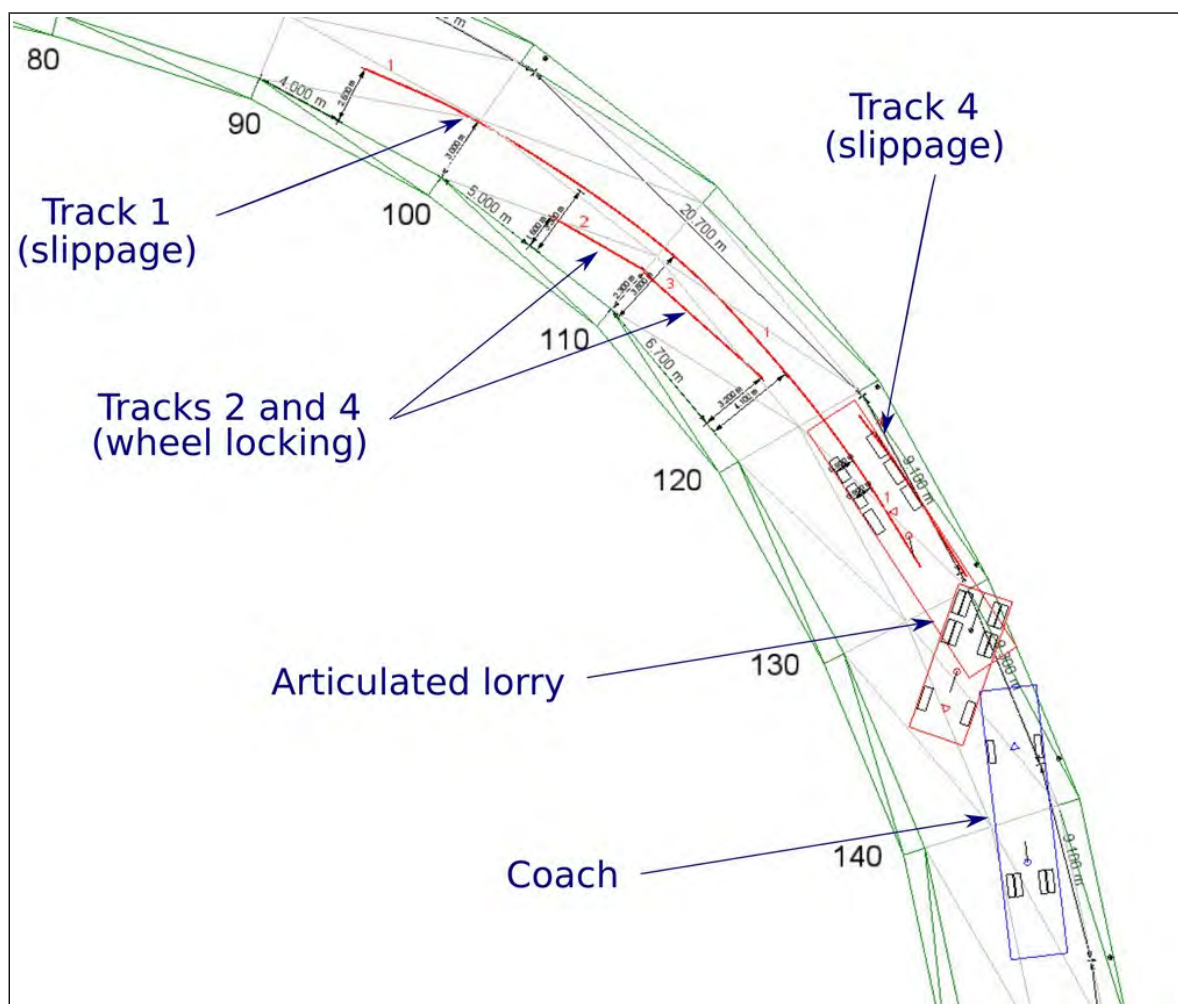
**Figure 71: Representation of tyre tracks found and final position of the vehicles at the scene of the accident**

The position and type of tyre tracks found (slipping and wheel locking) allowed BEA-TT investigators to observe:

- assuming that the lorry was travelling in its own lane, that track 1, which begins furthest away from the accident, corresponds to slipping of one of the lorry's left wheels,
- that this track, which shows continuous slipping and continues beyond the wheels of the semitrailer, was left by a left wheel of the tractor unit;
- that tracks 2 and 3 were most likely caused by locking of wheels 1D and 2D of the semitrailer, given the abrasions observed on their tyres;
- that track 4, which appears beyond the wheels of the semitrailer, was caused by the slipping of one of the tractor unit's wheels. Taking into account its proximity to the road edge, it was mostly likely left by one of the tractor unit's left rear wheels.

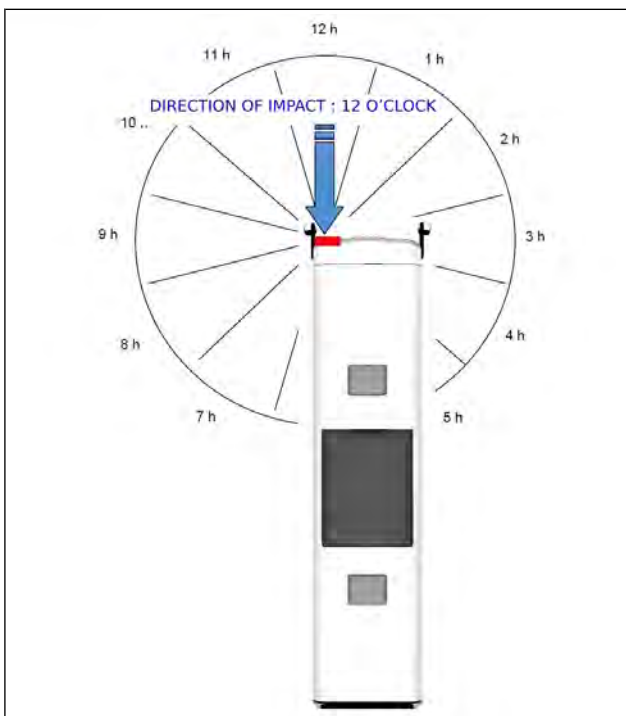
The coach shows signs of front impact on around 1/4 of its front left-hand side; the primary direction of the force exerted on the vehicle being at roughly 12 o'clock.

**Figure 72: Direction of impact on the coach**

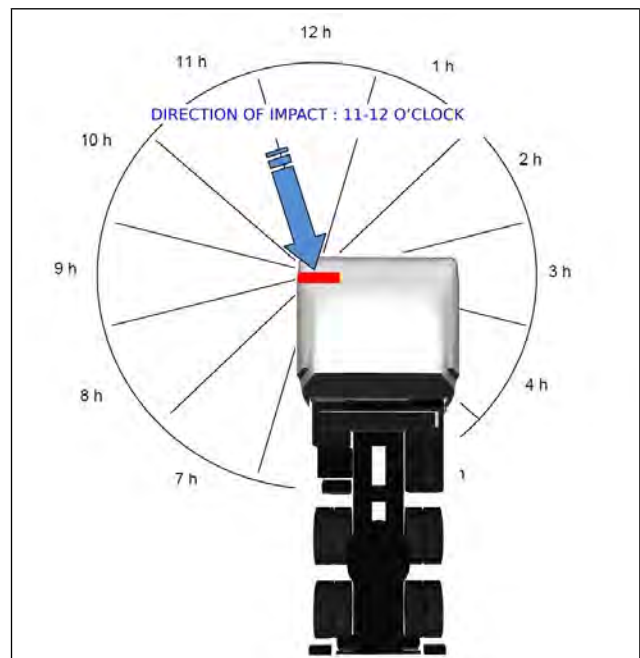
The tractor unit showed signs of frontal impact on roughly 1/4 of its front left-hand side; the primary direction of the force exerted on the vehicle being roughly between 11 o'clock and 12 o'clock.

**Figure 73: Direction of impact on the tractor unit**

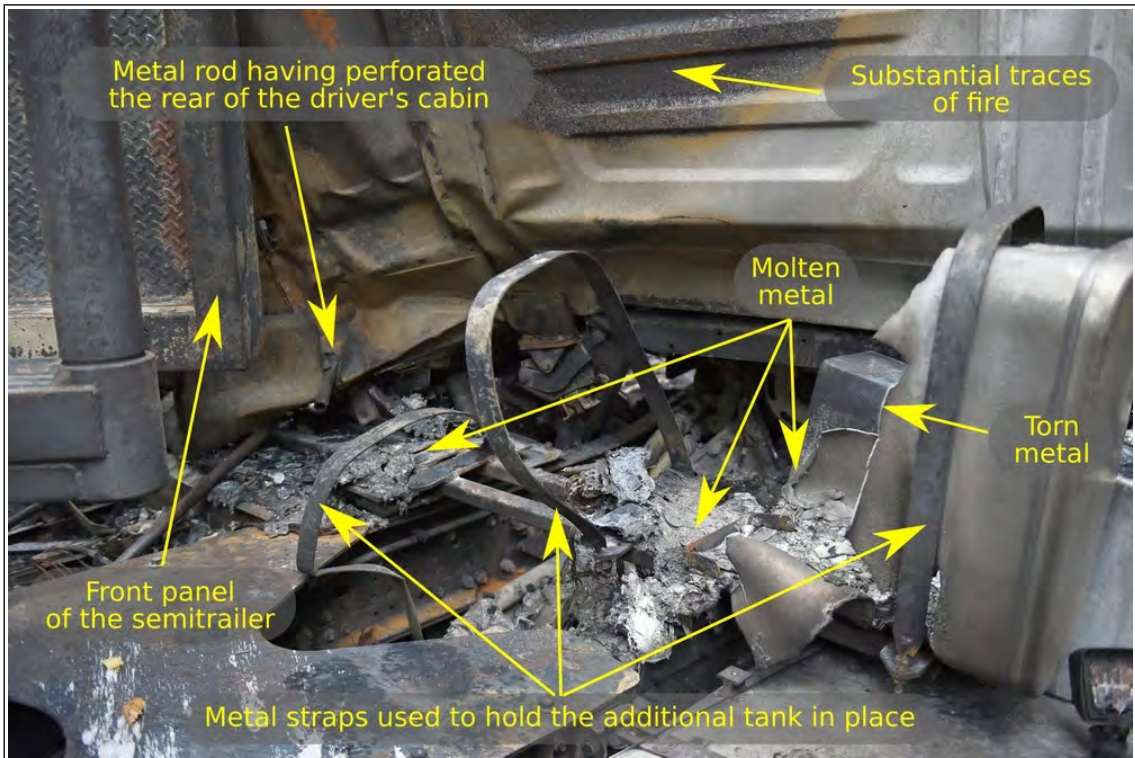
- the tank has almost completely melted, only its right part, its support and the metallic tie-down straps have been preserved from the fire;
- the location of the traces of molten aluminium found on the chassis of the tractor unit as well as the condition of the tank's metallic tie-down straps show that the left part of the tank pivoted backwards before melting;
- the right part of the intact tank has traces of melting as well as traces of tearing of the metal;
- the left side of the tank located at the metal rod that perforated the rear of the driver's cab has melted.

**Figure 77: View of the additional tank of the accident-damaged tractor unit**

Given the deformations observed on the tank and the position of the driver's cab of the tractor unit, which was found by the front panel of the semi-trailer, the BEA-TT thinks that this tank was most likely broken upon impact, crushed between the rear of the semi-trailer's cab and front panel, releasing its fuel.

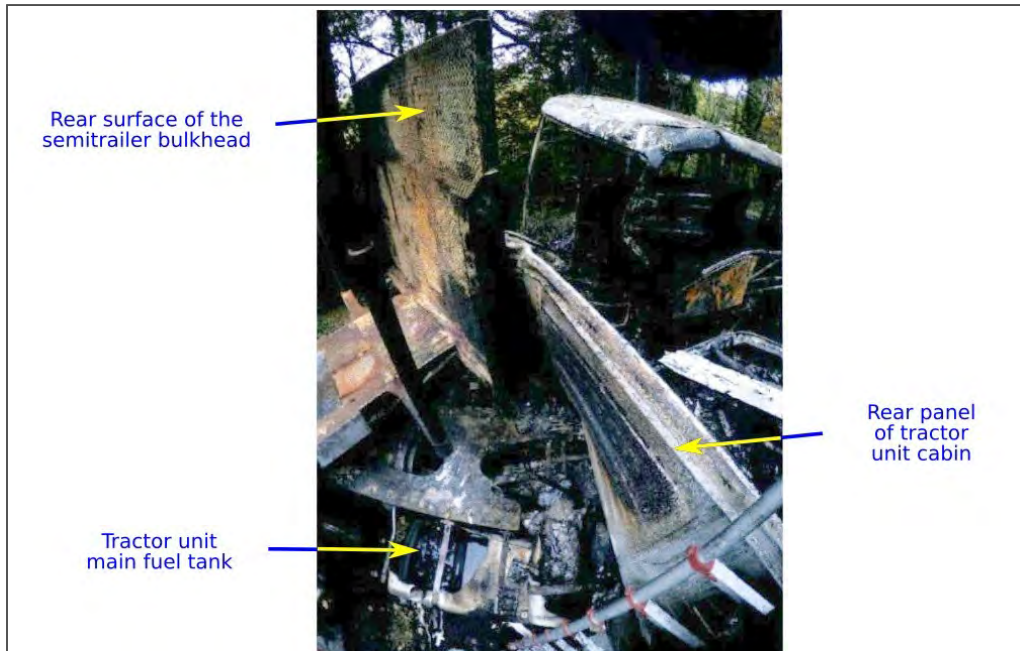
**Figure 78: Rear view of accident-damaged tractor unit**

This tank could have also be perforated by a metal rod which was stored in a trunk in the driver's cab of the tractor unit. This metal rod in fact perforated the rear of the driver's cab and its rear part was found at a location where the additional tank had been installed and in a position suggesting that it could have partially penetrated it.

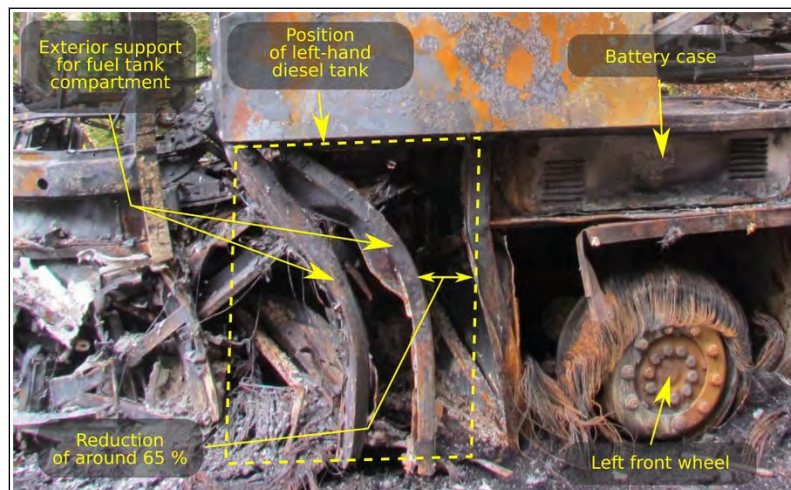
**The left fuel tank of the coach** is made of polyethylene and has been completely burned. There are no usable parts left. This tank was located in the direct area of impact in which the metal structures of the coach which protected it were extensively crushed. It is therefore very probable that this tank did not withstand the impact and that it broke during the collision, releasing its fuel which then spread to the ground.

**Figure 80: Close-up view of the front left-hand side of the coach involved in the accident**

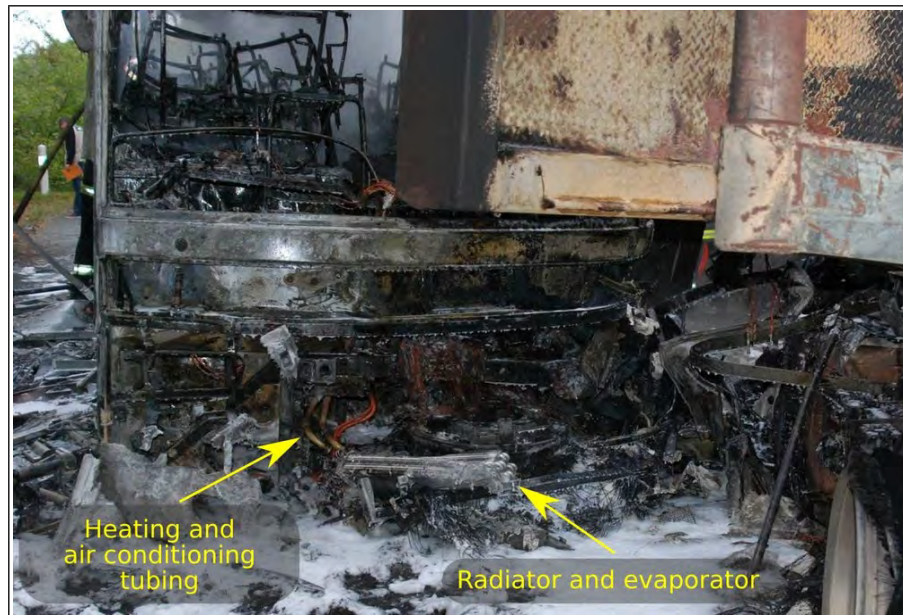
**The heating system components of the coach** situated in the front housing do not appear to have been directly impacted during the collision, but were damaged by the resulting fire. It is therefore very probable that the liquid contained within them, namely Glystantin G48, which is furthermore difficult to ignite, did not play a role in triggering the fire.

**Figure 81: View of the front face of the accident-damaged coach**

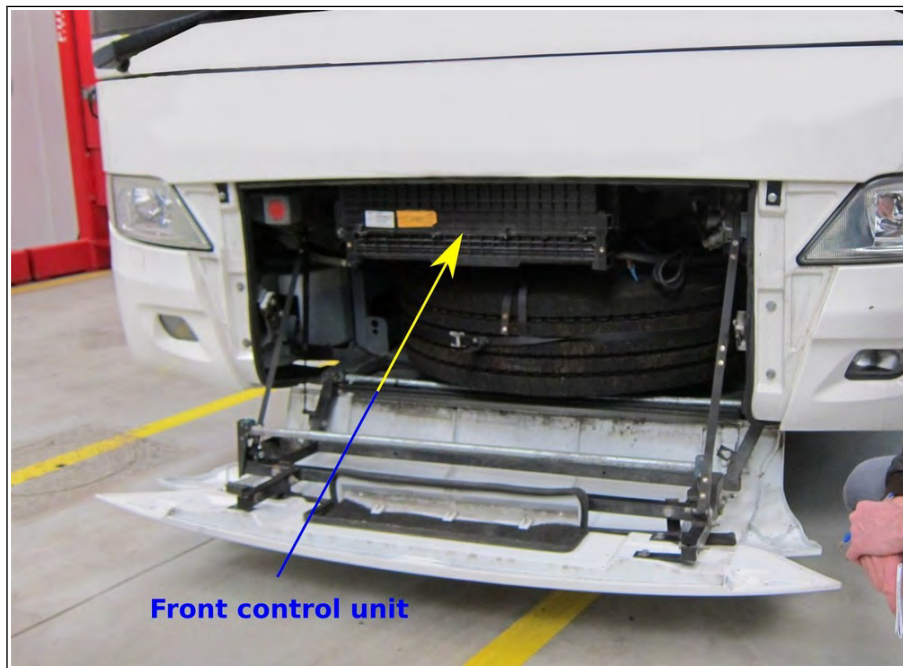
**Figure 90: View of the front heat exchange and blower unit on a similar coach**

The front part of the coach and the driver's compartment are heated by means of a heat exchange and blower unit installed at the front of the vehicle.

This unit, referred to as "Front blower unit" in figure 89 is shown in an identical coach in figure 90 below.

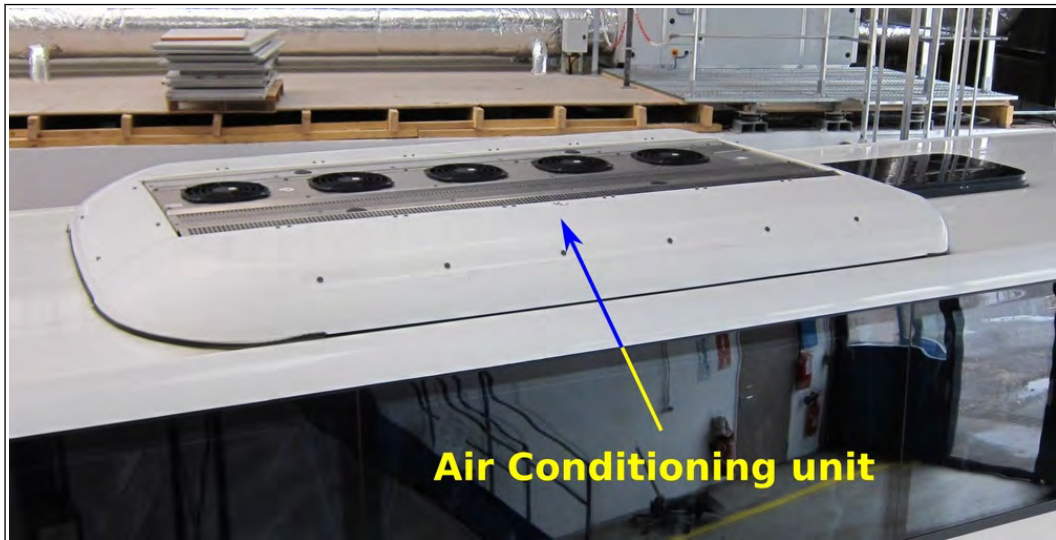
**Figure 93: View of the air handling unit  
on the roof of a similar coach**

Figure 93 below shows the installation of the air handling unit in an identical coach, located on the roof of the vehicle.
