SFBM S.p.A. Rome, Italy

Specific tests on CNG4 cylinders

Provider 1

Doc. No. 19042-R Rev. 2 – March 2018

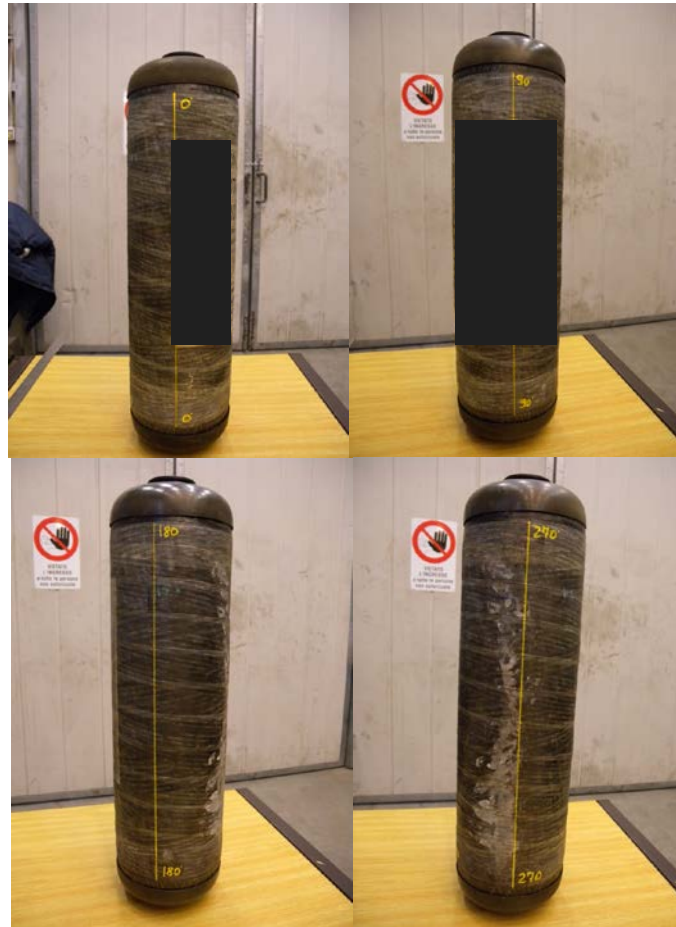
Figure 1-1: Dummy cylinder before drop tests

The dummy cylinder has been marked along 4 main generatrices, named 0°, 90°, 180° and 270°. The preliminary visual inspection did not show any kind of damage (dent, crack, etc.).

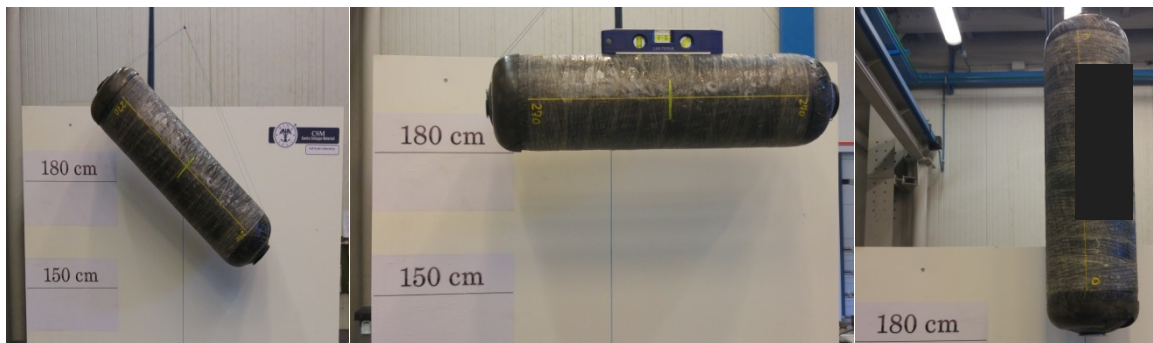
Figure 1-2: Drop tests different setups (drop height 1.8 m)

The protective dome on the valve side was lost after the 45° angle drop test at 1 m height; the following tests from 1.8 m height were then performed without it. The protective dome on the capped side presented several cracks and missing parts, as reported in Figure 2-3, after both 1 m and 1.8 m drop tests, but it was not separated from the cylinder body.

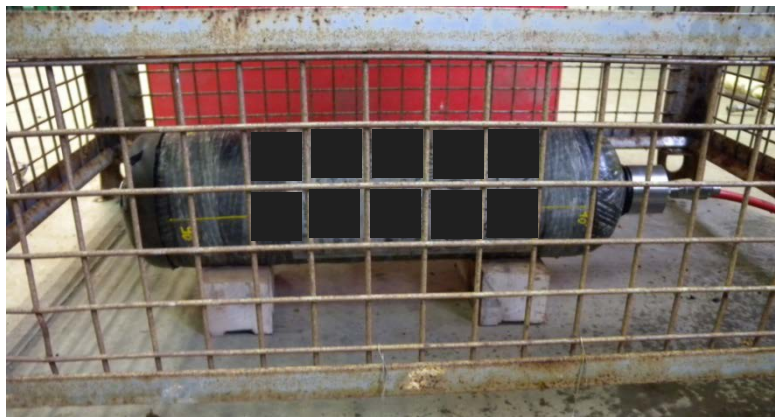
Figure 2-4: Dummy cylinder – Hydraulic test setup

After having completed the two series of drop tests from different heights, the dummy cylinder underwent the hydraulic test, according to ECE ONU R110 Annex 3, Paragraph A11 option 2. The cylinder ready for the test is shown in Figure 2-4.

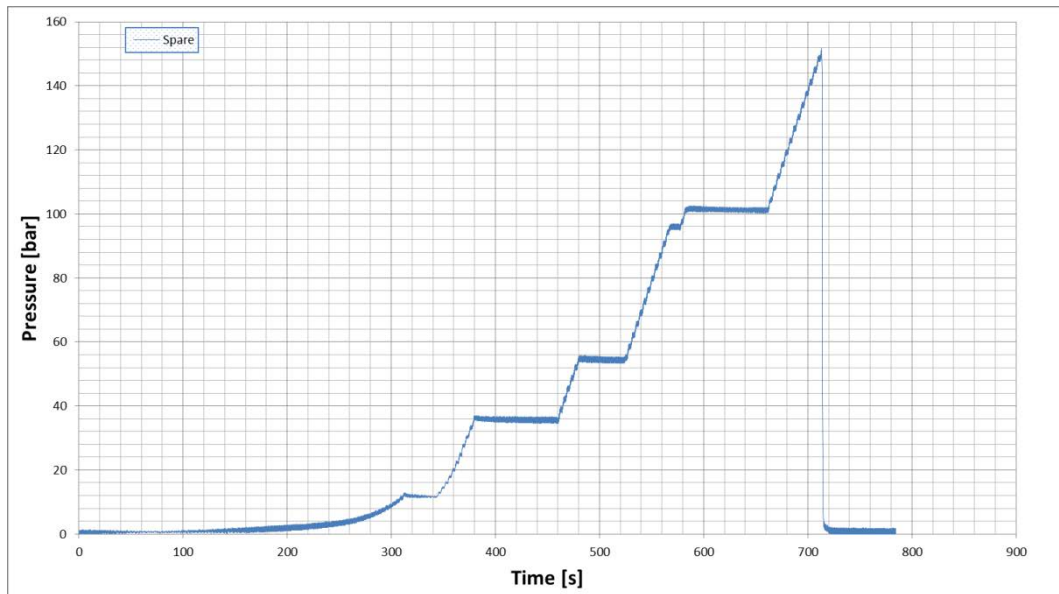
Figure 2-5: Dummy cylinder – Hydraulic test pressure-time plot

The dummy (spare) cylinder blew up at 150 bar, before achieving the target pressure (300 bar); the failure is put in clear evidence by the pressure collapsing in the plot reported in Figure 2-5.

The dummy cylinder consequently did not pass the hydraulic test after drop tests.

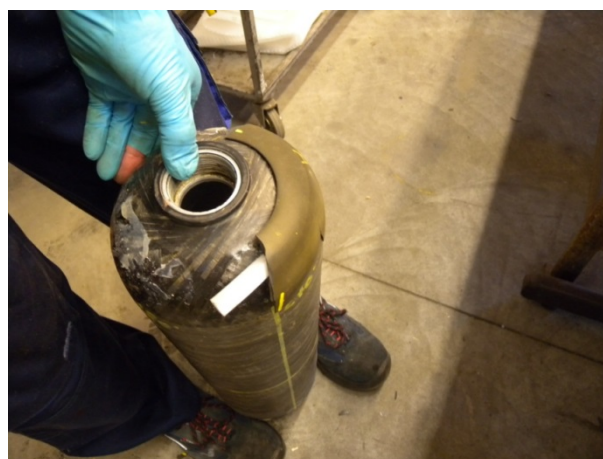
Figure 3-2: Protective dome removal using a PTFE wedge

The removal of the domes was carried out with great care, in order to avoid to make any damage on the external surface of the cylinders. Depending on the resistance opposed by the glue, the domes removal was performed by hands or using a PTFE wedge (Figure 3-2).

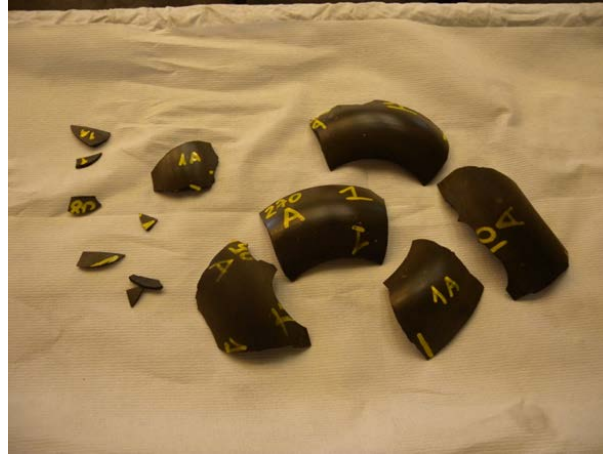
Figure 3-3: Parts of a broken protective dome collected and marked after removal

In some cases, the protective domes were broken during removal; in this case, each part of the dome was collected and marked as shown in Figure 3-3.

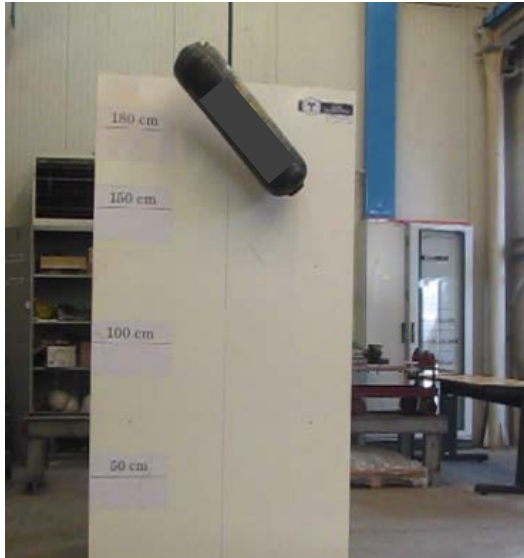
Figure 4-18: Cylinder 8 – Drop test

Cylinder 8 failed during the second hydraulic test. Visual inspection before this test showed a strongly discolored area in the valve side dome, at 180°, caused by the drop test performed at 45° angle. Pictures of the drop test and of the damaged area are reported in Figure 4-18 and Figure 4-19.
