Appendix 1 to document ECE/TRANS/WP.15/AC.2/2011/38 on the use of liquefied natural gas as a fuel

RECOMMENDATIONS TO INSPECTION BODIES RELATING TO THE ADN REGULATIONS

Liquefied Natural Gas to be used as fuel for the vessels' propulsion

Pursuant to Article 7.2.3.31.1, Article 7.2.3.41.3, Article 9.3.x.31.1 and Article 9.3.x.41.2 of the ADN Regulations, the tanker vessel "Argonon" (yard no. 07 KHO 169 of Trico Shipyard Rotterdam, European vessel identification number to be obtained) is authorised to use Liquefied Natural Gas (LNG) as fuel for the propulsion installation, subject to the following conditions:

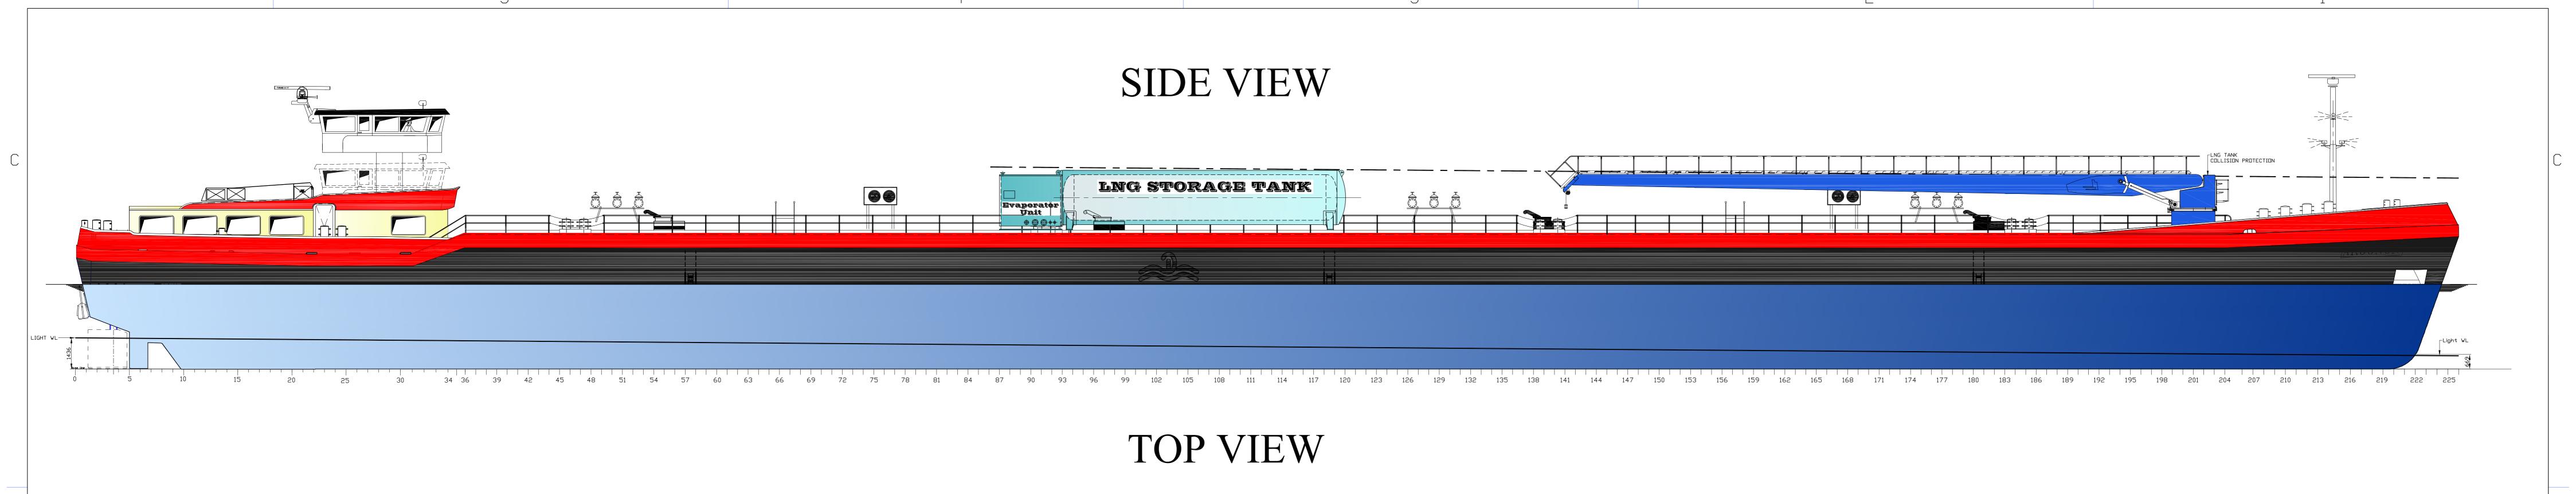
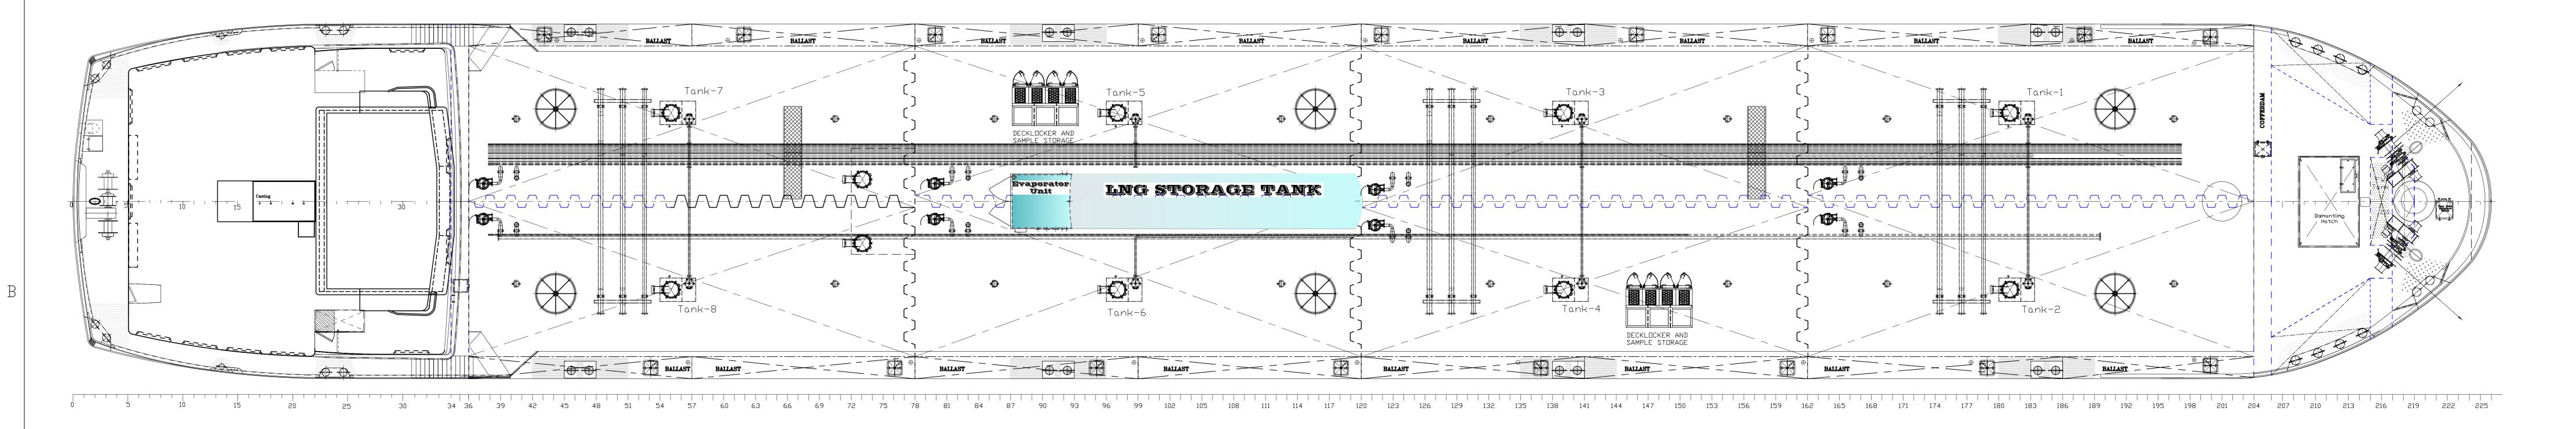
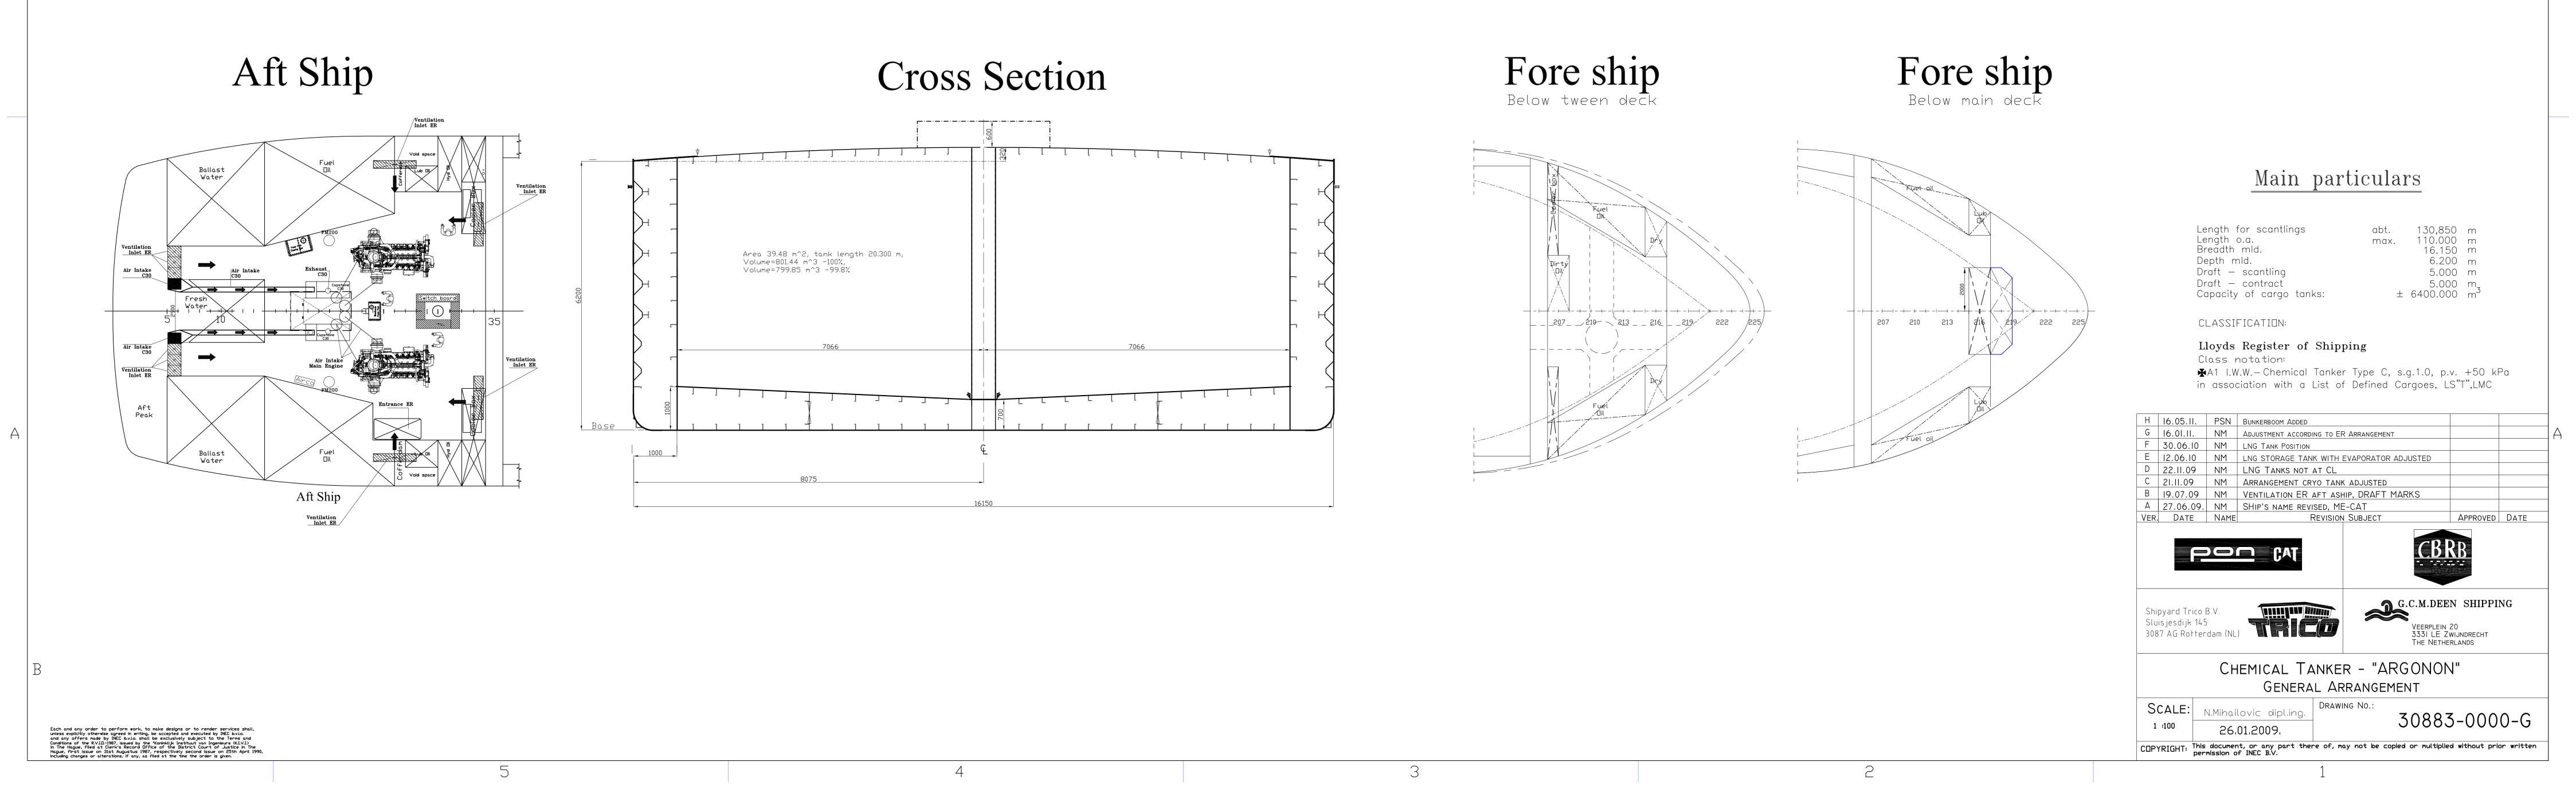
System: Dual fuel engine arrangement			Drawing: P&ID 3512DF Fuel Gas Line		HAZID sheet 7		
Area: Machinery space			Revision: (-) (5-10-2010)		29 November 2010		
Equipment : Dual fuel engine			Also: 400-00_LNG Pipeline Diagram (Rev B) and 1002-110_P&ID LNG Fuel System (Rev 8)				
ITEM/guide CAUSE HAZARD			POTENTIAL EFFECTS SAFEGUARDS		RECOMMENDATIONS		
7.8.3	emergency shut down	loss propulsion blackout	loss of manoeuvring loss of auxiliary generators	- LNG supply shut off at master valves; - change over to diesel fuel operation automatic on loss of gas supply - UPS provided, front generators will start			
7.9 Human Error							
7.9.1.	Incorrect operation			Gas fuelled operation is automatic and no human intervention is required. In case of failure, gas is shut off and engine runs on oil fuel.

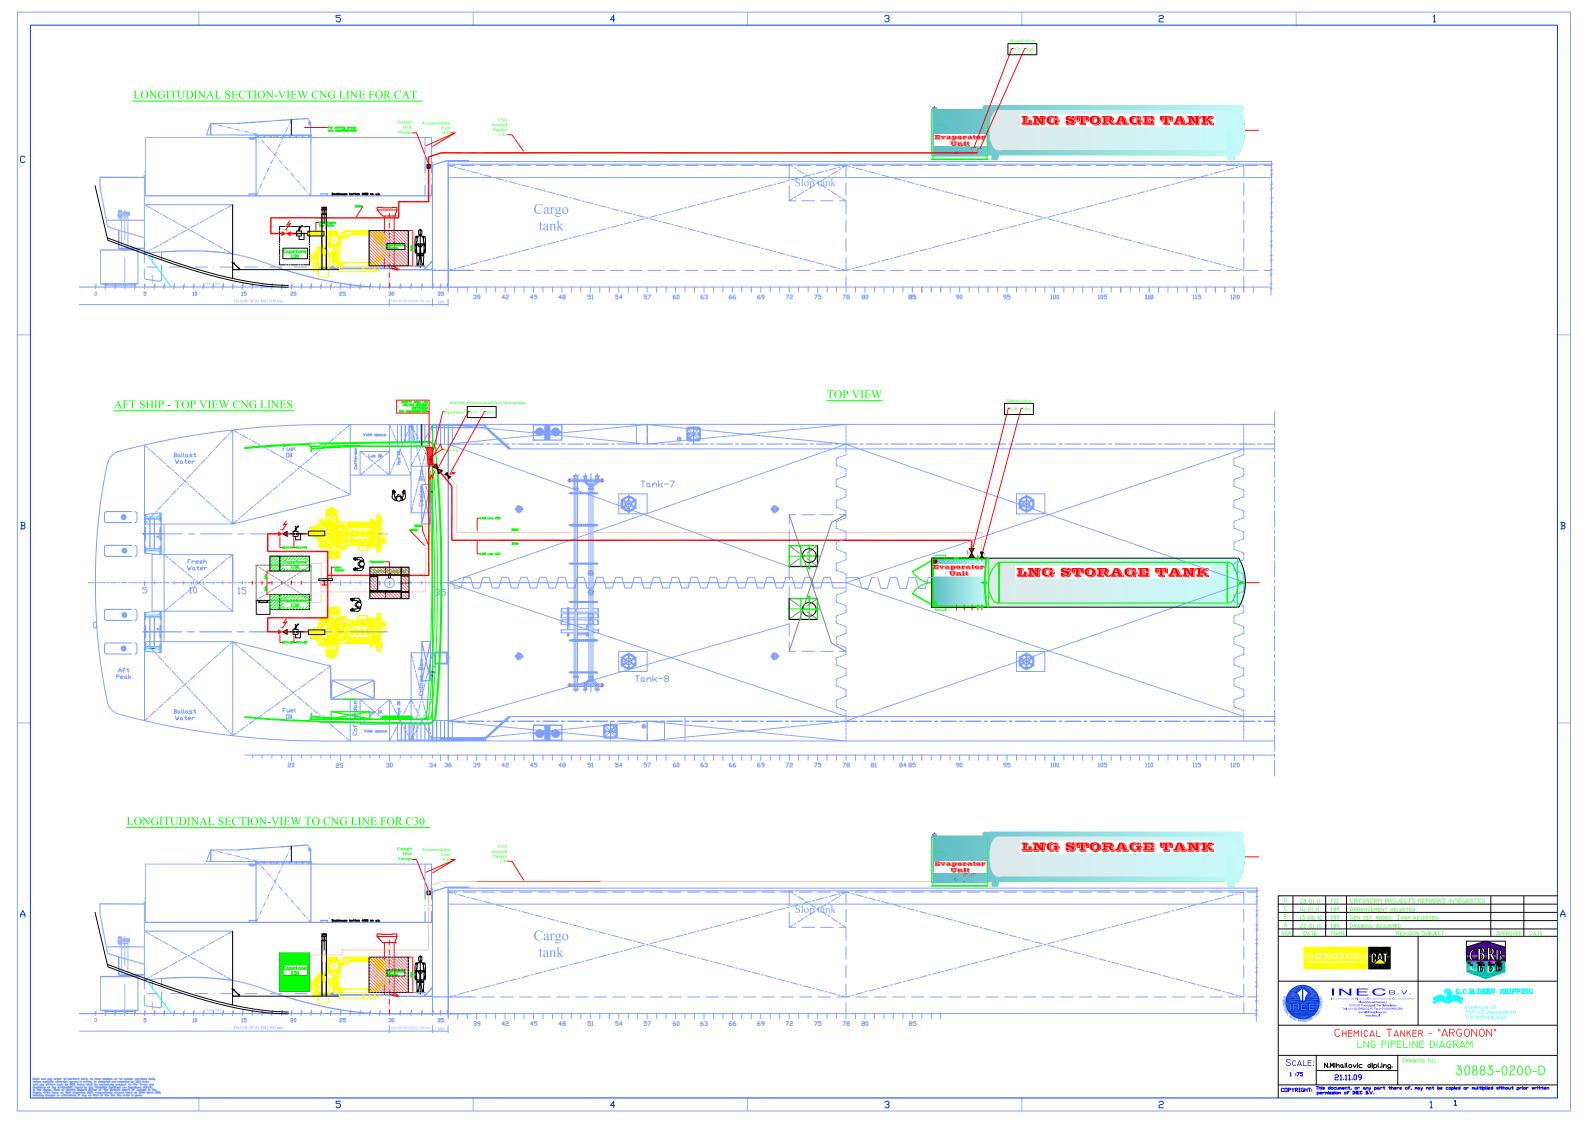
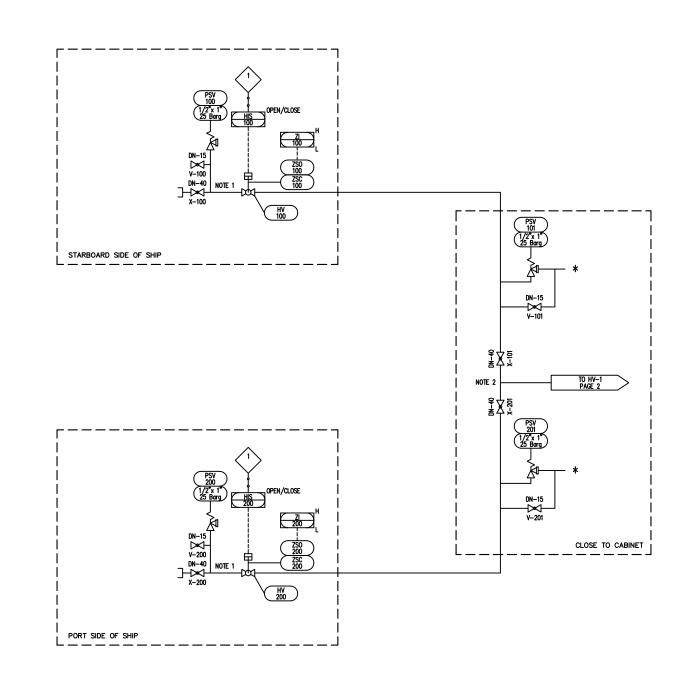
1002-110

- ** CONNECTS TO VENT HEADER UPSTREAM TE/TT-9

11	PAGE 3 ADDED COMPLETELY	HJS		28-01-2011		
10	VALVES V-1' + V-2' + V-9 AUTOMATED		HJS		05-01-2011	
9	9 LINE NUMBERS ADDED				17-11-2010	
8	TE-3 AND TE-9 ADDED + 2x TRUCK-LOADING POINTS				15-10-2010	
REV.	DESCRIPTION			снк.	DATE	
	P&ID LNG/CNG FUEL SYSTEM CHECK			SCALE	NTS	
P&				CHECKED: HS DATE		
DEI	DEEN SHIPPING		REPLACES:			
	CAD NR			CAD NR: 1002-110.dwg

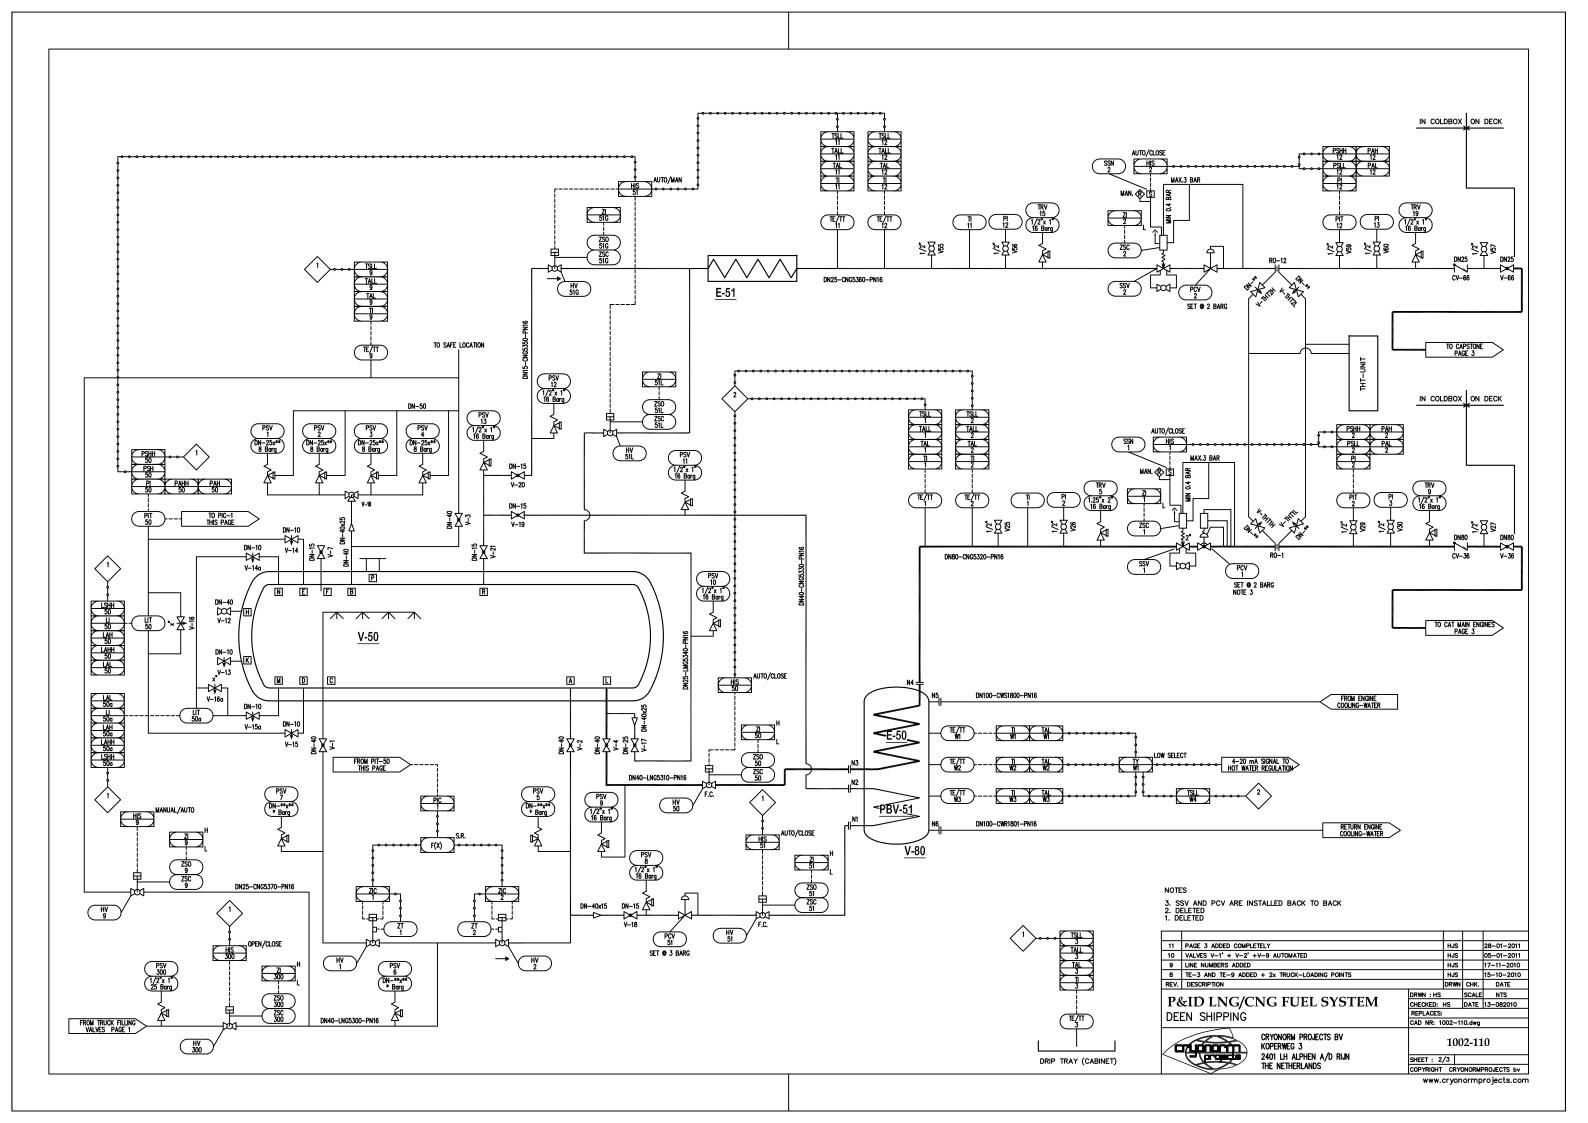
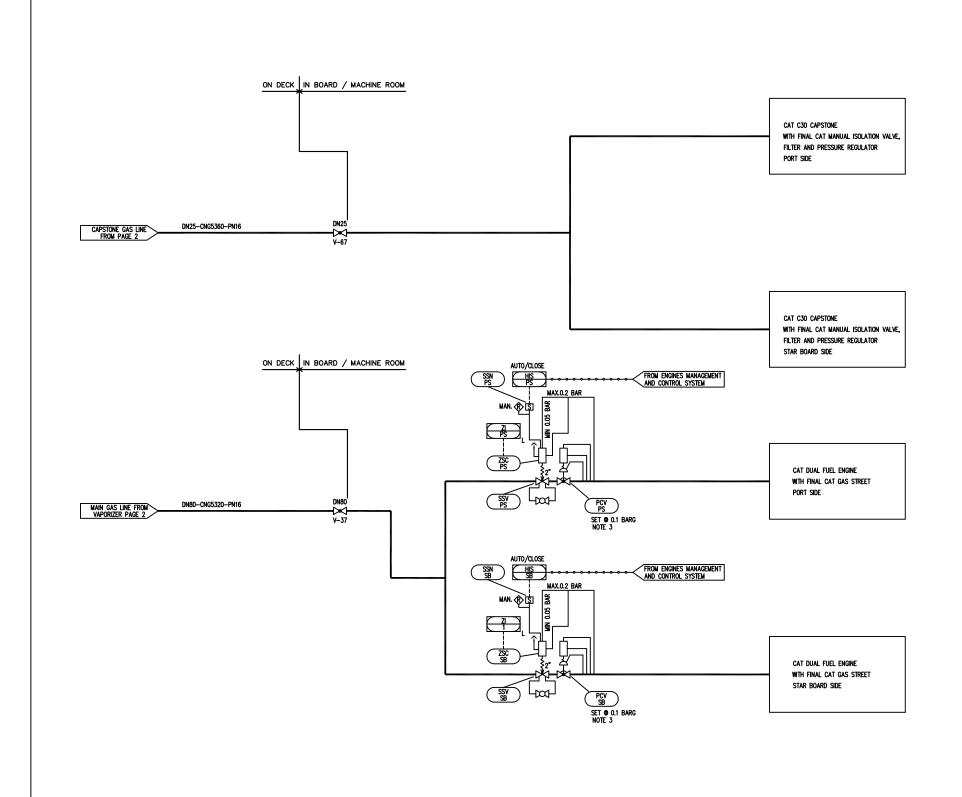
3. SSV AND PCV ARE INSTALLED BACK TO BACK 2. DELETED 1. DELETED

l .	l		
	11	PAGE 3 ADDED COMPLETELY					28-01-2011	
	10	10 VALVES V-1' + V-2' +V-9 AUTOMATED					05-01-2011	
	9	LINE NUMBERS ADDED			HJS		17-11-2010	
	8	TE-3 AND TE-9 ADDED + 2	K TRUCK-LOADING POINTS		HJS		15-10-2010	
	REV.	V. DESCRIPTION				снк.	DATE	
	DEEN SHIPPING REPLACE				: HS		NTS	
					HECKED: HS		13-082010	
					REPLACES:			
					R: 1002-110.dwg			
	<u>/</u> E	KOP	CRYONORM PROJECTS BV KOPERWEG 3		1002-110			
		2401 LH ALPHEN A/D RIJN		SHEET: 3	/3			
		THE NETHERLANDS			COPYRIGHT CRYONORMPROJECTS by
