**HYDROGEN VEHICLE FUEL SYSTEMS – LOCALIZED FIRE
PROTECTION CONSIDERATIONS**

VEHICLE FIRE CONDITION REPORT

**Transport Canada
Road Safety**

**Powertech Labs Inc.
12388 – 88th Avenue
Surrey, B.C. V3W 7R7
Canada**

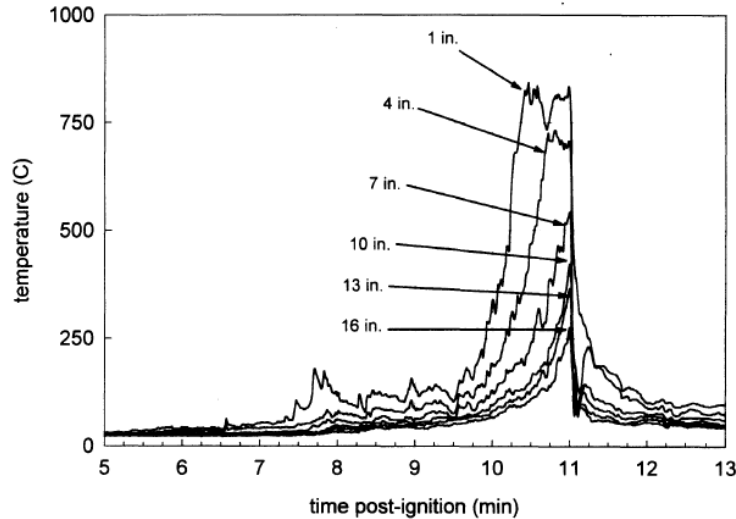
Figure 1: Fire Test F96115 - Plot of Air Temperature in Passenger Compartment Below Headlining.

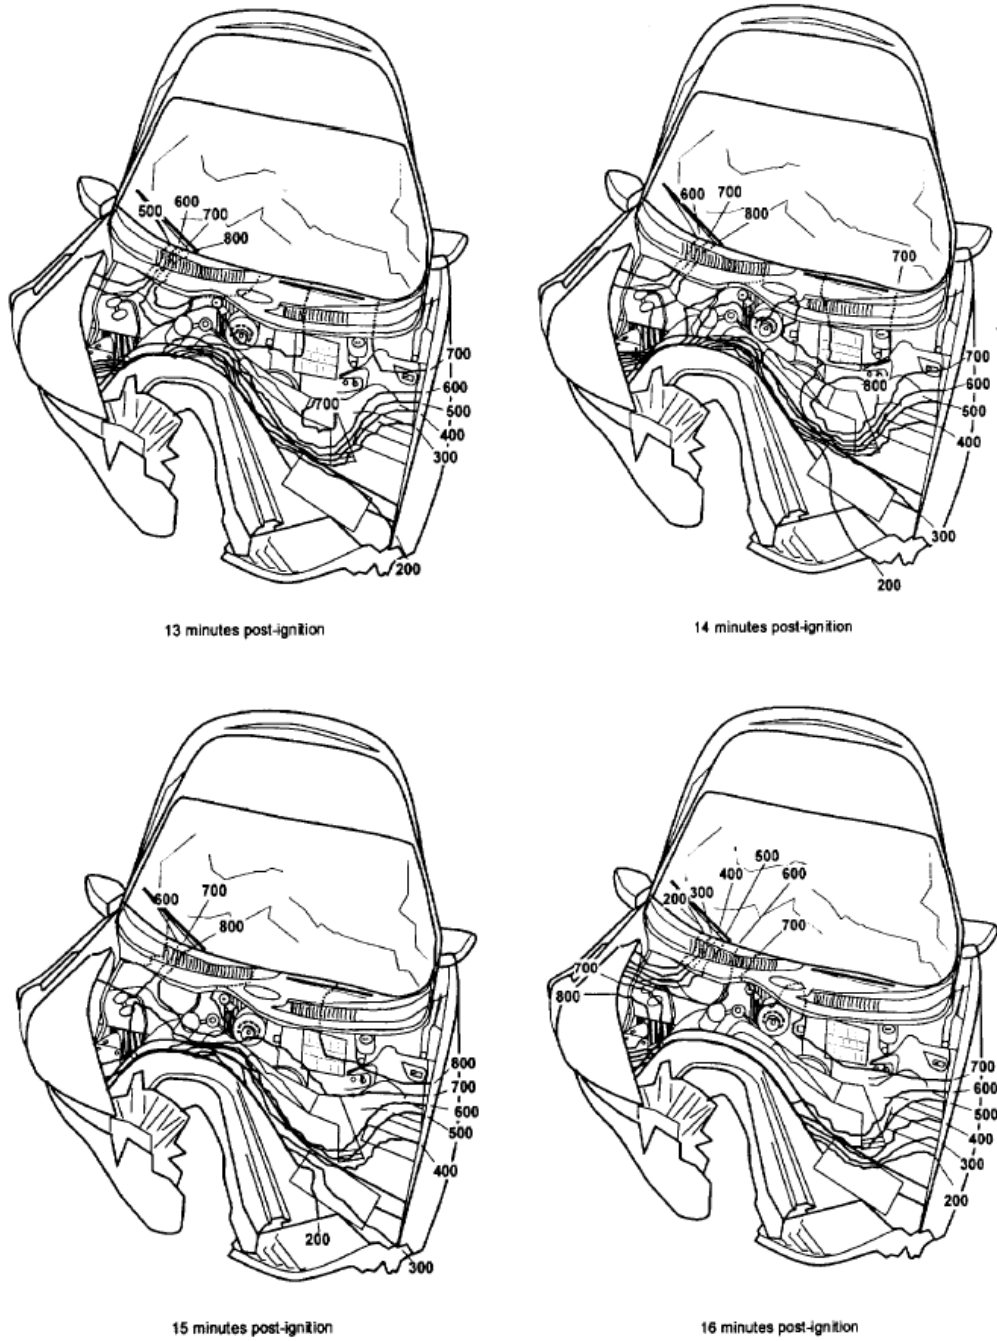
Figure 6: Fire Test F971003 - Isothermal contour plots of est. temps in upper engine compartment.

The pattern of fire damage observed during inspection of the test vehicle after this test suggested that flame-spread into the passenger compartment progressed along two pathways simultaneously. These pathways include the windshield and the HVAC module in the dash panel, both of which were broken in the crash test.

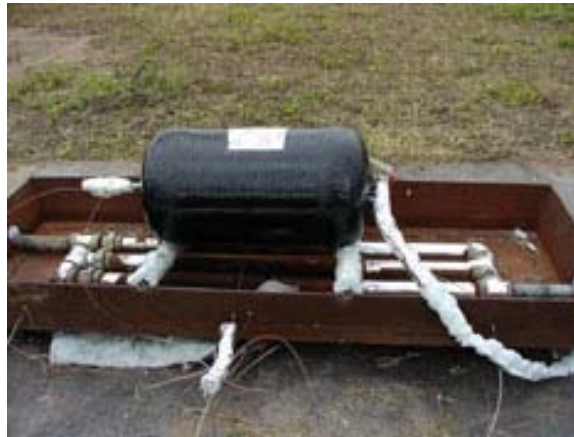
Figure 15: Hydrogen Tank Bonfire Test Apparatus

In a bonfire test Digges conducted without a TPRD, the composite material on the surface of the tank ignited after approximately 45 seconds. After 6 minutes and 27 seconds, the cylinder failed catastrophically through the bottom, launching the 14.0 kg main portion 82 m from the test location. Blast pressures were 300 KPa at 190 cm. The internal temperature and pressure of the hydrogen at the time of failure was 39°C and 35.7 MPa, respectively. The pressure inside the cylinder did not rise sufficiently so that a pressure-activated pressure relief device would have activated to prevent rupture. The temperature inside the cylinder also did not climb sufficiently to activate a thermally-activated pressure relief device if it used the *internal* temperature as the temperature source. Digges concluded it is necessary to place TPRDs such that they see the same, or worse, fire as the tank.

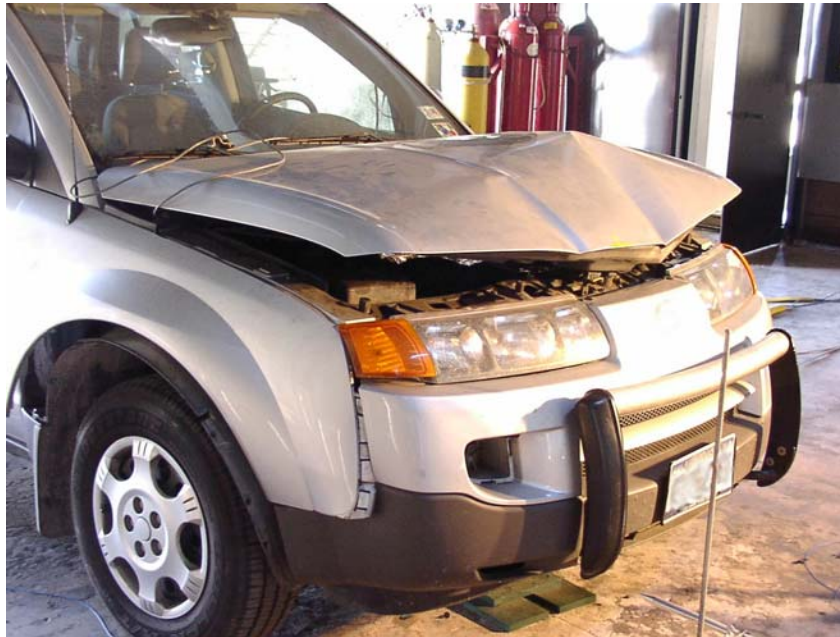
Figure 16: Damage done to Vehicle During H₂ Fire Test

Similar to the GM tests on gasoline pool and engine compartment fire tests, Digges simulated hydrogen leaks and ignition in passenger vehicles, measuring temperature and heat flux. Underside and engine compartment tests were done, some allowing the hydrogen to accumulate prior to ignition.

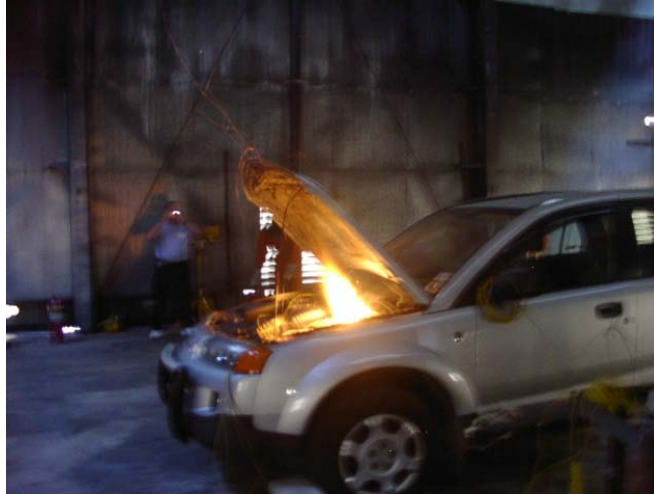
Figure 17: Fuel Line Leakage w Hood Open

In other tests, hydrogen jet-fires impinged directly on the underside of the hood of the engine compartment. The thermocouple in the direct path of the jet-fire recorded a temperature above 1204°C in each test, but temperatures on the underside of the vehicle did not increase appreciably.

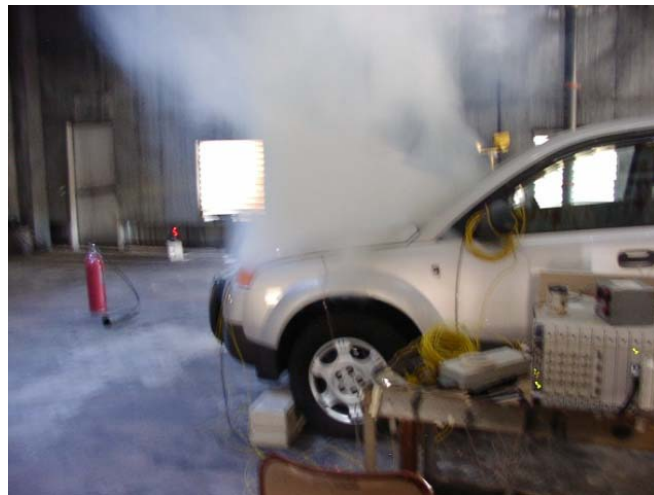
Figure 18: Fuel Line Leakage w Hood Closed
