Informal document GRSP-55-40
(55th GRSP, 19 - 23 May 2014,
agenda item 3(b))

Status of the Task Force Bumper Test Area

**55th Session of the Working Party on Passive Safety (GRSP)
Geneva, 19 -23 May 2014**

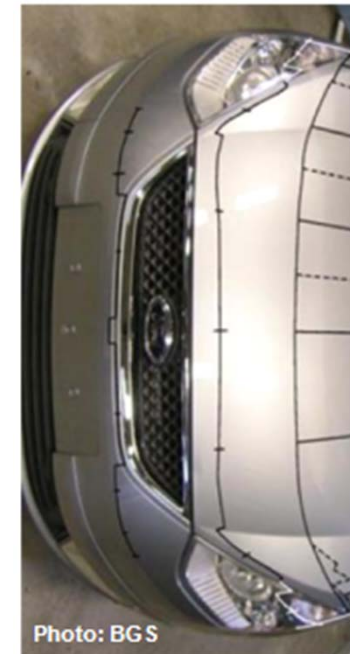
- 3.13. "Corner of bumper" means the vehicle's point of contact with a vertical plane which makes an angle of 60° with the vertical longitudinal plane of the car and is tangential to the outer surface of the bumper (see Figure 5).

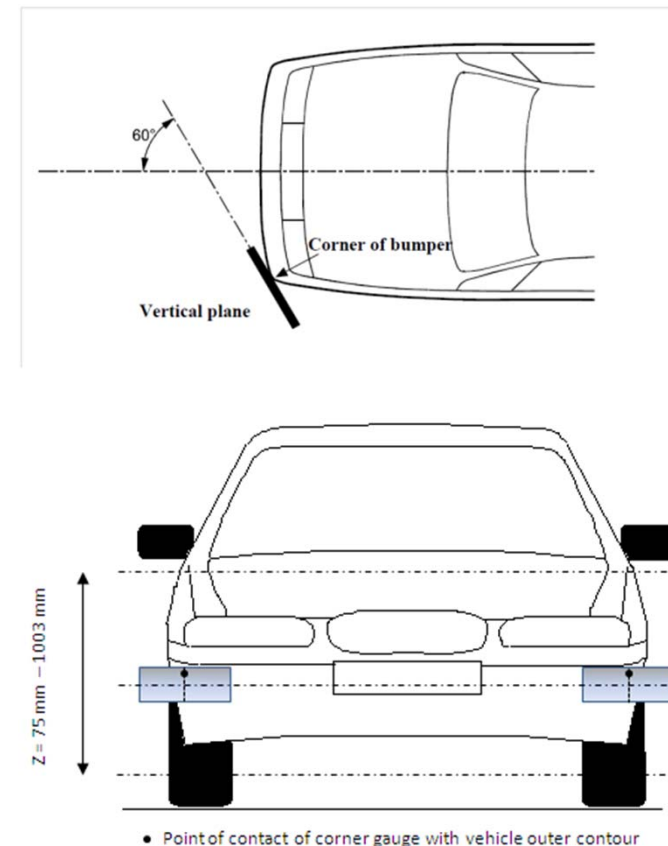
Definition of the Bumper Test Area as the area between the bumper corners, moving on either side 42 mm inboard parallel to a lateral vertical vehicle plane.

Definition of the bumper corners by the outermost contact point defined by contacting the vehicle with the vertical centerline of a 610 mm * 114 mm corner gauge at a height of the corner gauge's horizontal centerline between 75 mm and 1003 mm above ground level, with the gauges having an angle of 60° to the vertical longitudinal plane of the vehicle, and with the actual assessment area limited by lower and upper bumper reference lines
