**THE PROBLEM OF HIGH-DECKER COACHES IN THE STANDARD
ROLLOVER TEST**
(Presented by Hungary)

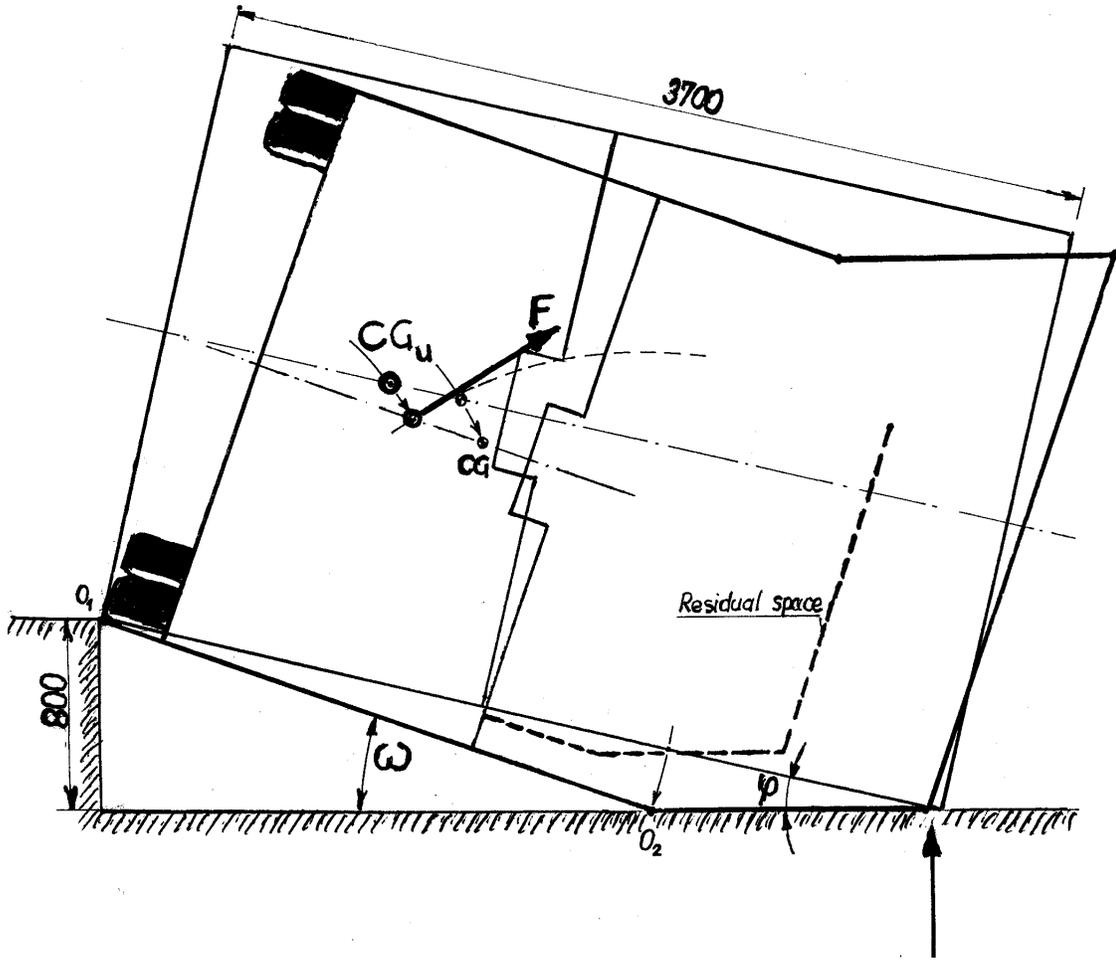
Fig.1. Deformation stops when the waistrail touches the ground (O_2)

- 2.1. In the case of a HD coach, tested according to the standard rollover test, if its superstructure has a four plastic hinges (PH) deformation mechanism (where the PH-s are located close to the cantrails and waistrails), the structural deformation stops, when the waistrails also touches the ground (See Fig.1.) As the results of the dynamic mass load “F” the bus slips away on the concrete surface of the ditch. The possible distortion of the superstructure may be characterised by the angle “ ω ”, depending on total height (H) of the coach.

- 2.3. If $\omega < v$ that means: the distortion of the superstructure in a standard rollover test will be stopped because of the geometrical configuration of the test bench, even in the case of a weak superstructure, too.

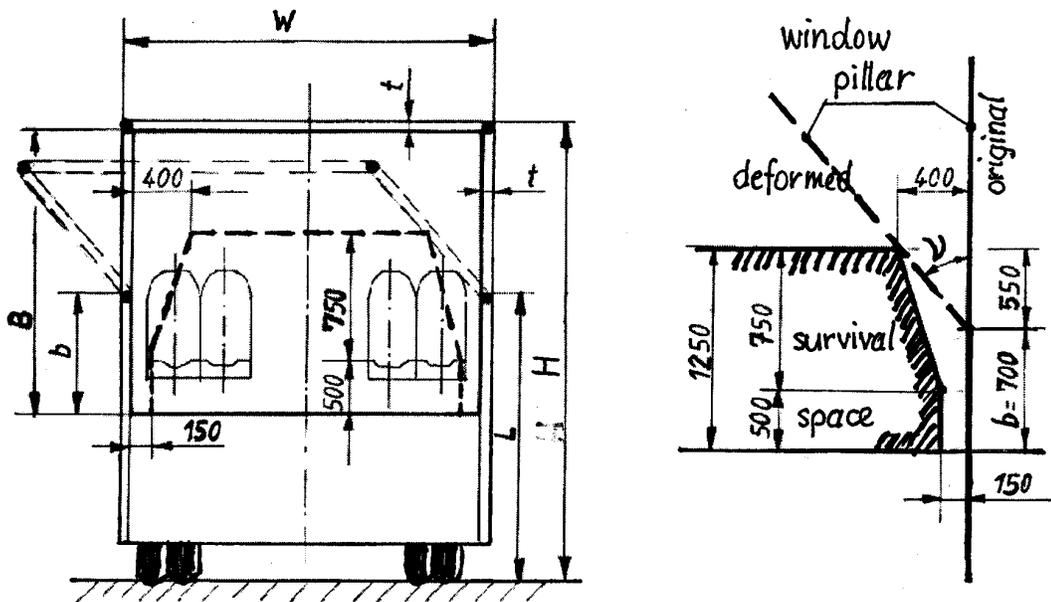
Fig.2. The acceptable limit of structural deformation

- 2.2. In the case of the 4 PH-s deformation mechanism, which is very frequent in the existing bus constructions, the maximum acceptable distortion of the superstructure (when the window pillars just touch the survival space) may be characterised by the angle “ v ”, depending on residual space geometry in the passenger compartment.
