# SUV - Windshield Head Impacts

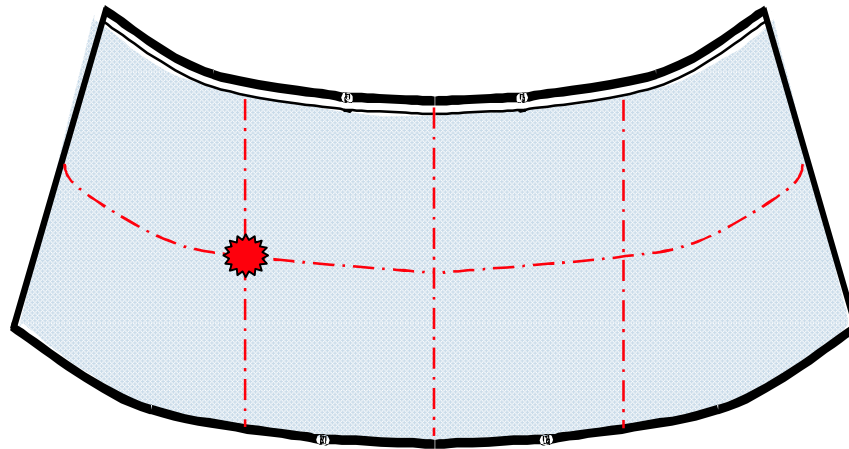
Impact to windshield:

- Midway between base and top of windshield
- 1/4 windshield width inboard from passenger side of vehicle

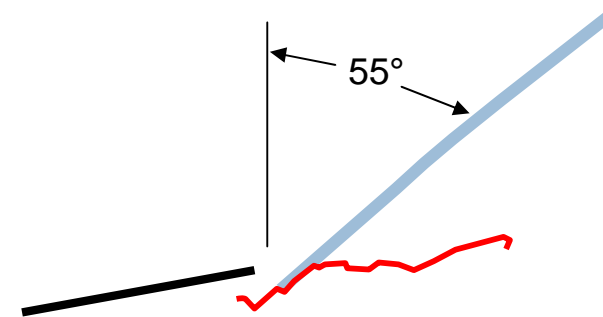
Windshield marking  
(replacement part only):

Laminated GS

DOT-376 ASI M334

Trans 75% MIN

AP Technoglass.

43R-000052

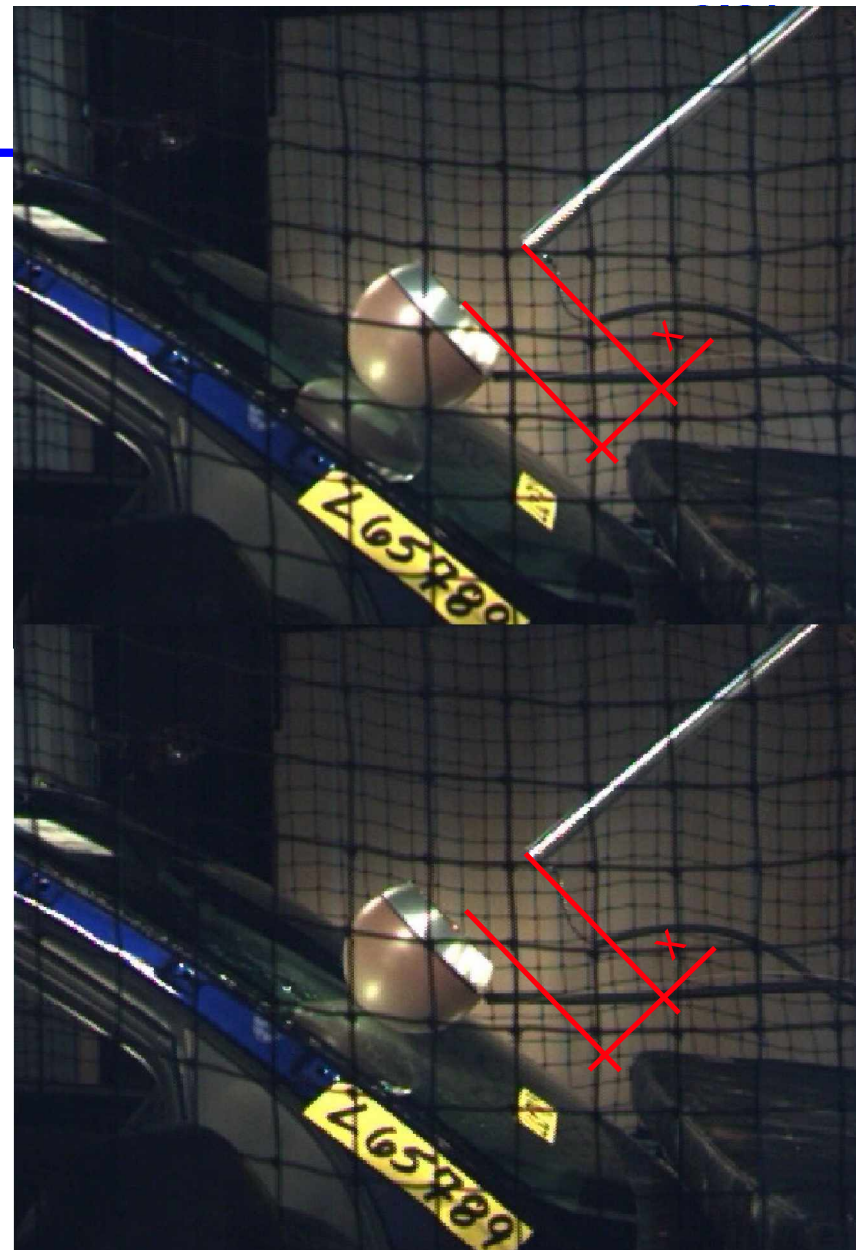
Tests 2, 3, 4, 6 and 7:

Windshield bounces before  
fracturing

x = headform travel distance  
at the time of the first contact

- Ø Impact angles 35°, 40°, 65° do not appear to have a significant effect on HIC levels.
- Ø HIC and intrusion depend on timing of windshield fracture.
- Ø Secondary impacts due to intrusion seen as biggest concern.
- Ø **Test results are unpredictable.**
- Ø **Design towards compliance seems impossible.**
- Ø **Further research necessary, especially regarding the behavior of the windshield glass.**

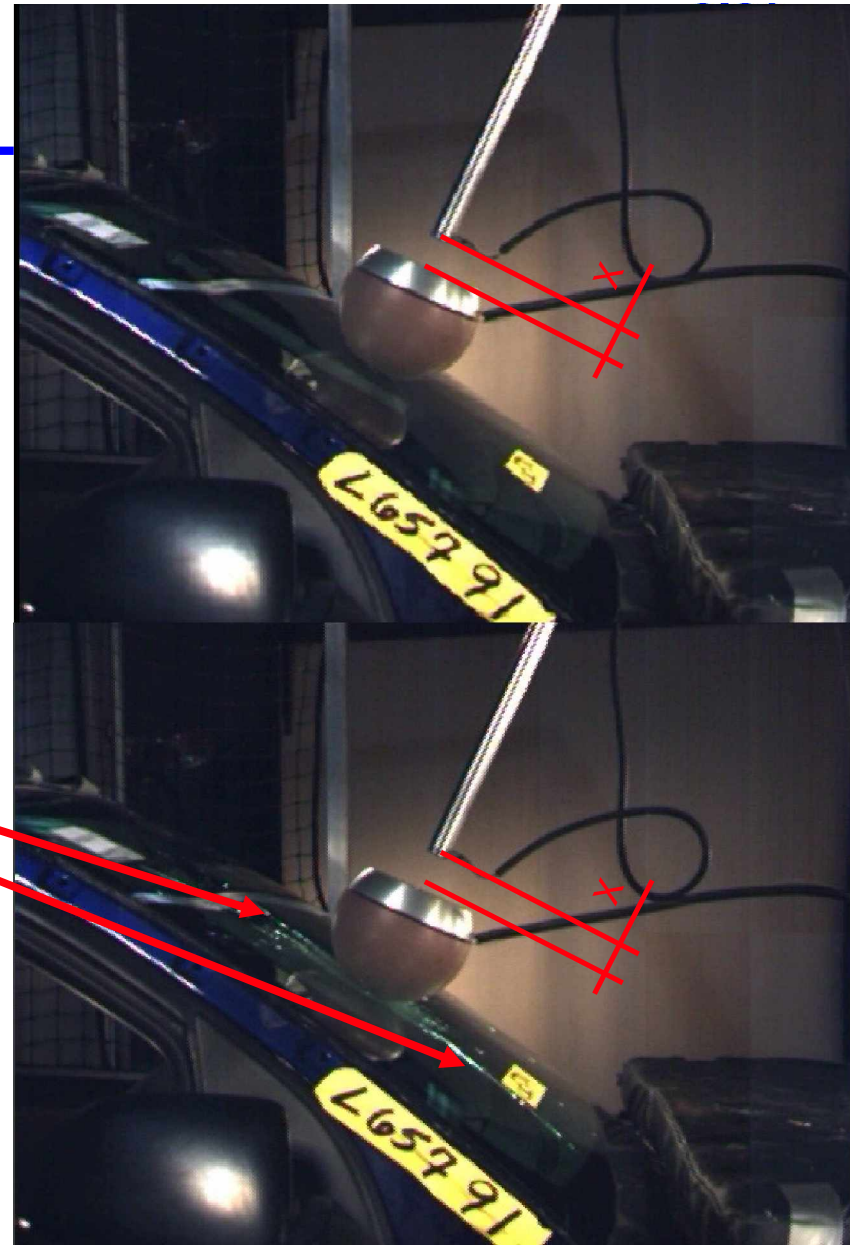
Tests 1 and 5:

- Lower HIC
- Greater intrusion of headform

Only difference: Windshield fractures immediately after being contacted by the headform

x = headform travel distance  
at the time of the first contact
