COMPONENT LEG TESTING OF VEHICLE FRONT STRUCTURES

Paper Number 05-0194

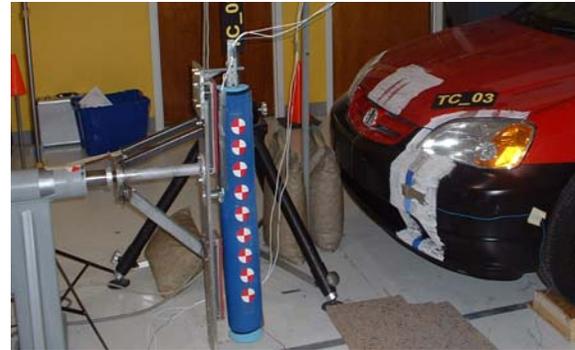
Legforms were launched in this test series by a carriage mounted to a hydraulic linear ram. During acceleration, the legforms were suspended from a pin at the top of the carriage and supported horizontally by padded fixtures mounted on the carriage adjacent to the upper leg and the lower leg (Figure 1).

Figure 1. Test setup.

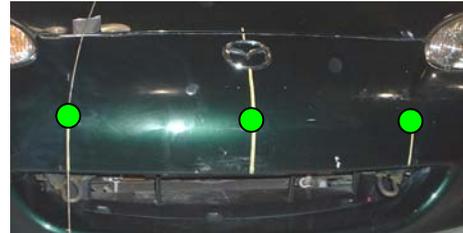
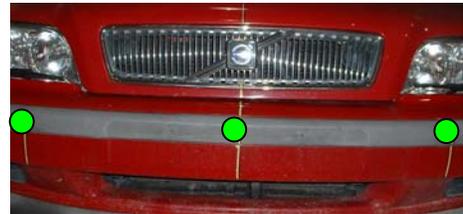
Bumper impacts were targeted at the areas near the left and right side bumper supports and centrally at the bumper midline. Figure 2 illustrates the impact points on each vehicle bumper. The locations of the off-center (hereafter referred to as “lateral”) impacts on each vehicle were symmetrical about the vehicle centerline. No impact points were within 65 mm of the bumper corner, as defined in the EuroNCAP procedure. Tire pressure was set according to manufacturer’s instructions. The emergency brake was engaged. No additional ballast was added to the vehicle weight. Tests were performed at all three locations before replacing the entire bumper system.

Figure 2. Impact points on each bumper system.

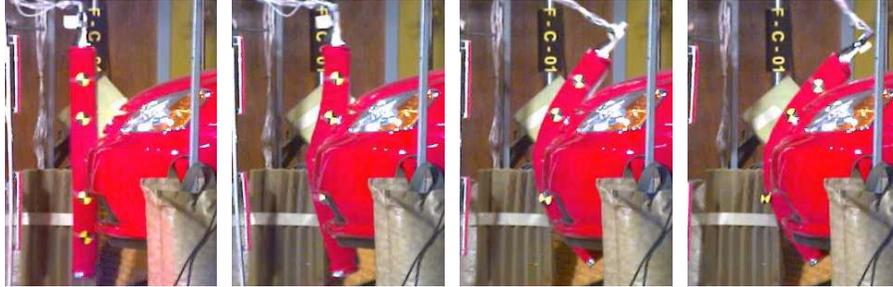
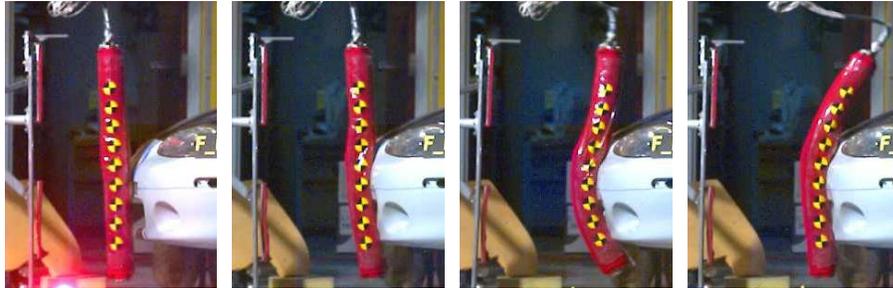
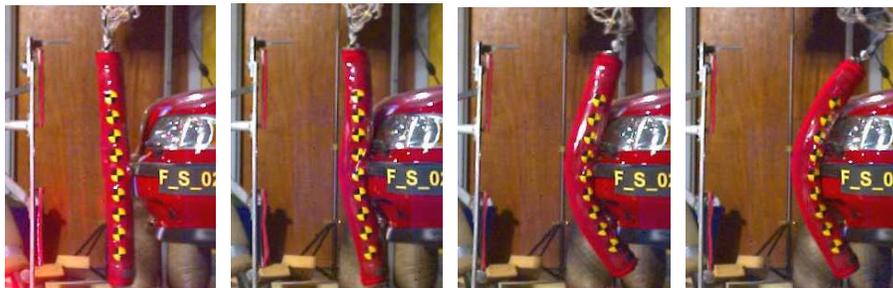
Kinematics of the FlexPLI are shown for tests into the lateral bumper of the Honda Civic, Mazda Miata, and Volvo S40 in Figure 10. The frames at 10 to 20 milliseconds show the knee end of the femur, and to a lesser extent the tibia, bending away from the bumper after contact in the knee area. The resulting convex curvature of the thigh and leg away from the bumper is

Figure 10. Kinematics of FlexPLI legform for three vehicles.

Figures 3 and 10 show the marked difference between how the TRL and FlexPLI legforms interact with the vehicles. The single-jointed TRL bent only at the knee while the FlexPLI's flexible femur and tibial elements allowed it to wrap around the front of the vehicle. This difference in how the legforms conform to the vehicle shape is likely to affect not only the magnitude of bending angle at the knee but all injury measures. Variations in the shape of the bumper, grille, and hood leading-edge structures may have a different effect on injury measures recorded by one legform than they do on the other legform.
