Window requirements for forestry machines

Jouni Havu
14—15.6.2011 Hamburg

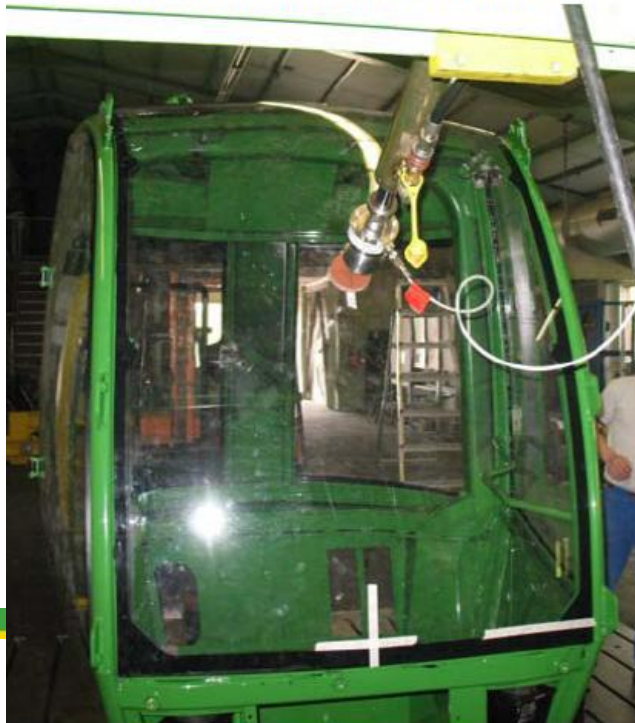
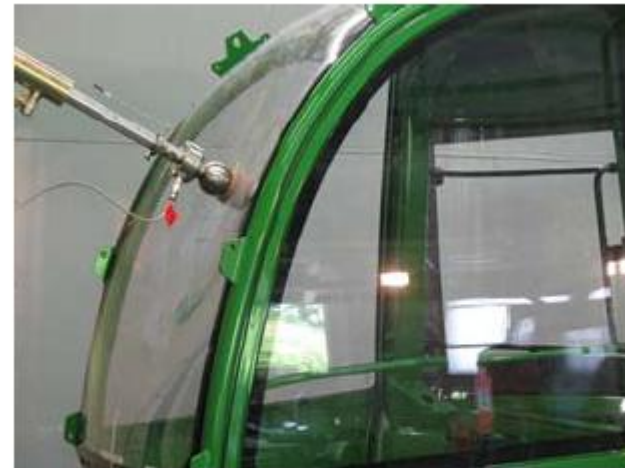
Frontscheibe (front window)

Belastung der Scheibenmitte bei Testende
(loading of the centre at end of test)

Window protection ISO 8084 OPS

4.3 Procedure

4.3.1 Slowly apply the force (5 mm/s max., to approximate static loading) from the test object normal to the exterior surface under test until this applied force attains a value of 17 800 N. Sustain the force at this value for 1 min before releasing it.

When the test is performed anywhere on the OPS, the DLV, in accordance with ISO 3164, shall not be entered by any part of the OPS or the test object, and the major diameter of the test object shall not pass through the surface under test.

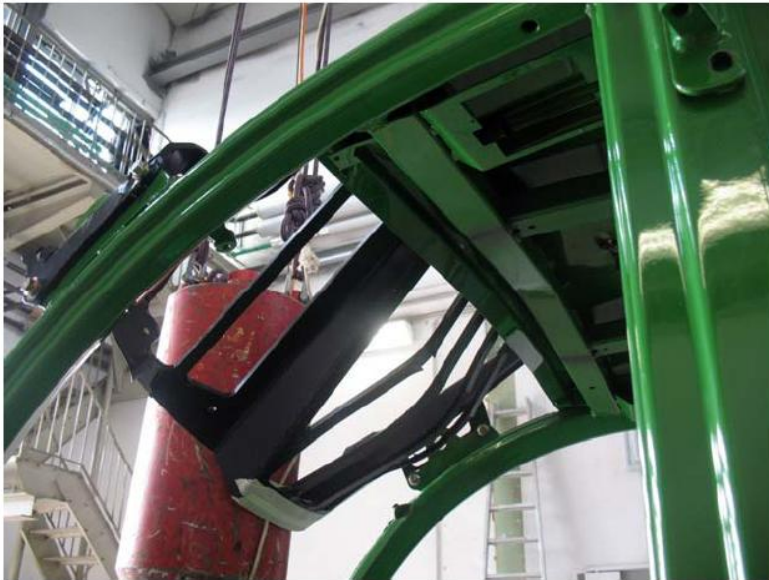
Nach dem Auftreffen des Fallkörpers auf das FOPS-Gitter- Ansicht von der Unterseite
(After the drop of the falling object on the FOPS-grid – view from down side)

4.3.3 Raise the drop test object vertically to a height above the position indicated in 4.3.1 and 4.3.2 to develop an energy of 5 800 J or 11 600 J based on the mass of an object shaped as shown in figure 1. Two energy levels are given : national authorities may choose the level of requirement according to local conditions such as log size, etc. The drop test object shall be aimed to impact at a location on the FOPS to produce the maximum deflection.

The protective properties of the FOPS system shall be estimated by the ability of the cabin or protective structure to retain its safety zone intact after the impact. The DLV as defined in 3.2 and specified in 4.2.1 shall not be entered by any part of the protective structure under the first or subsequent impact of the drop test object. If the drop test object penetrates the DLV, the FOPS shall be deemed to have failed.

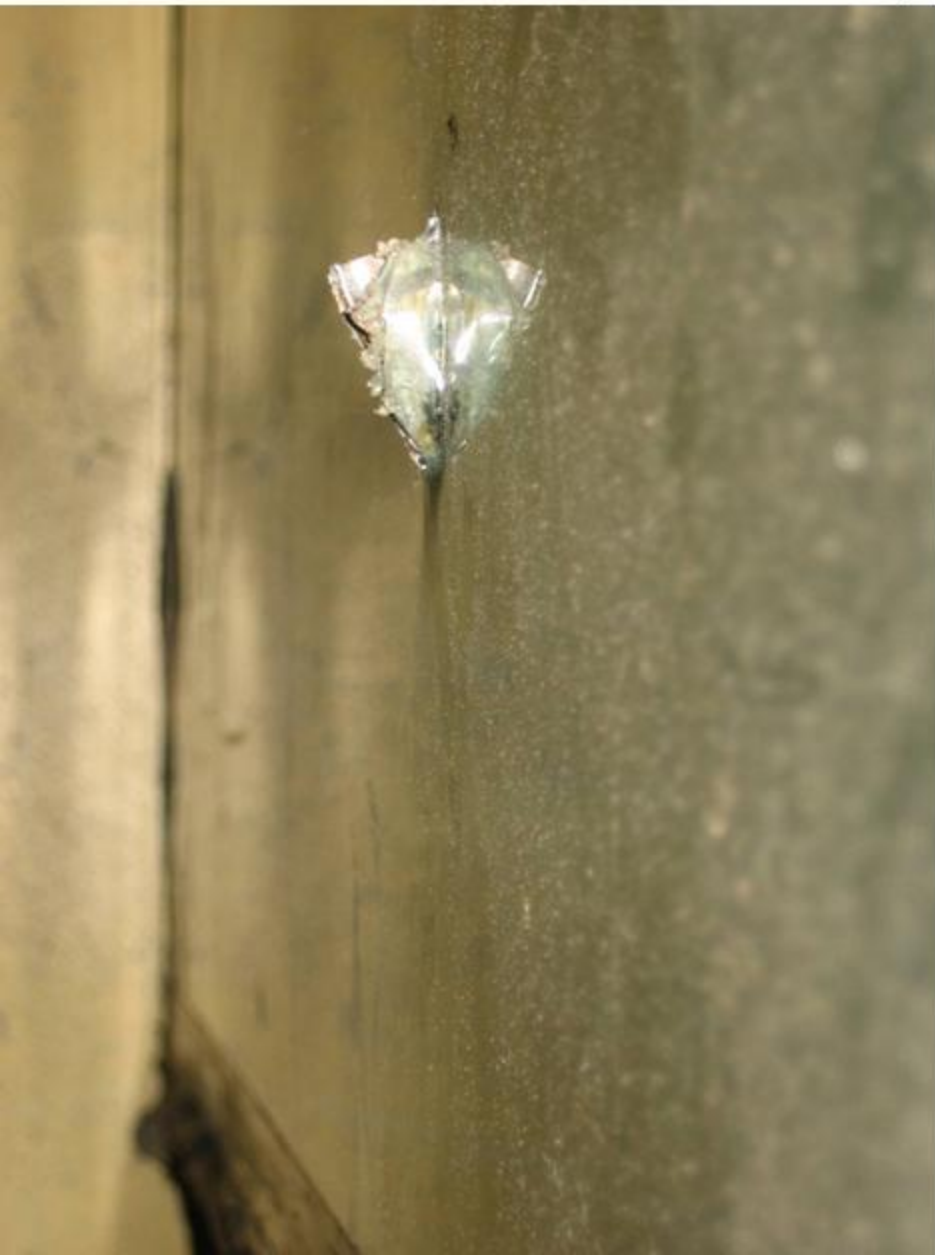
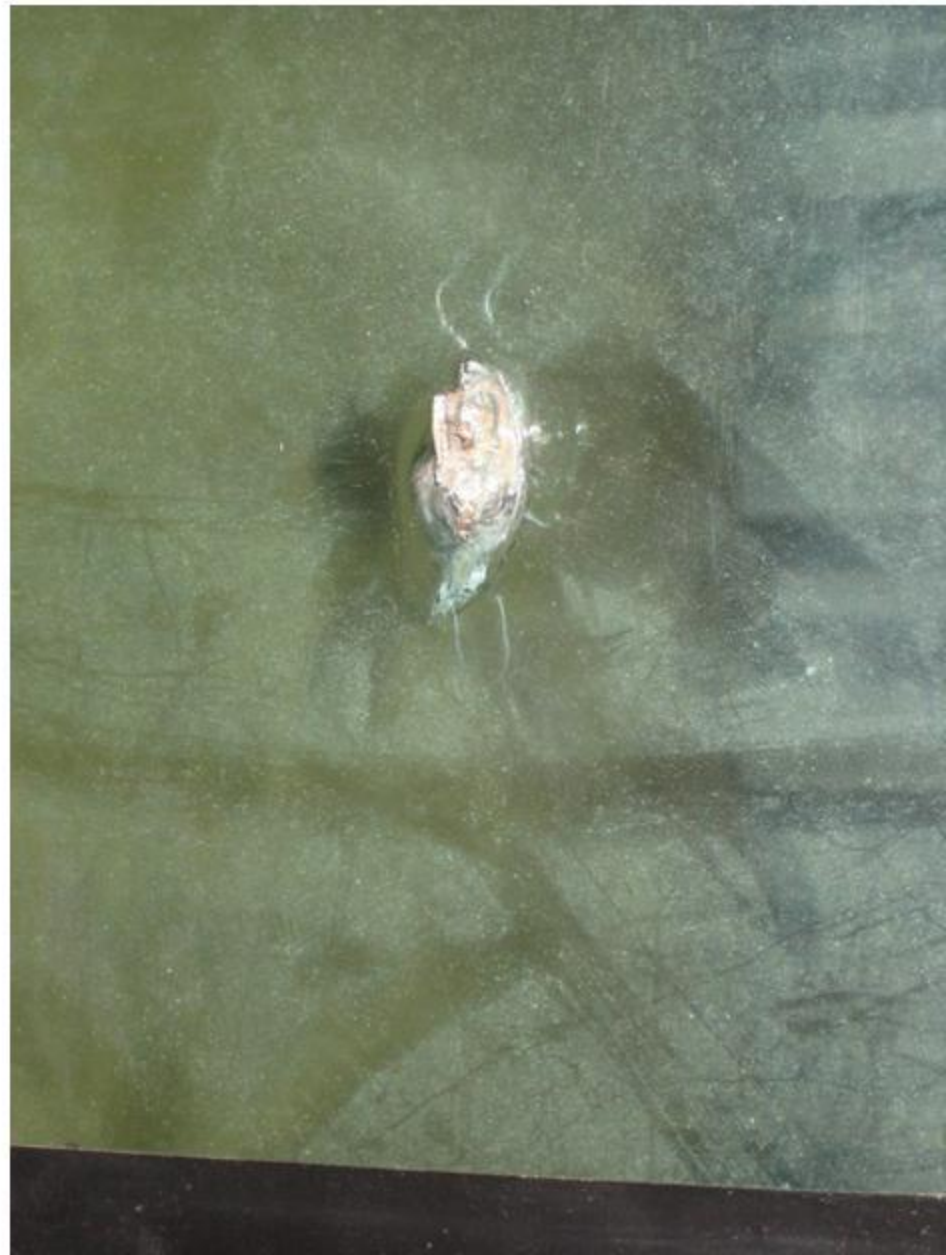
Piece of chain, no full penetration (12 mm)

What is chain shot

Chain does break during sawing

1-3 chain links loose and fly

Even 450 m/s speed measured

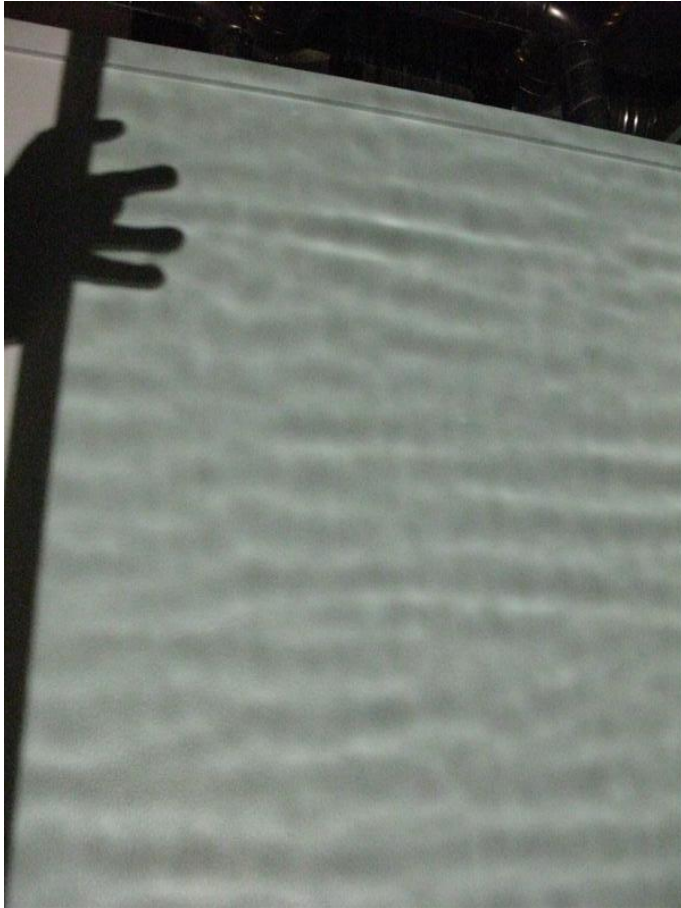
Old 12 mm polycarbonate

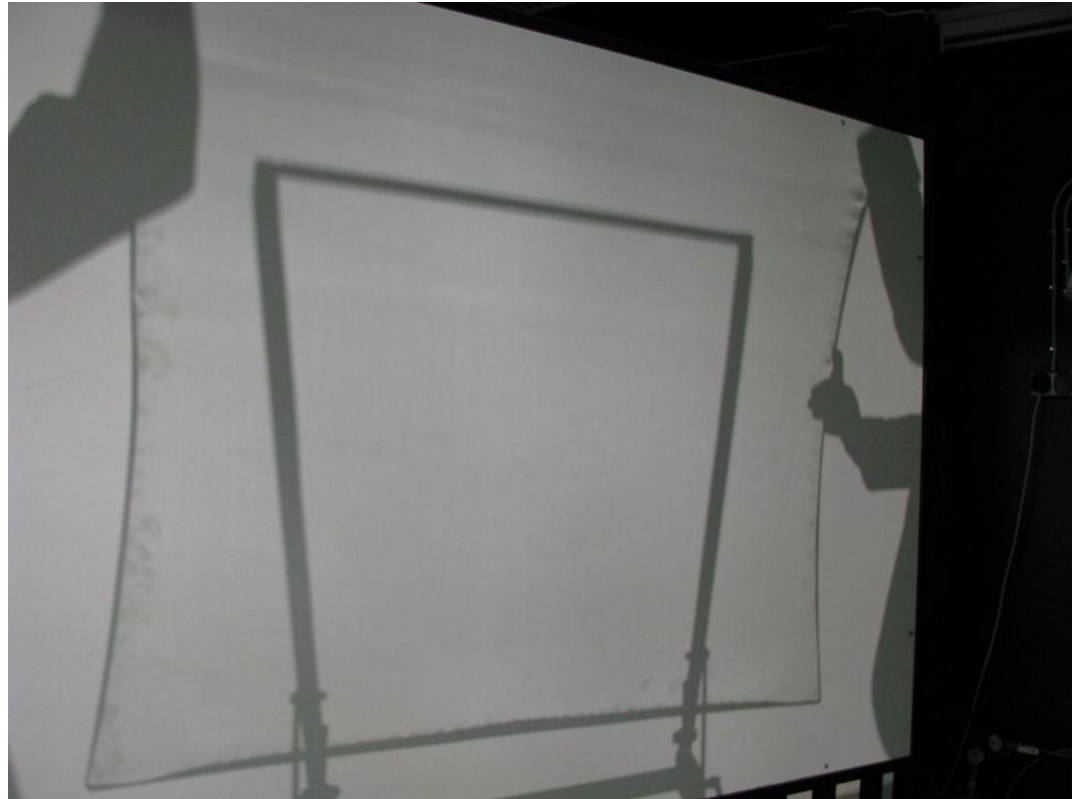
4 + 4 mm laminated standard, preferred optics
