# Introduction of Tianjin Port Accident

The extremely severe fire and explosion at Ruihai International Logistics hazardous goods warehouse at Tianjin Port on 12 August 2015

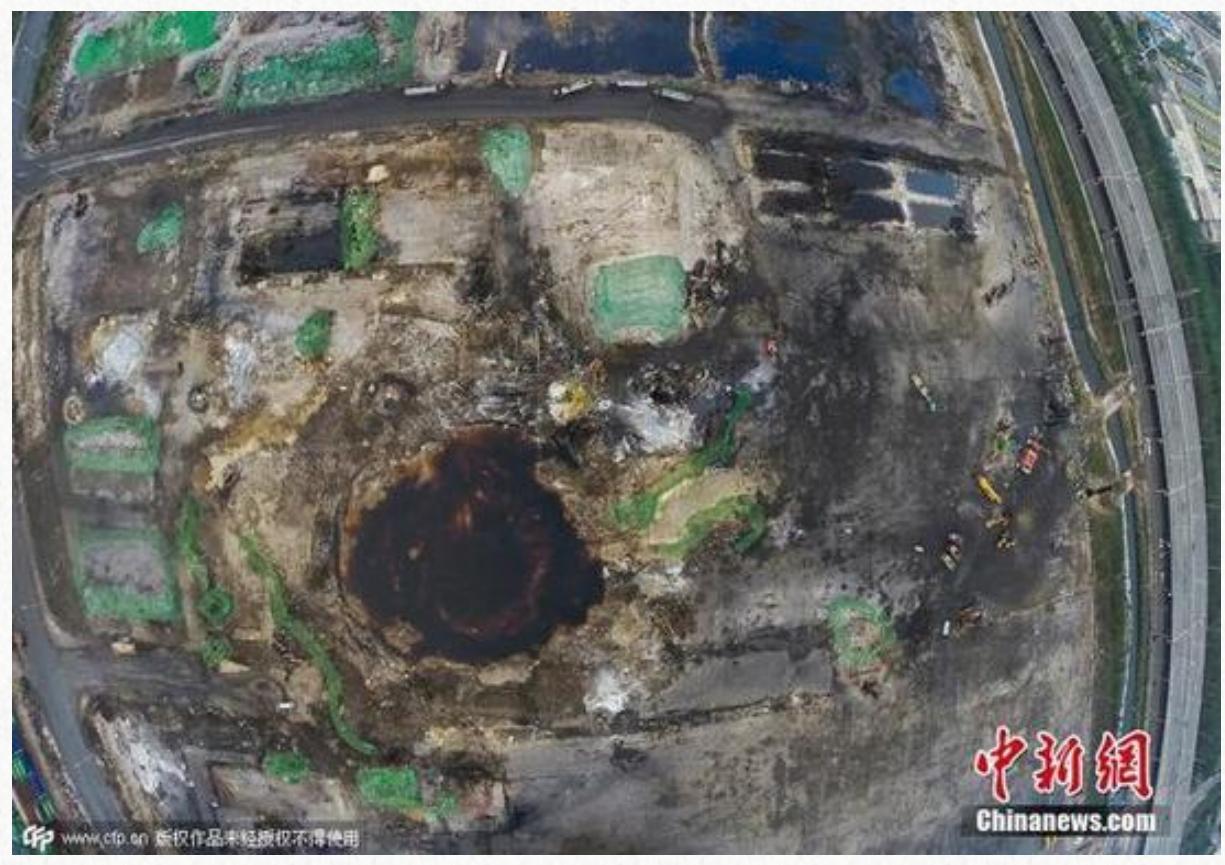
According to the degree of damage, the area was categorized into the central zone and the affected zone.

The surface area of the central zone is approximately 540 000 m<sup>2</sup>.

The explosion pit was considered to be the main centre of the explosion. (diameter: 97 m; depth: 2.7 m)

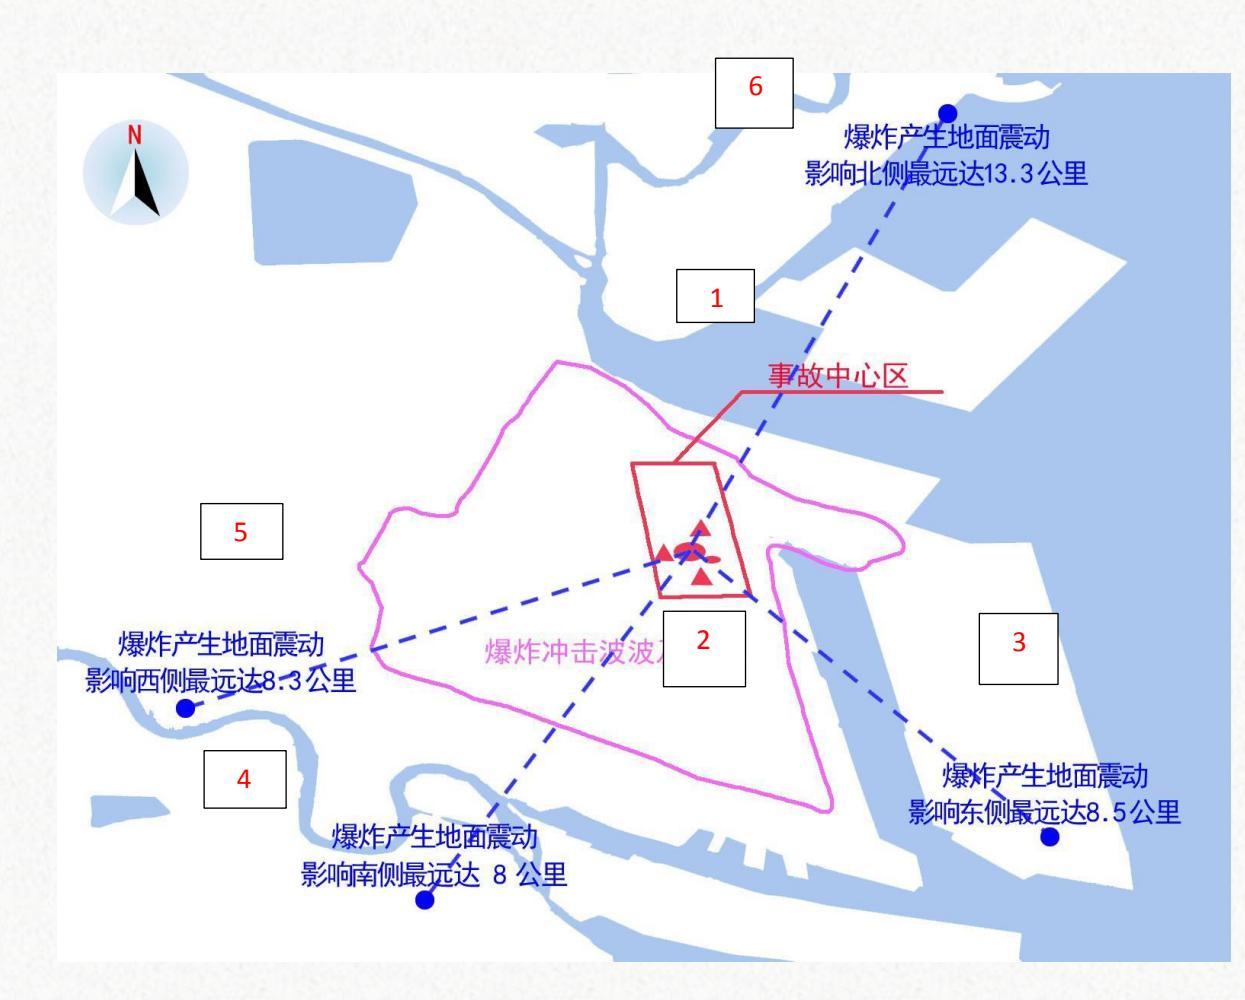
Map 4: Schematic sketch of the blast shock-wave affected zones

Ground shaking caused by the explosions detected as far as 13.3 km away from the explosion center in the north

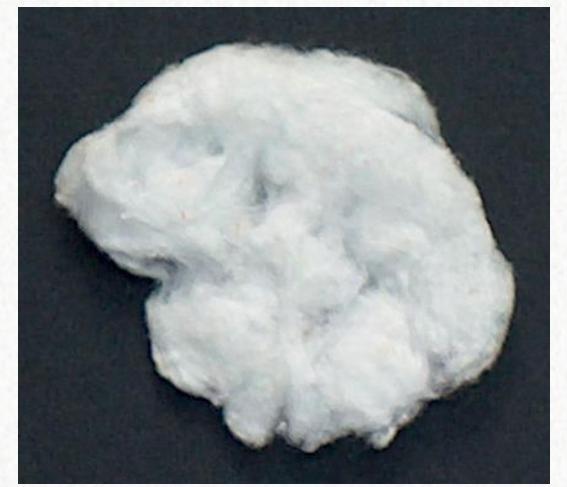
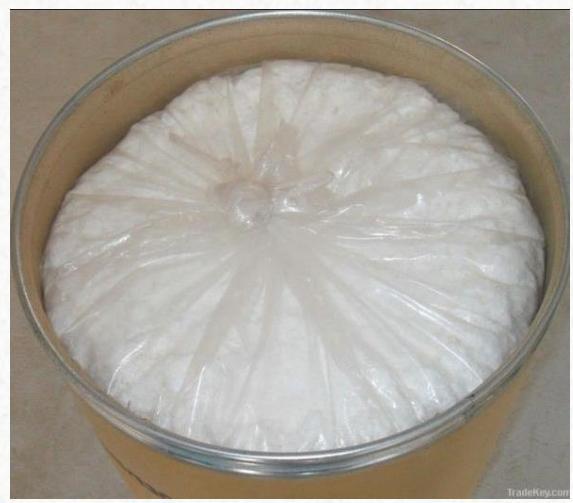
Damping agent ethanol was Used in the packaging

Nitrocellulose packaging with packaging strings, instead Of thermoplastic sealing

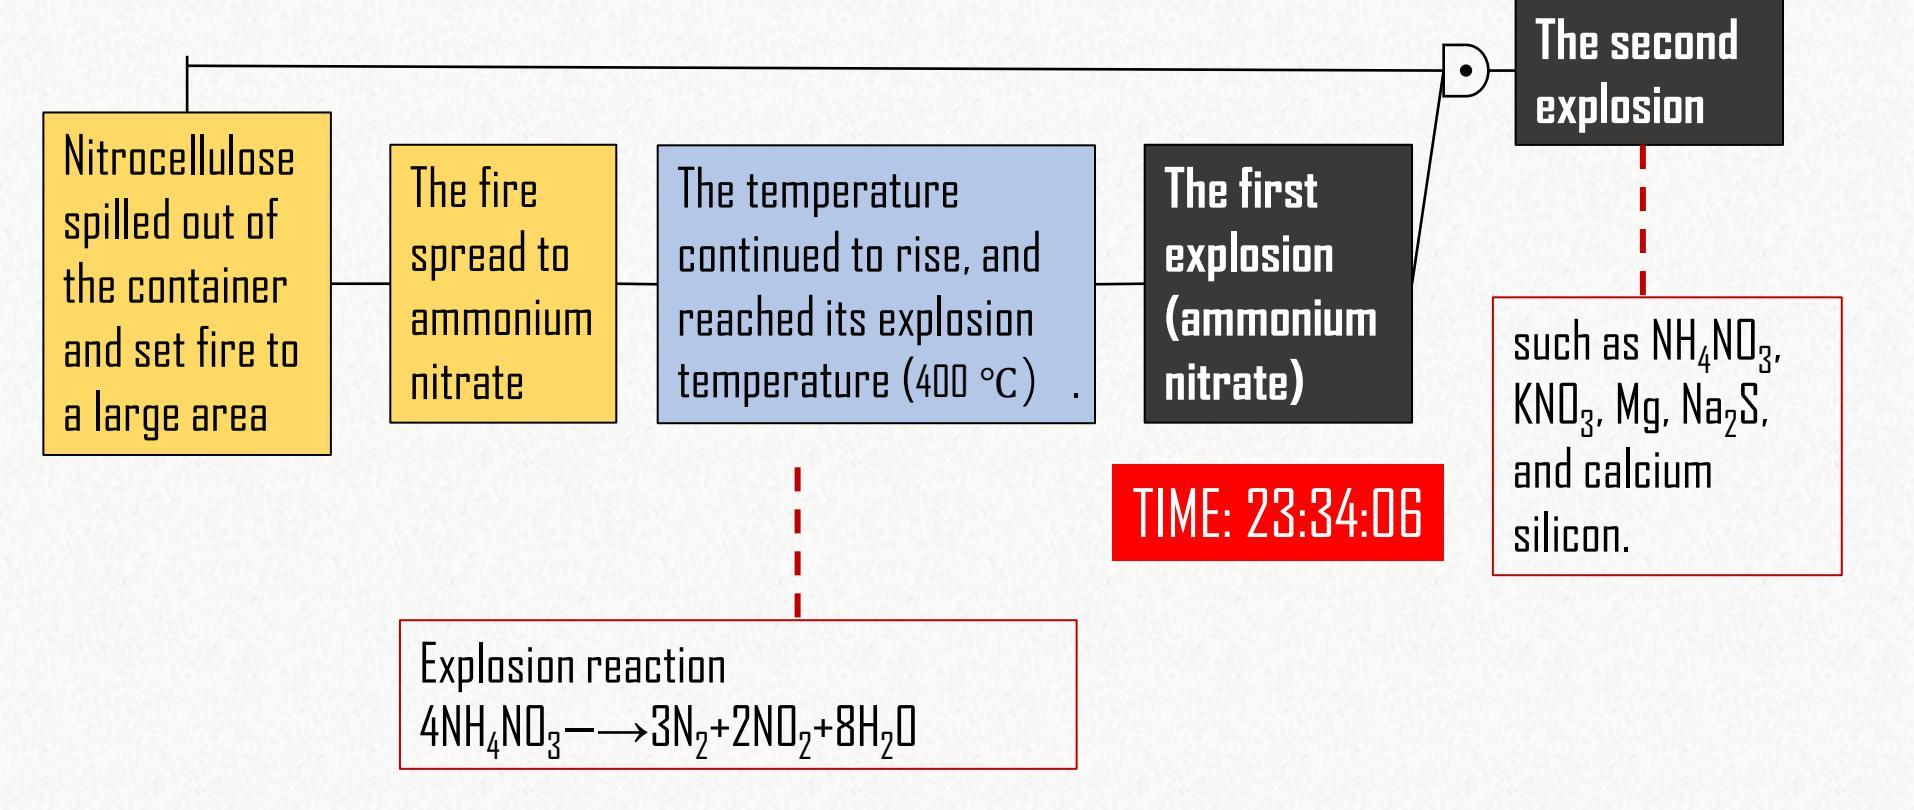
TIME: 23:34:37

The total strength of the explosions involved in the accident was equivalent to approximately **450 tonnes of TNT.**

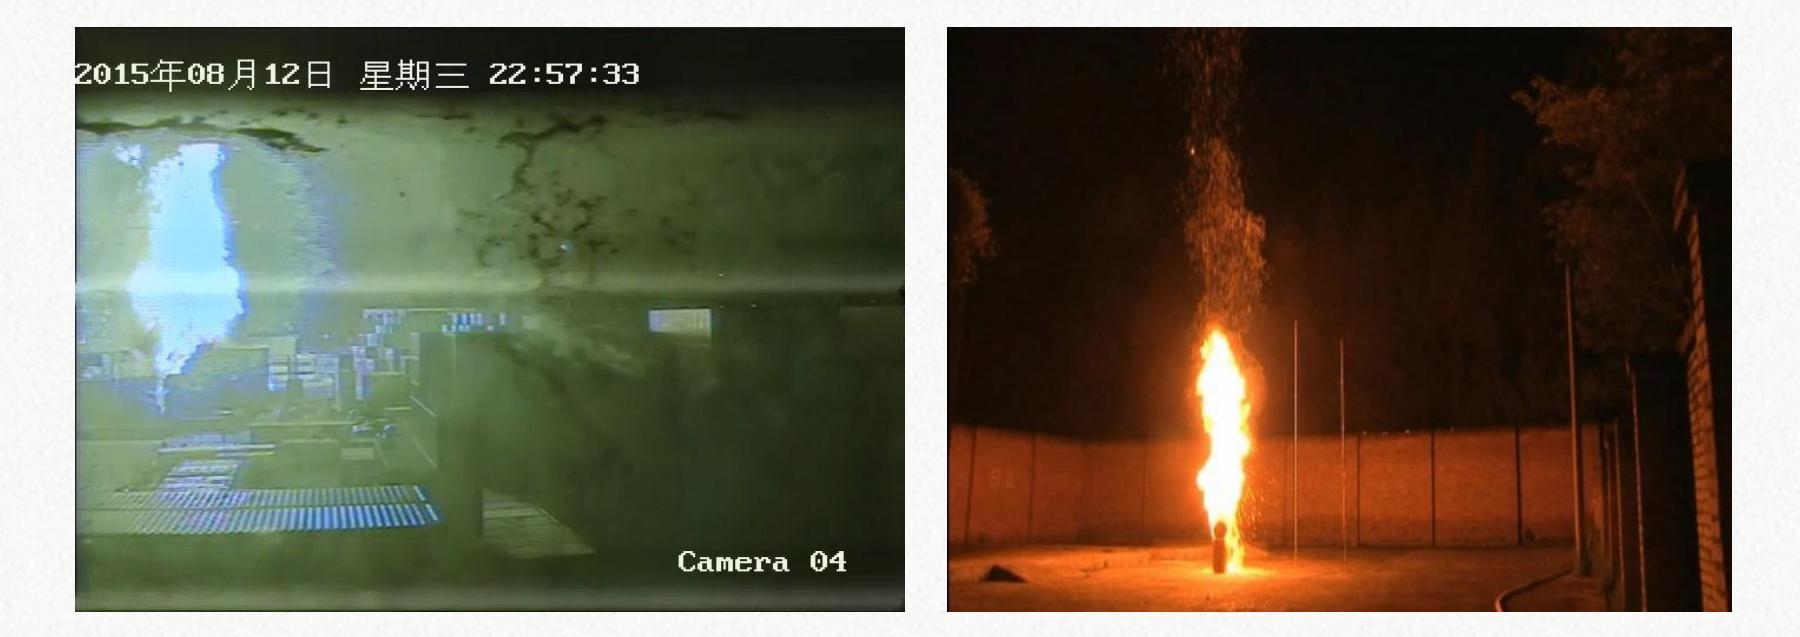
#### Surveillance video No 4

Combustion experiment on a 40 kg drum of nitrocellulose
