ANNEX M - SUMMARY GRAPHS

List of Figures

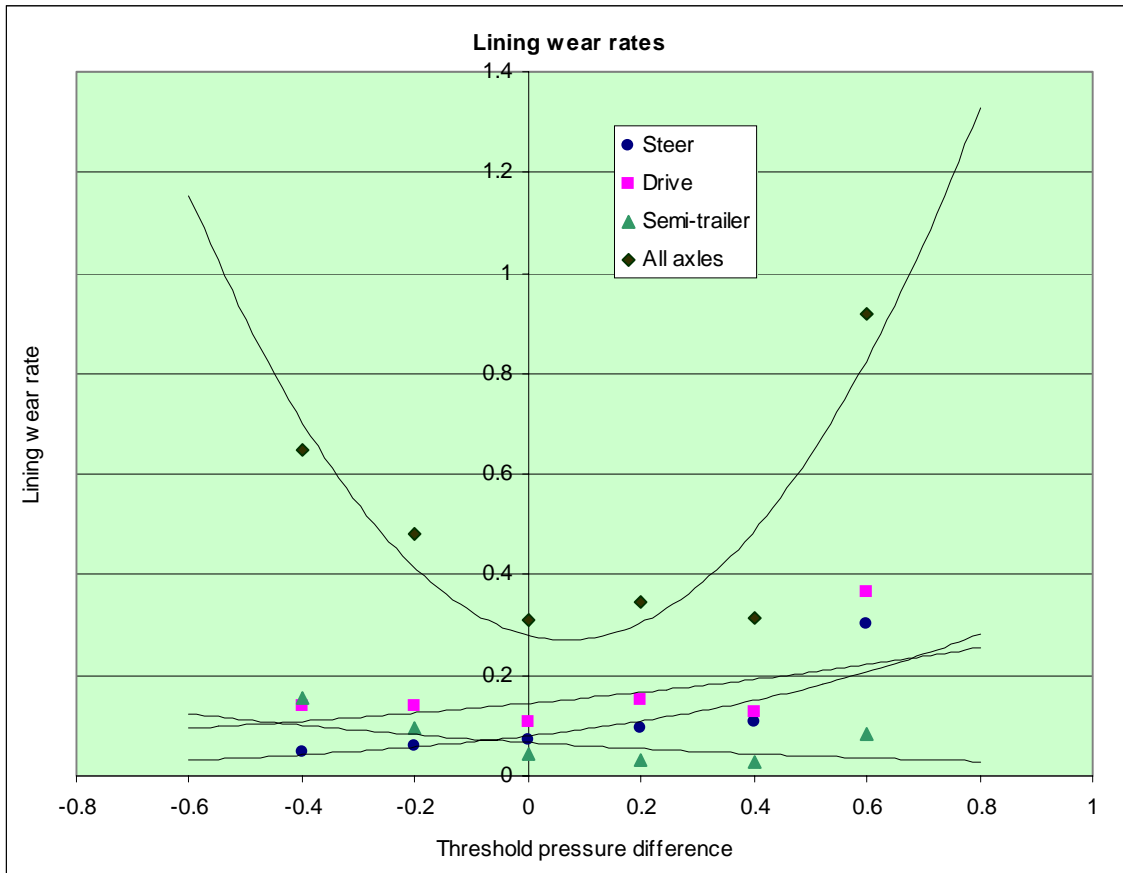
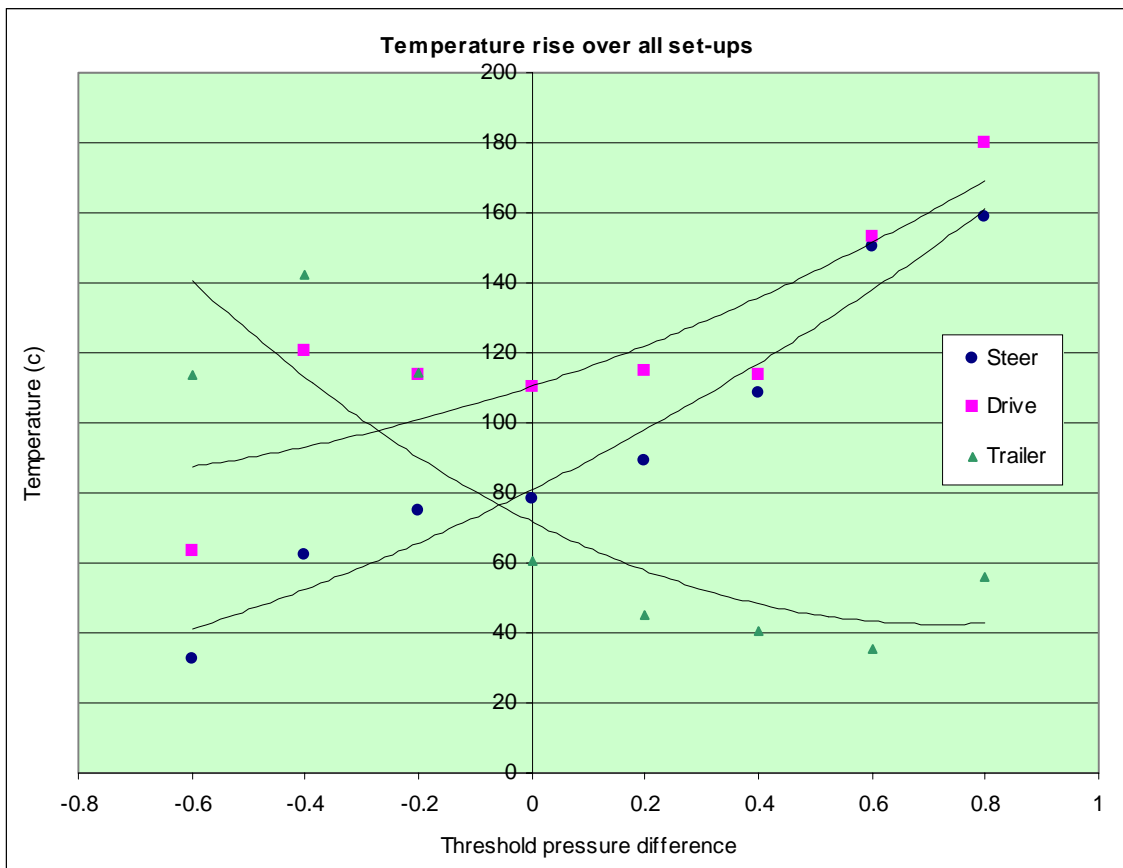
ANNEX M1: Summary Graphs

- Figure M1** Overall lining wear rate and overall temperature over road trials
Figure M2 Wear rate vs temperature rise over road trials
and work done over road trials
