Presented by Hungarian expert

IMPROVING THE REQUIREMENTS OF BUS EMERGENCY EXITS

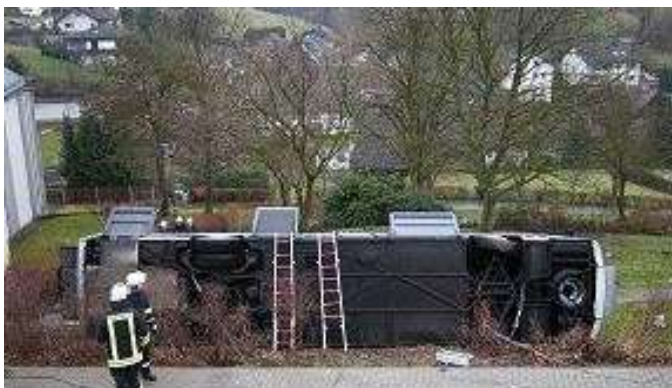
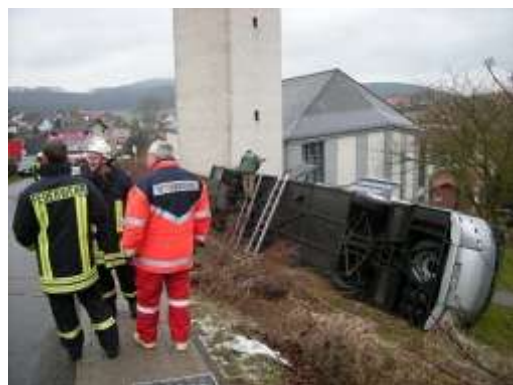
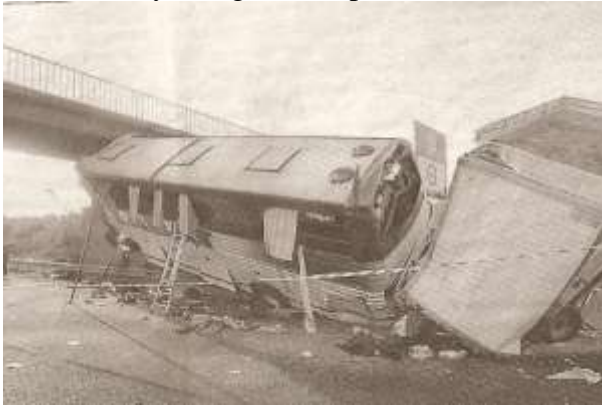
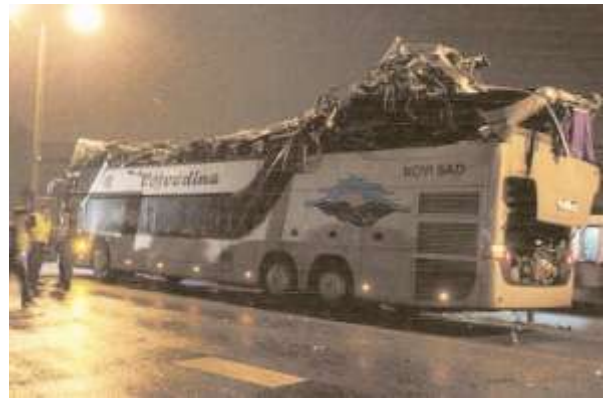
4. Some examples are shown below about real accident situations, way of evacuations, actions of fire brigades, etc.
 - 4.1. The side windows cannot be used as EE without outside help (e.g. ladder). This is the situation in HD and DD coaches and also when the bus is lying on its side. In these cases the minimum required dimensions are insufficient.

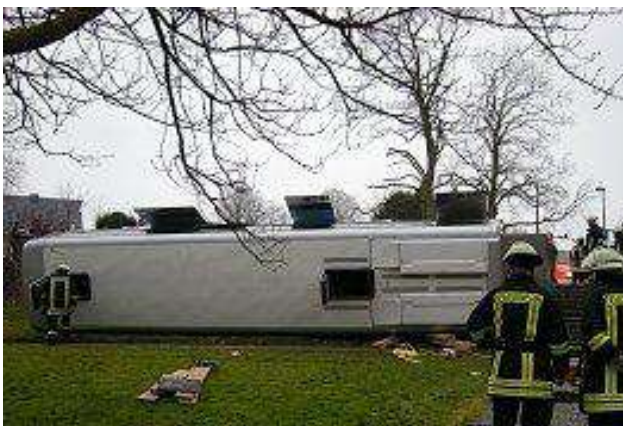
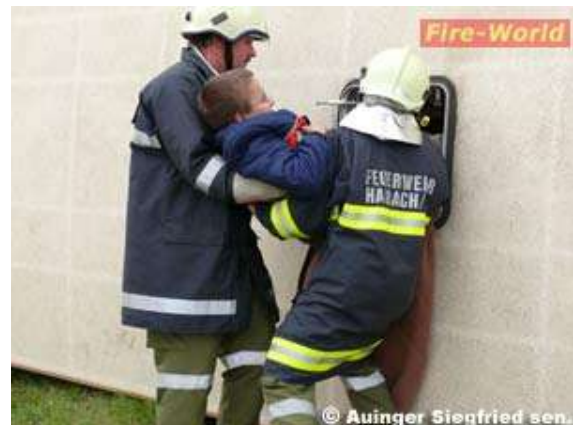
4.2. The minimum dimensions of the escape hatch seem to be good for an active, capable passenger, but could be small, when injured passengers are evacuated using outside and inside help. Panic and fire should be also considered.

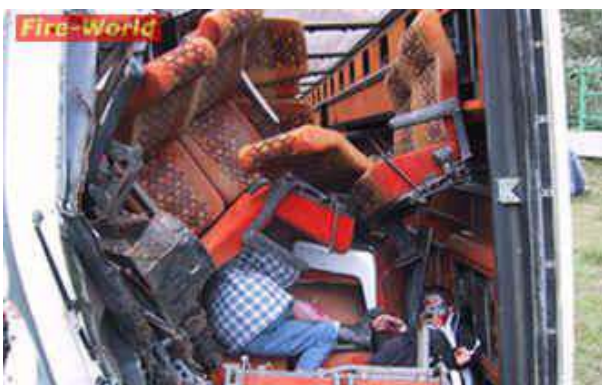
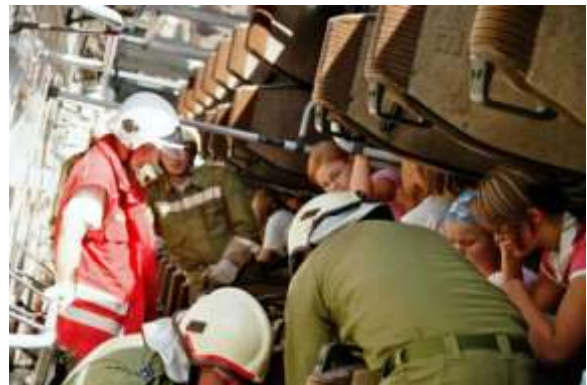
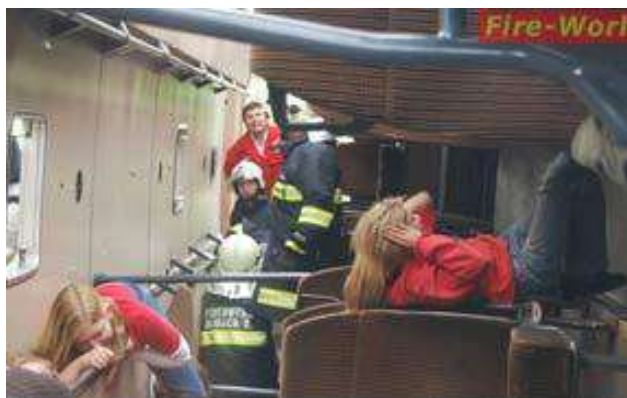
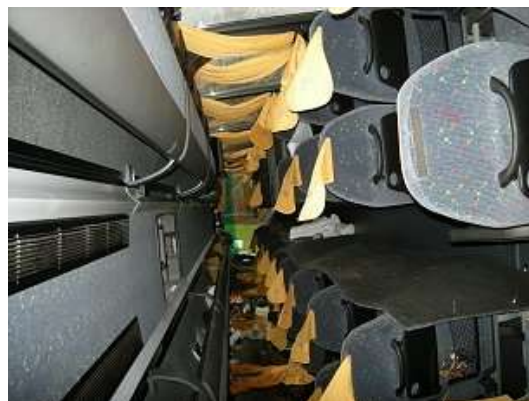
4.3. These pictures give good examples about the completely different situation in relation to the passengers and the possible EEs. There is no floor, gangway on which the passengers can move, the seats are obstacles, the passengers are lying on each other having very peculiar position, and some of them are injured.

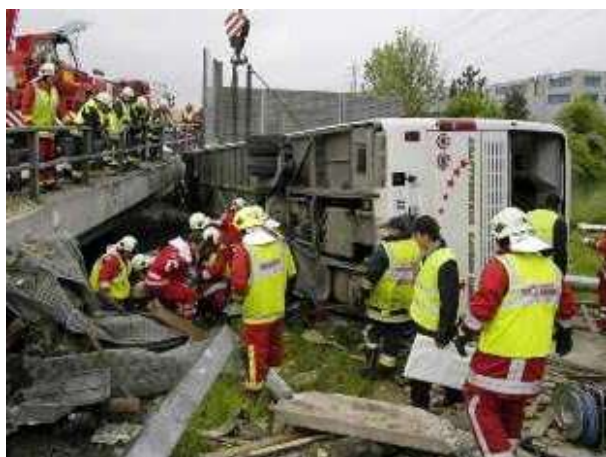
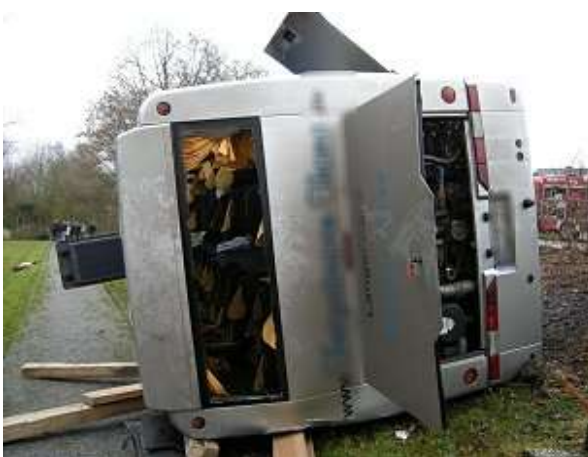
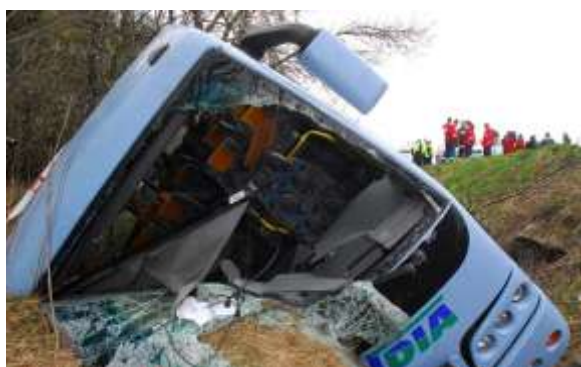
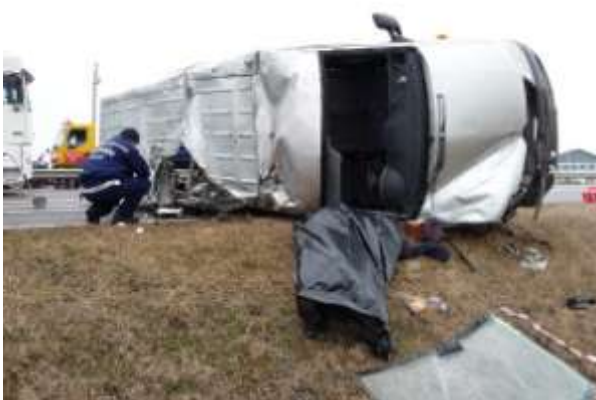
4.4. The rear wall window and the windscreen shall have much higher importance as EEs in the future. May be it would be useful and necessary to require them as EE with the belonging technical specifications. In the everyday practice they are used very often as EEs. Unfortunately there is no rear wall window in many coaches, mainly in the HD versions.
