Jerzy W. Kownacki (ITS)**Od:** Valtonen Juha [Juha.Valtonen@mintc.fi]**Wysłano:** 5 lipca 2010 15:26**Do:** jerzy.kownacki@its.waw.pl**Temat:** SDWEE - group; Case bus fire in Karkkila Finland december 2008**Załączniki:** IMG_1043.JPG; IMG_1047.JPG; IMG_1055.JPG; IMG_1056.JPG; IMG_1044.JPG; IMG_1065.JPG

In Finland bus fires have been in severe concern during the last couple of years. The amount of them have been high and stable in spite of increased information. No severe losses have occurred, but in december 2008 one was very close in town of Karkkila, about 100 km from Helsinki. It was winter, late afternoon (dark, no street lightning) when a bus full of tourists (65, age range 3 - 81 year) caught fire in electric center under instrument panel.

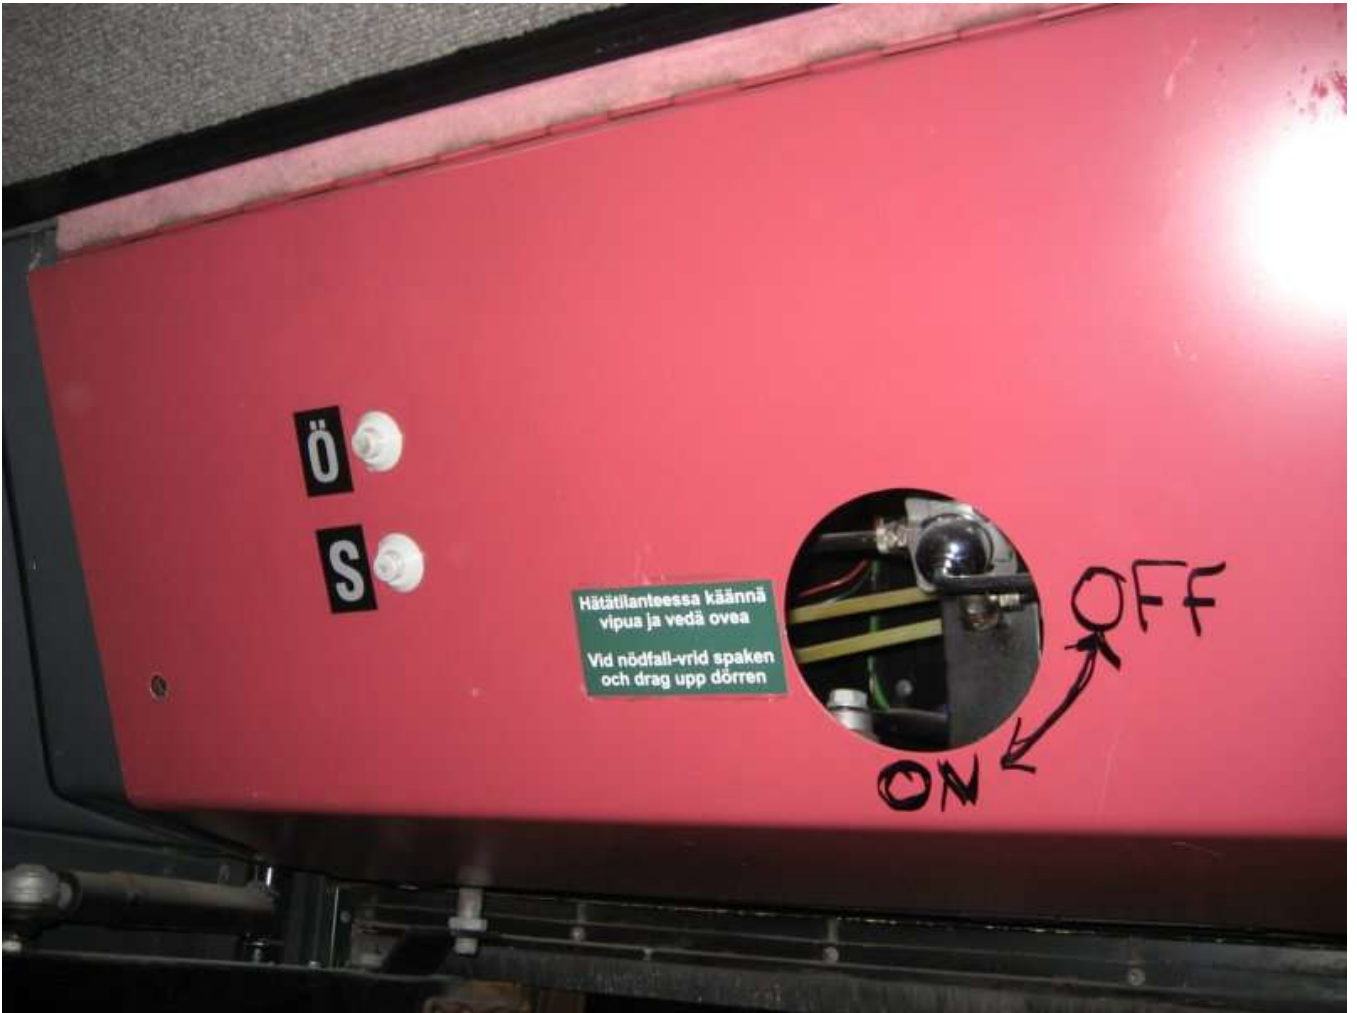
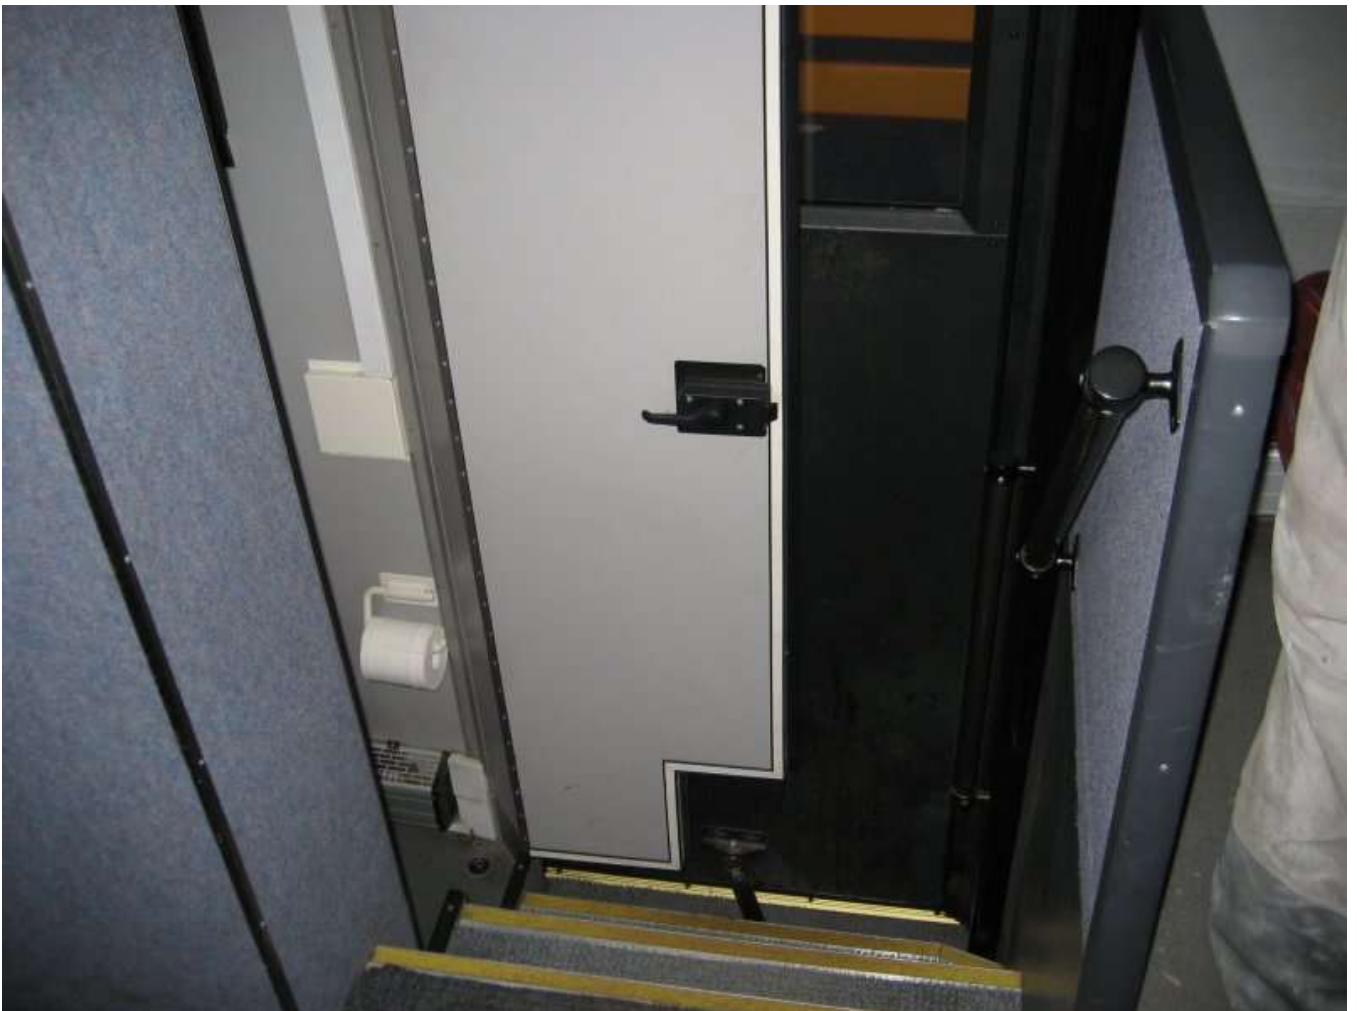
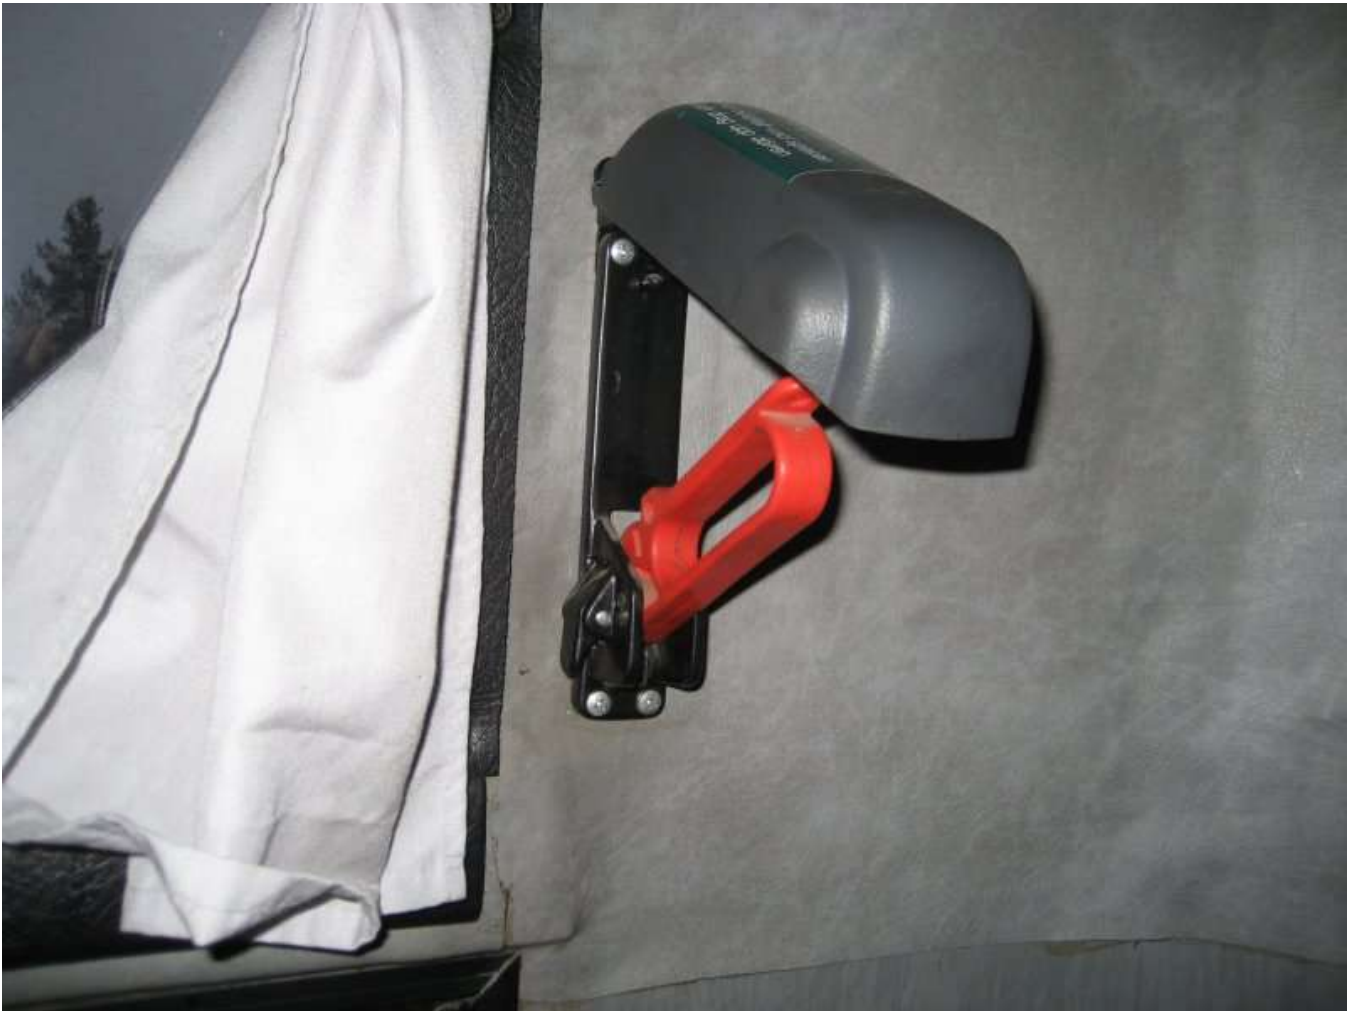
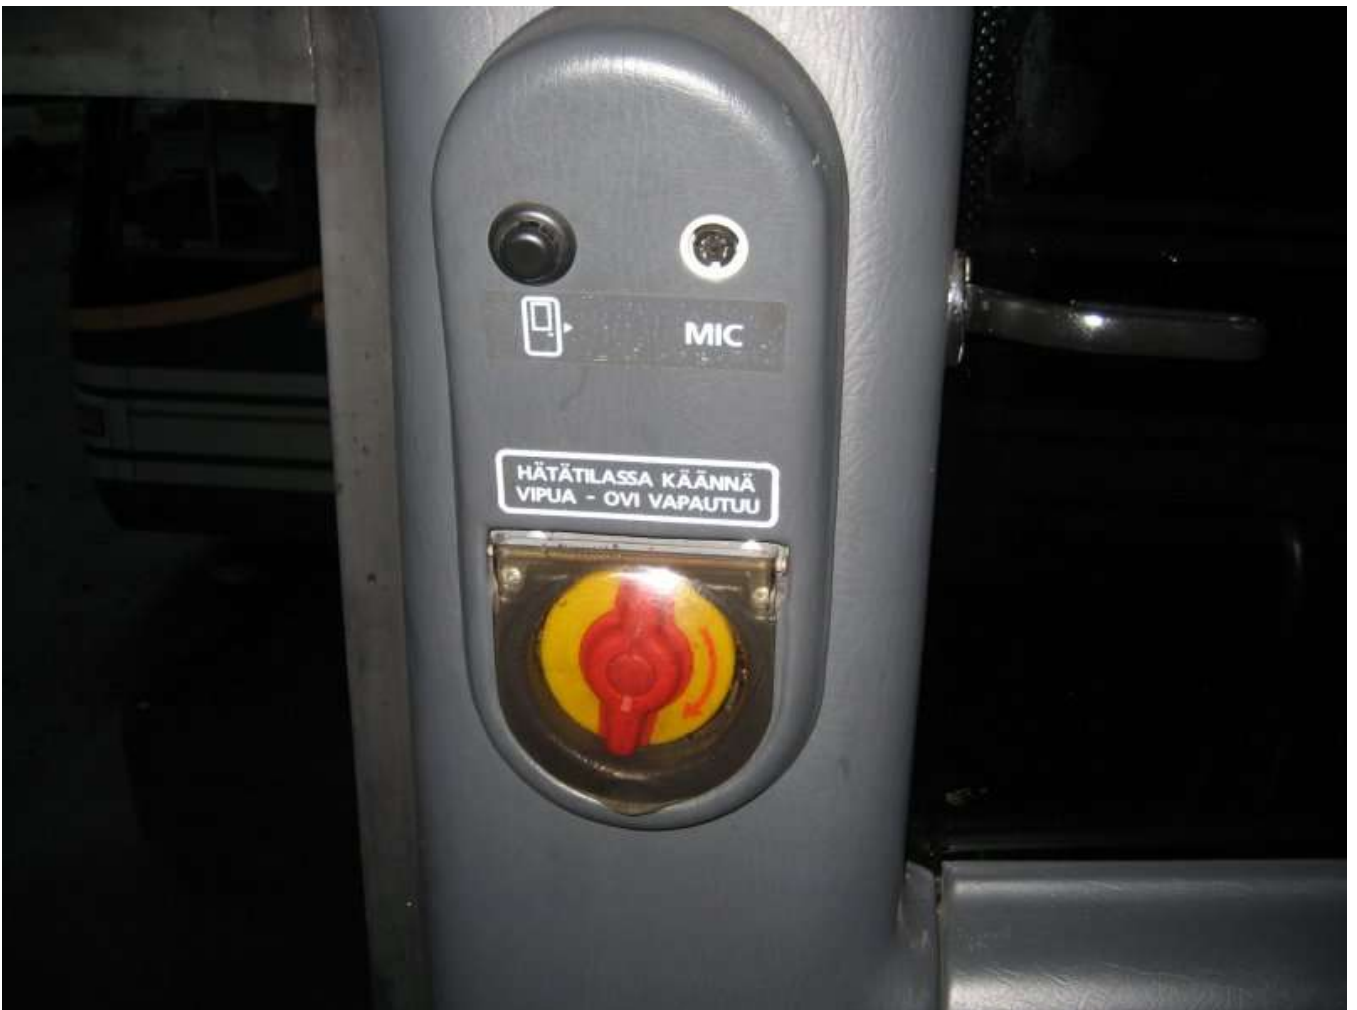
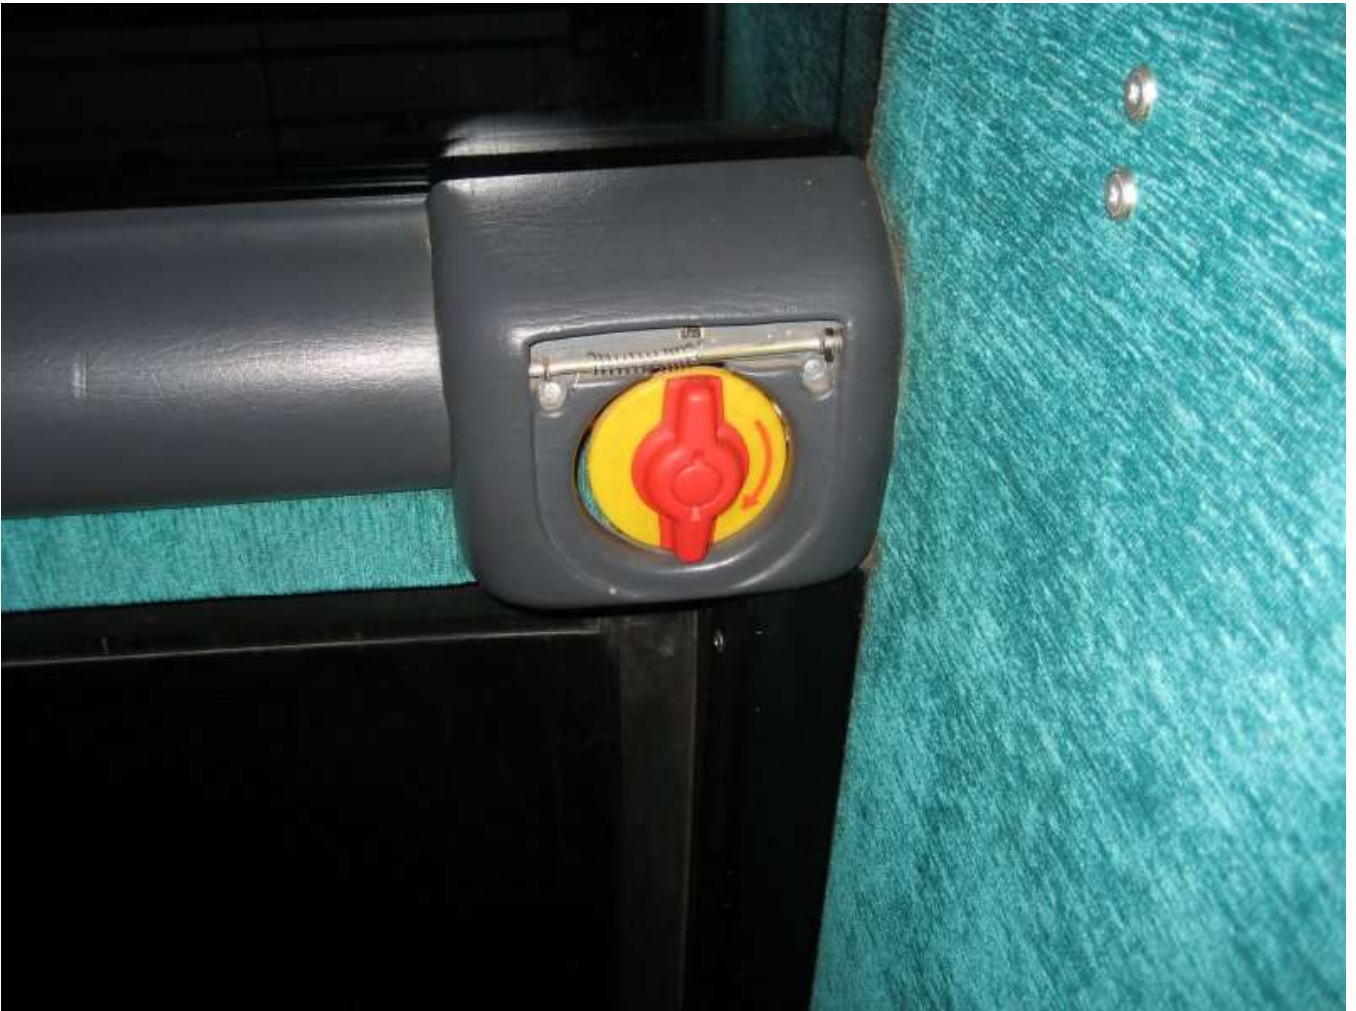
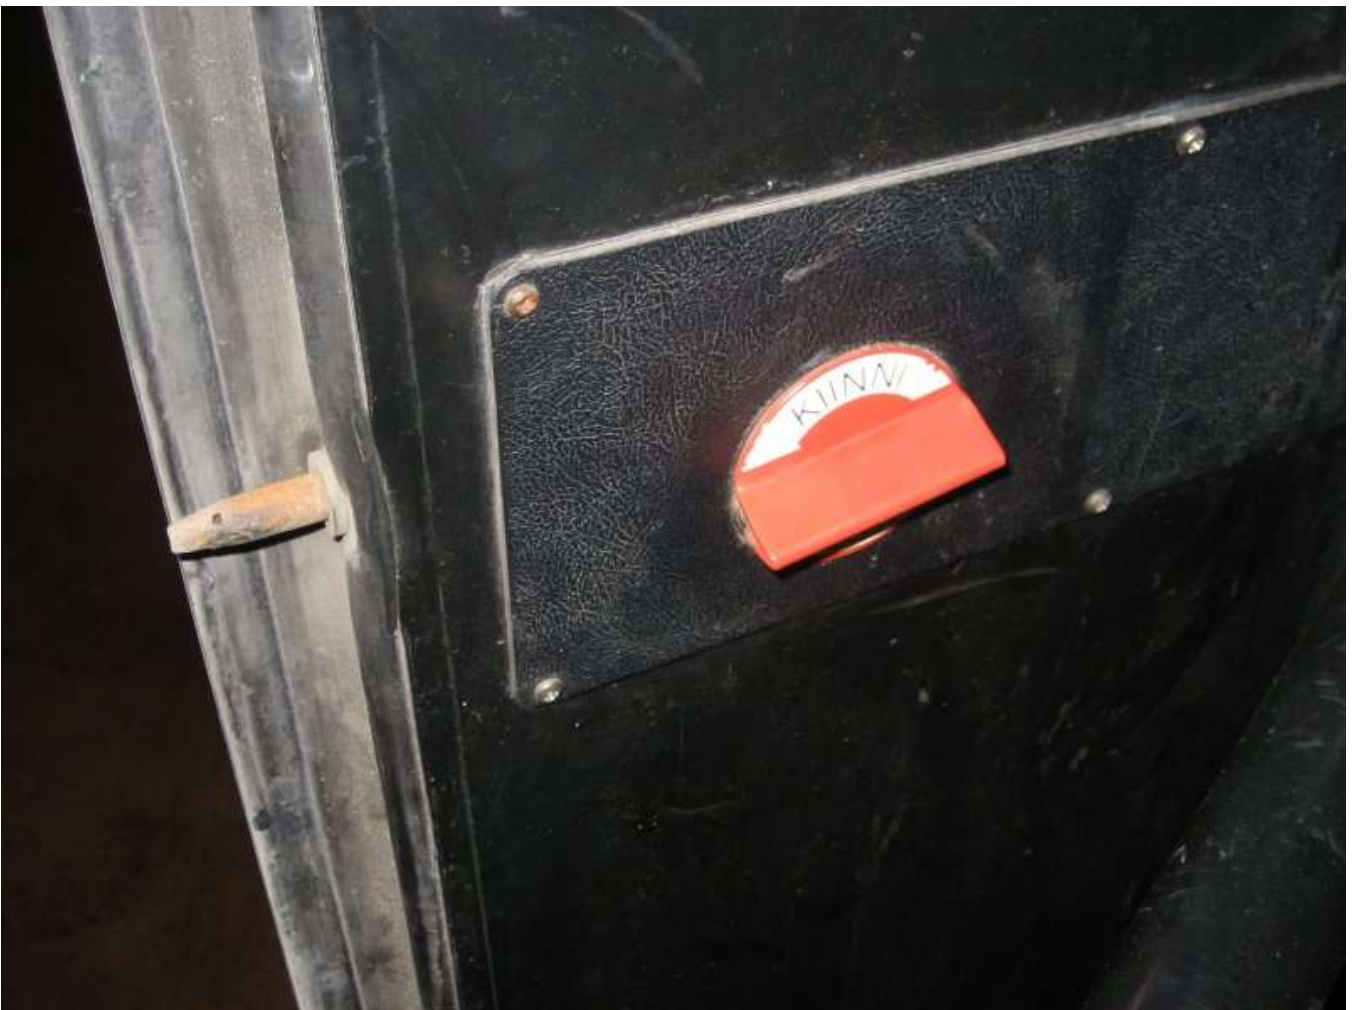
The bus drive stopped, when he smelt smoke. He used driver's door and went out to check the situation. He shut the door, because avoiding danger for other traffic. Fire caused short-circuit and activated the centre-locking and loss of air pressure in the service door opening system. Also the lightning in passenger compartment died out during the first moments.

The front door locked mechanically by steel pin and was very hard to open. It couldn't be fully opened during the fire at all. The bus was high because of the big luggage compartment, so also the escape windows were placed high, about 2.5 m from ground level. And because, the bus was stopped on the side of way (typical narrow two-lane highway), the deep and graggy ditch made the escape jump even more higher. It was almost impossible to jump out without injuries, if one was even able to try. The pneumatic doors of the luggage compartment automatically opened, because the loss of pressure, and got up to cover side windows and made the escape route

The emergency switches of the service doors (one in front and one in middle of the bus) were difficult to find and difficult to use. The front one was placed high (>170 cm), so it was difficult to come up to it. The middle door one was placed so that it was not possible to see it from gangway.

The investigation team checked later on different types of emergency switches of doors. The findings were very diverse, attached is couple of pictures of them. In one case for example a opened door of toilet may cover the switch totally. The way how switches should be use are different, and instructions to it are insufficient. In the case of mentioned fire accident, instructions were not in Finnish, because the bus was imported as used vehicle to Finland and first registered in the other country.
