Economic Commission for Europe**Inland Transport Committee**

Working Party on the Transport of Dangerous Goods**Joint Meeting of Experts on the Regulations annexed to the European Agreement concerning the International Carriage of Dangerous Goods by Inland Waterways (ADN) (ADN Safety Committee)****Nineteenth session**

Paragraph 9.3.2.15 Stability (damaged condition)**Transmitted by the Informal Working Group of Recommended ADN Classification Societies****Introduction**

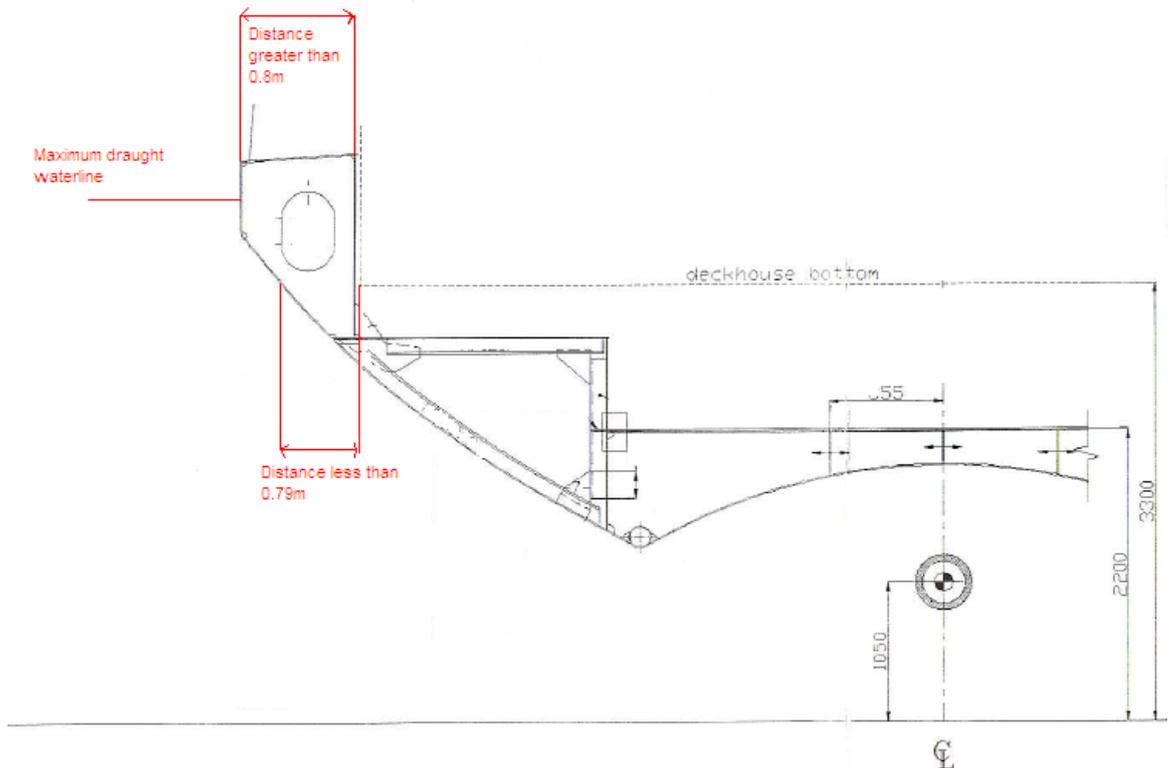
transverse extent: 0.79 m; inboard from the vessel's side at right angles to the centreline at the level corresponding to the maximum draught;

The interpretation may have an impact for the aft and fore part construction, mainly as concerns the accommodation (see below a diagram to illustrate the situation).

3. The regulation does not explicitly explain how to calculate the extent of side damage, whether this is from the side shell or from the maximum draught waterline.

It should be noted that the fact of considering or not the distance from the side shell has no impact for cargo tanks, as the dimensions of double hulls must be in conformity with paragraph 9.3.2.11.7 of ADN (or similar for other vessel types)
