Humanetics Innovative Solutions, Inc.

Jaw / C4 Contact Issue

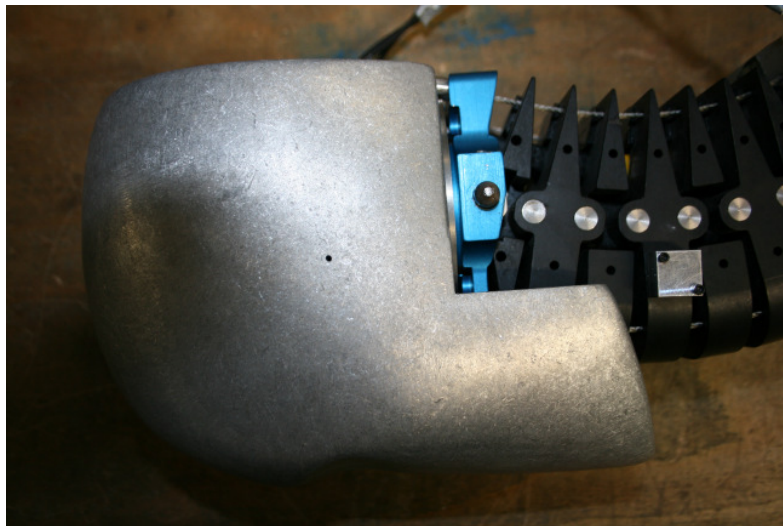
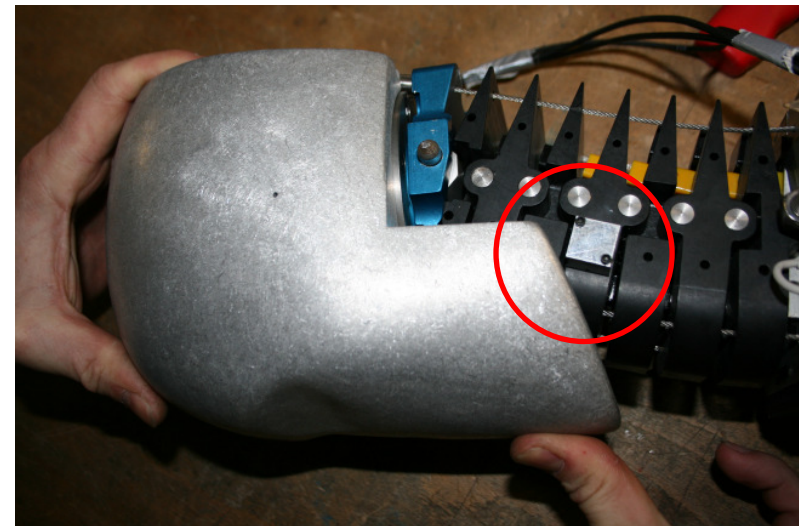
It was observed that during dynamic testing the jaw can still get in contact with the C4 accelerometers and cube respectively. This issue has not been brought to our Attention since the modification made to the C4 vertebrae back in Oct. 2001 (moving C4 cube 6mm rearwards)
