ECE/TRANS/WP.29/GRSG/2006/23  
28 July 2006

**COMMENTS BY THE EUROPEAN COMMISSION EXPLAINING ITS POSITION  
CONCERNING THE USE OF A PICTOGRAM TO IDENTIFY EMERGENCY EXITS  
IN REGULATION No. 107**

(M<sub>2</sub> and M<sub>3</sub> vehicles)

Submitted by the expert from the European Commission (EC)

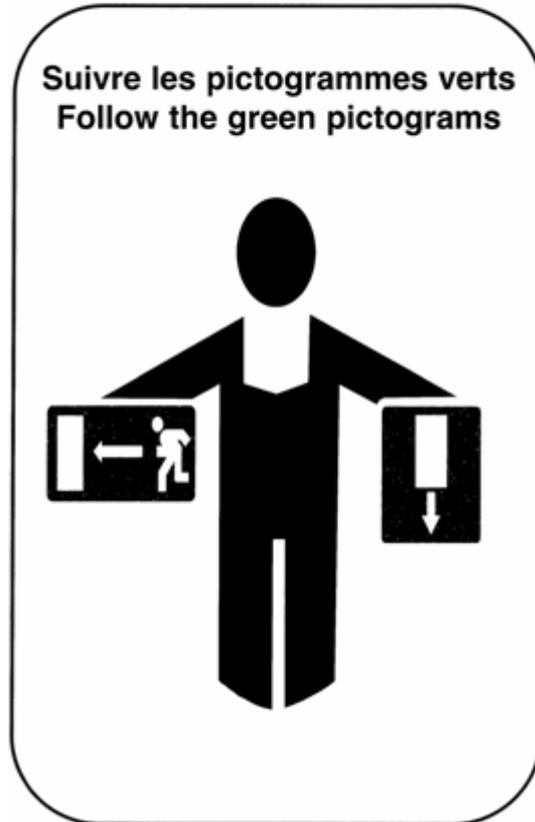
Figure 1

More commonly, the pictograms referred to in paragraph 3.4. of Annex II of Directive 92/58/EEC are used in corridors in public buildings to show the route to find exits. At the exit itself (or in the front of the exit), another pictogram - a rectangle plus an arrow- is used (see Figure 1).

**EN CAS D'EVACUATION  
IN CASE OF EVACUATION**

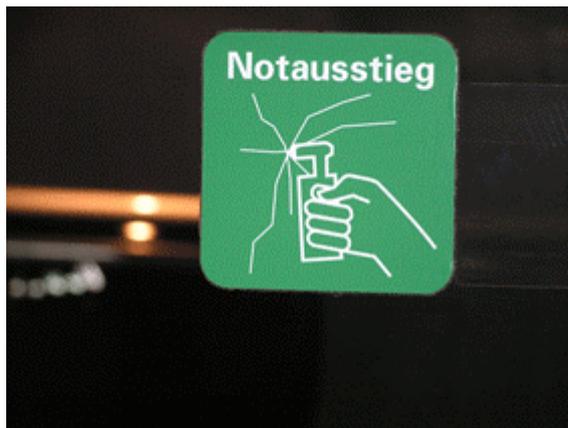
Figure 2

It has to be pointed out that some manufacturers use other pictograms on emergency windows which could probably serve as a reference (see Figure 2). Therefore, the EC believes that ISO relevant committee should be invited to consider this issue.
