# Smash the Gate: Unintended Consequences

Presentation to Expert Group on Road Signs and Signals, M. Pronin, 31 May-1 June 2018, Geneva

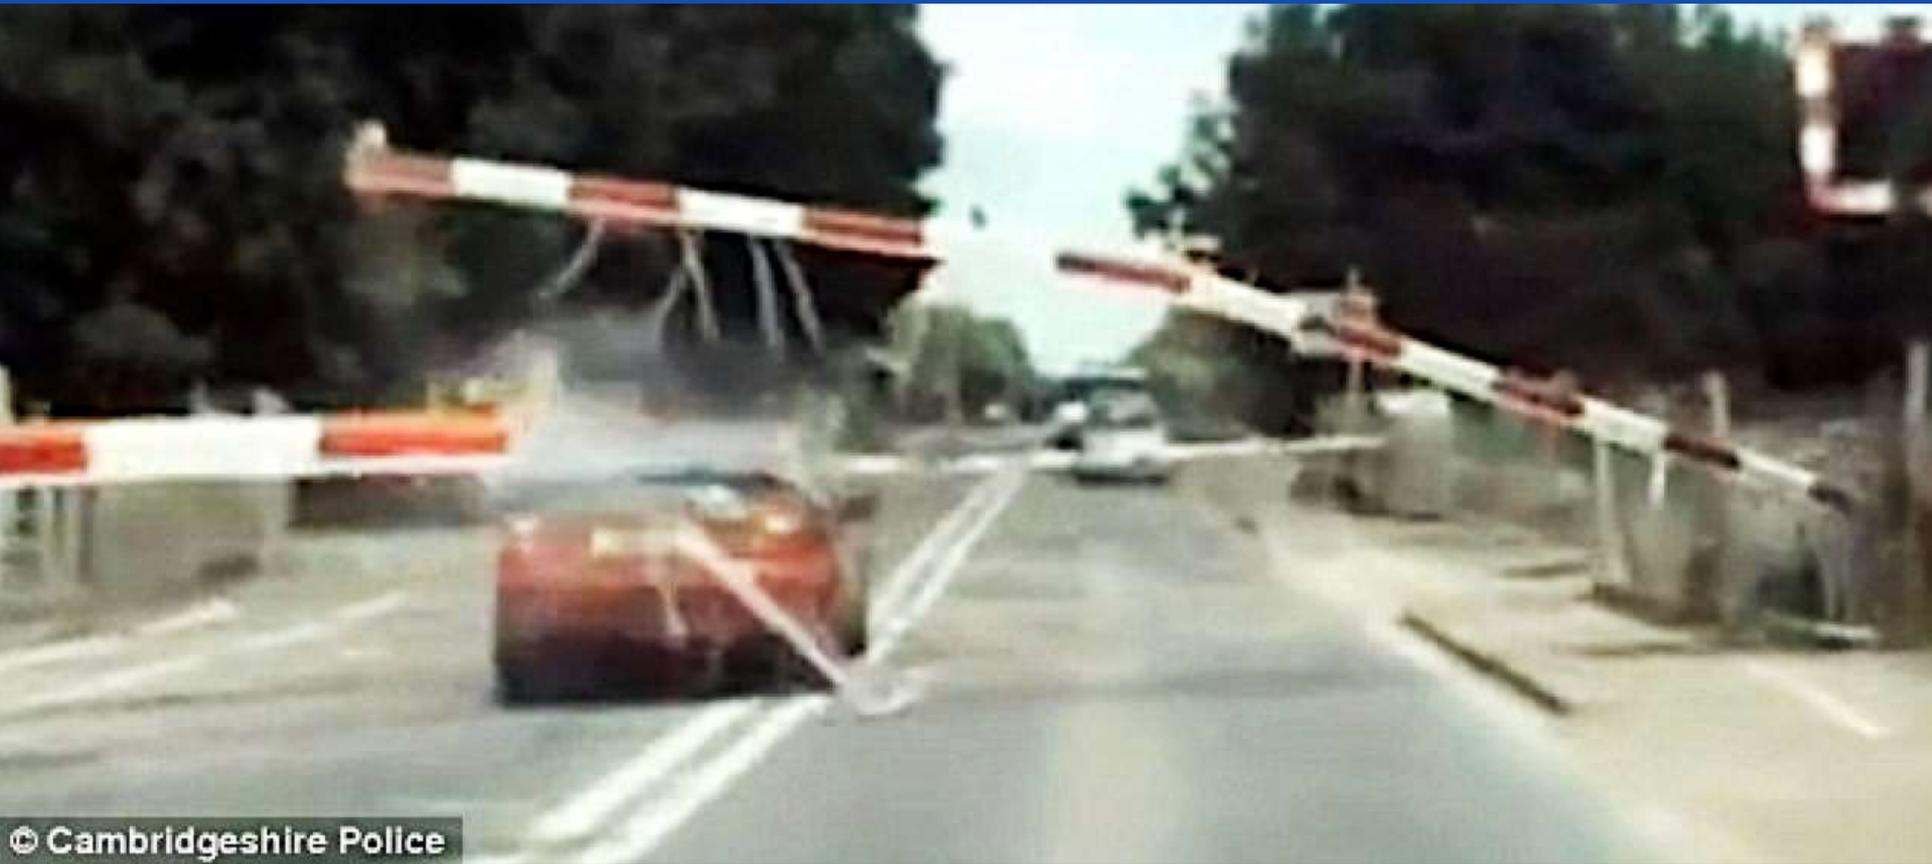
Vehicle crashing the near gate

Motorist knew gates are breakable

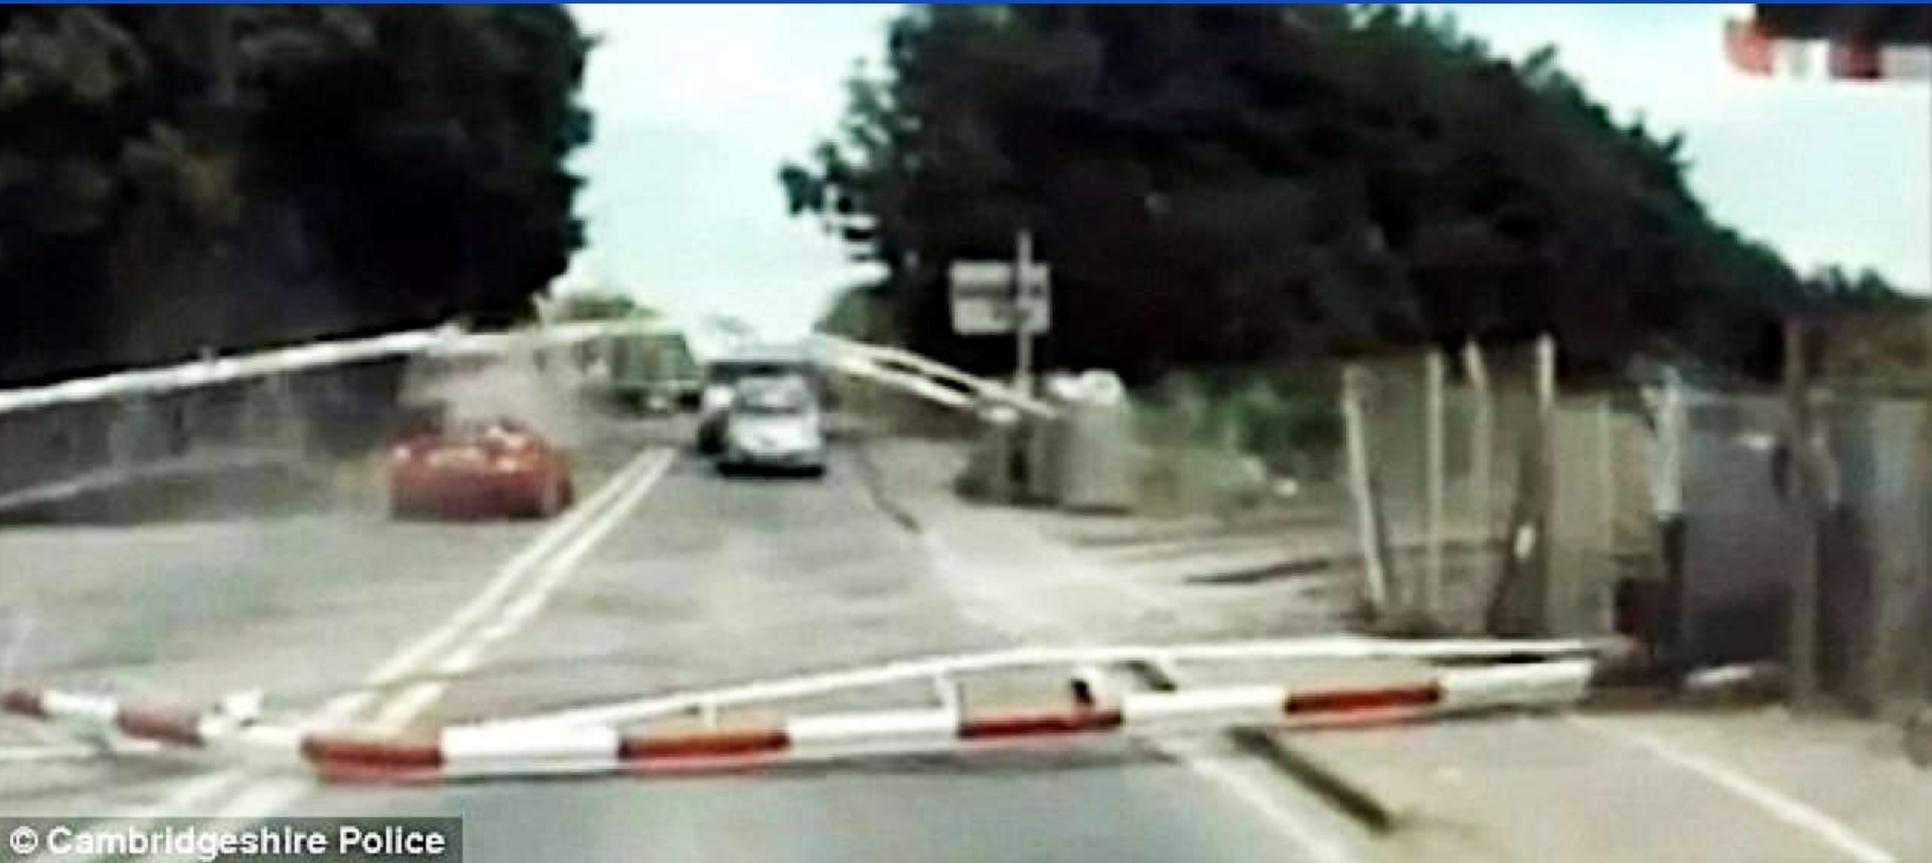
Vehicle has crashed into both gates

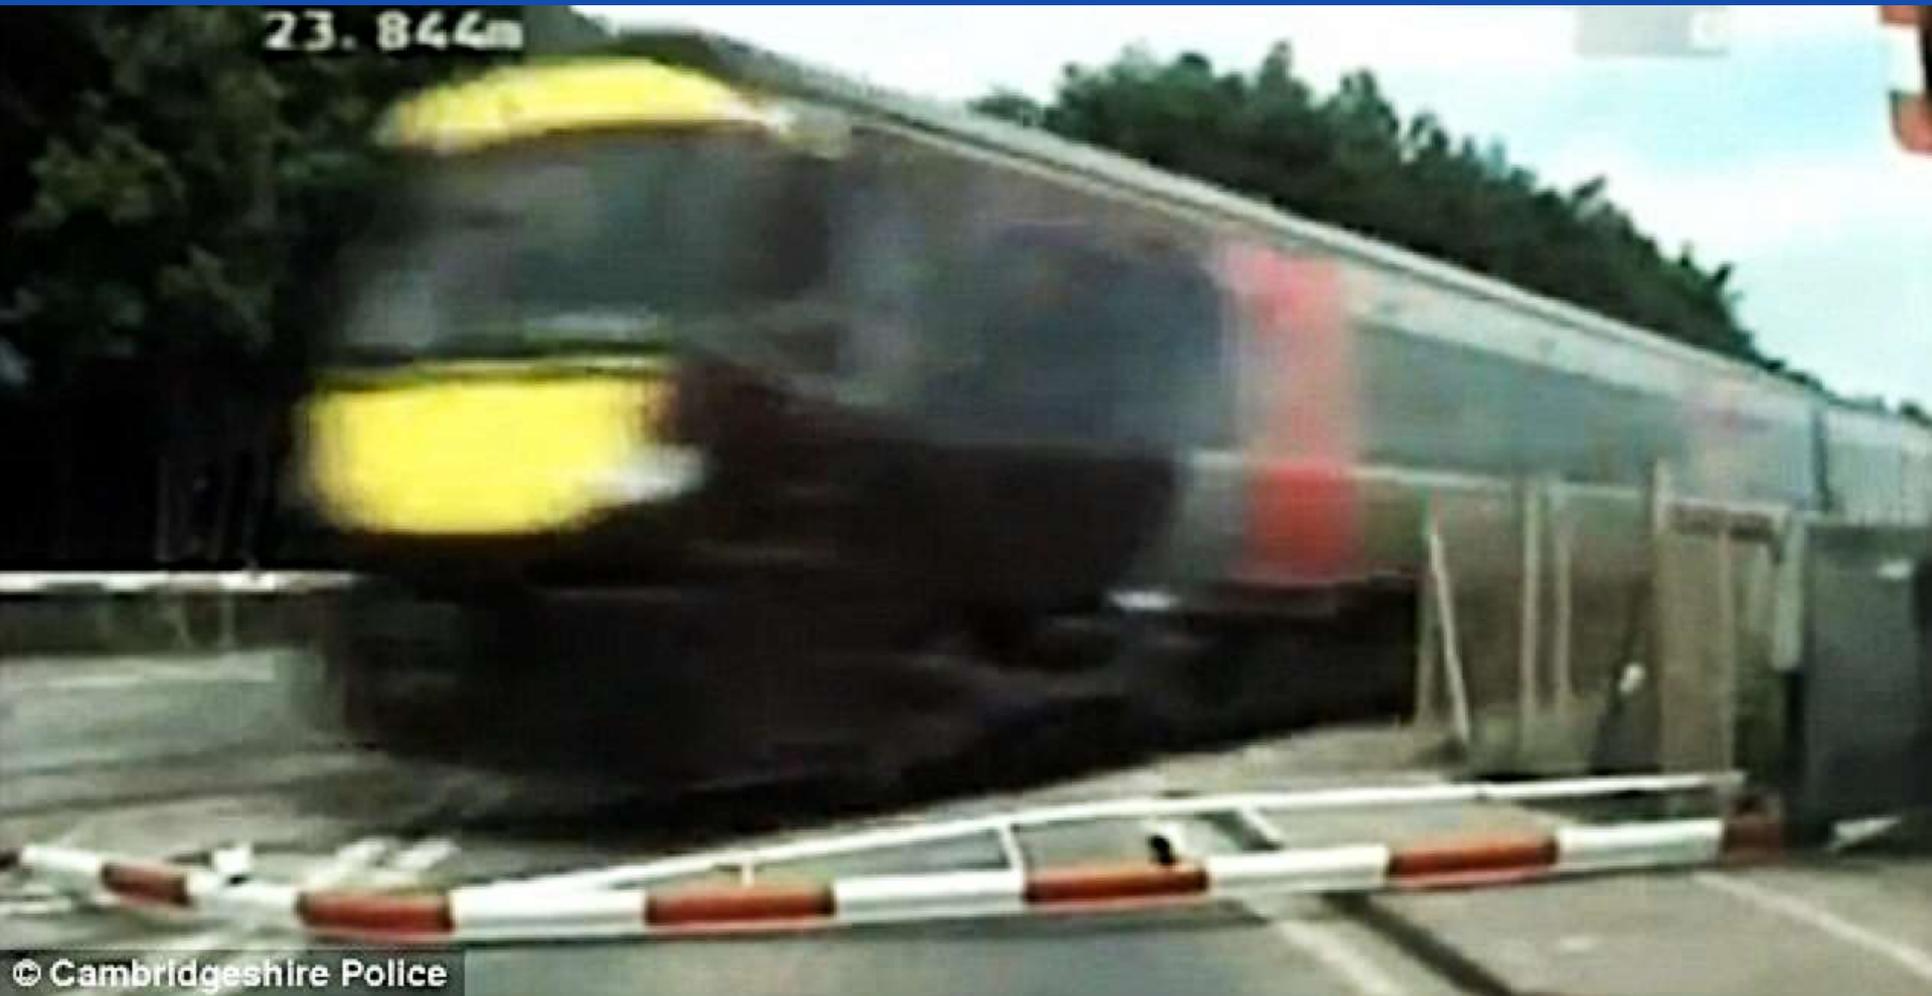
Gates do not break into pieces.  
Gates bend, swing, and often fall across rail tracks.  
Both near and far gates may land on the tracks.

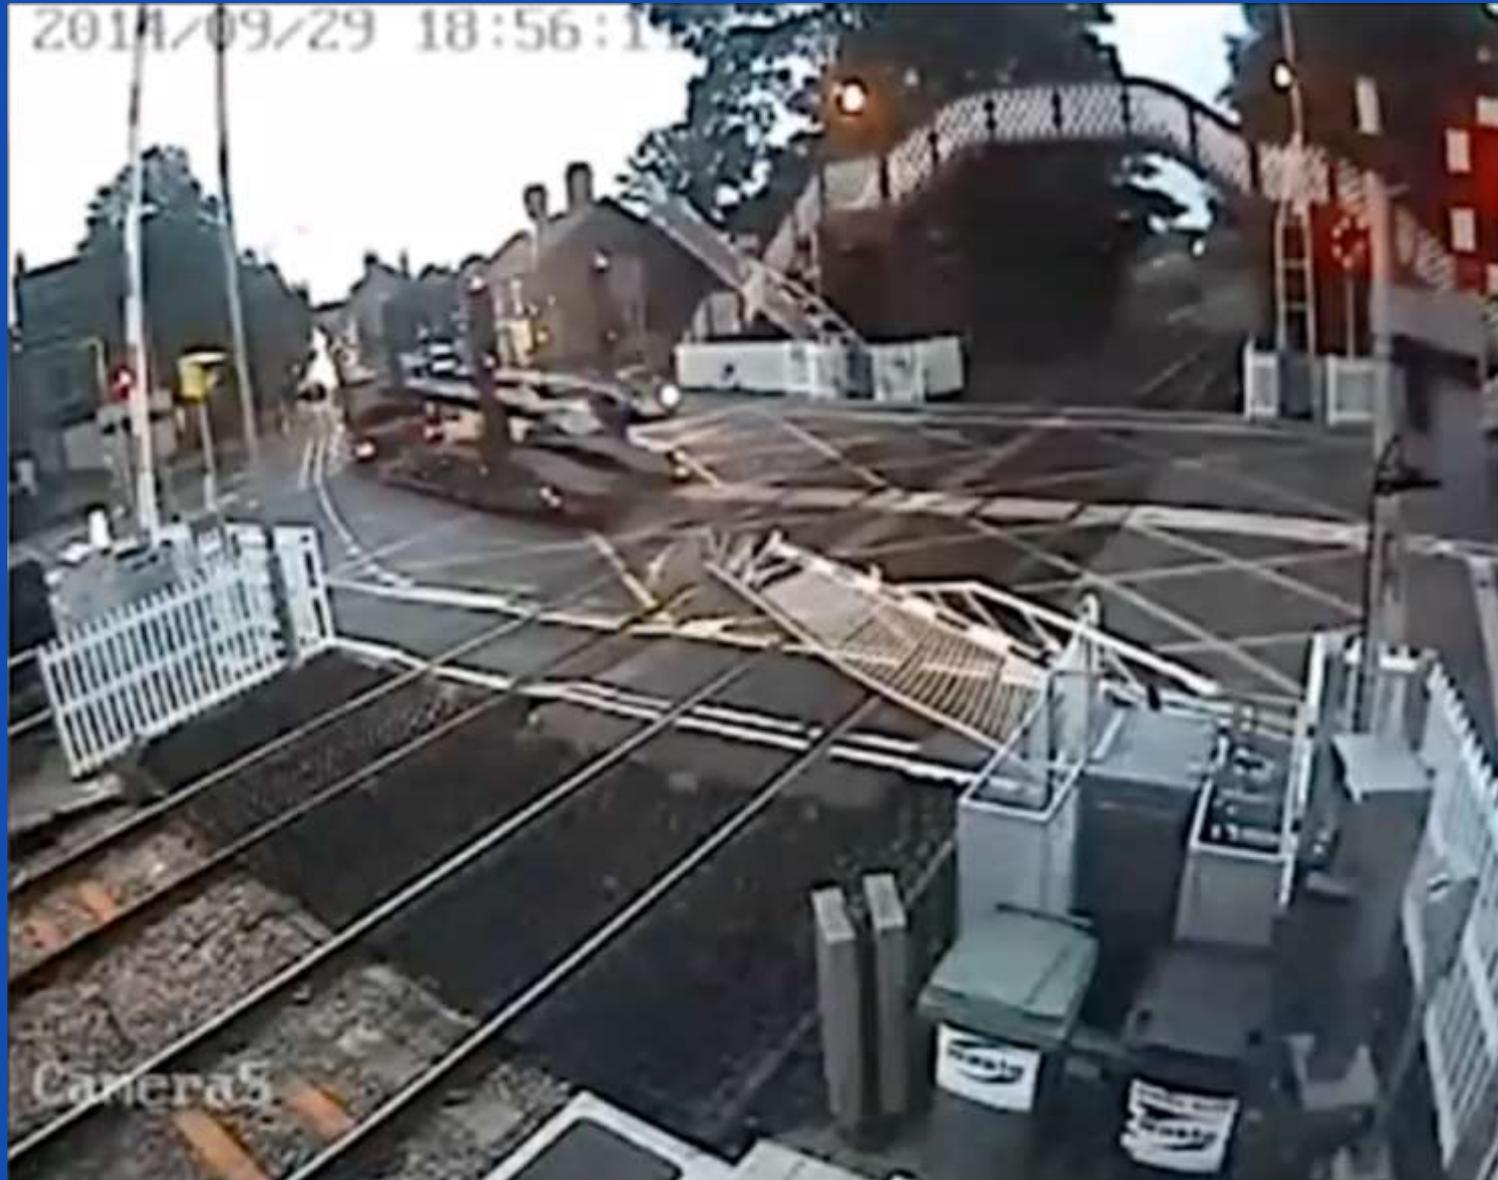
Car strikes near gate / Gate and boat from car roof land on both tracks

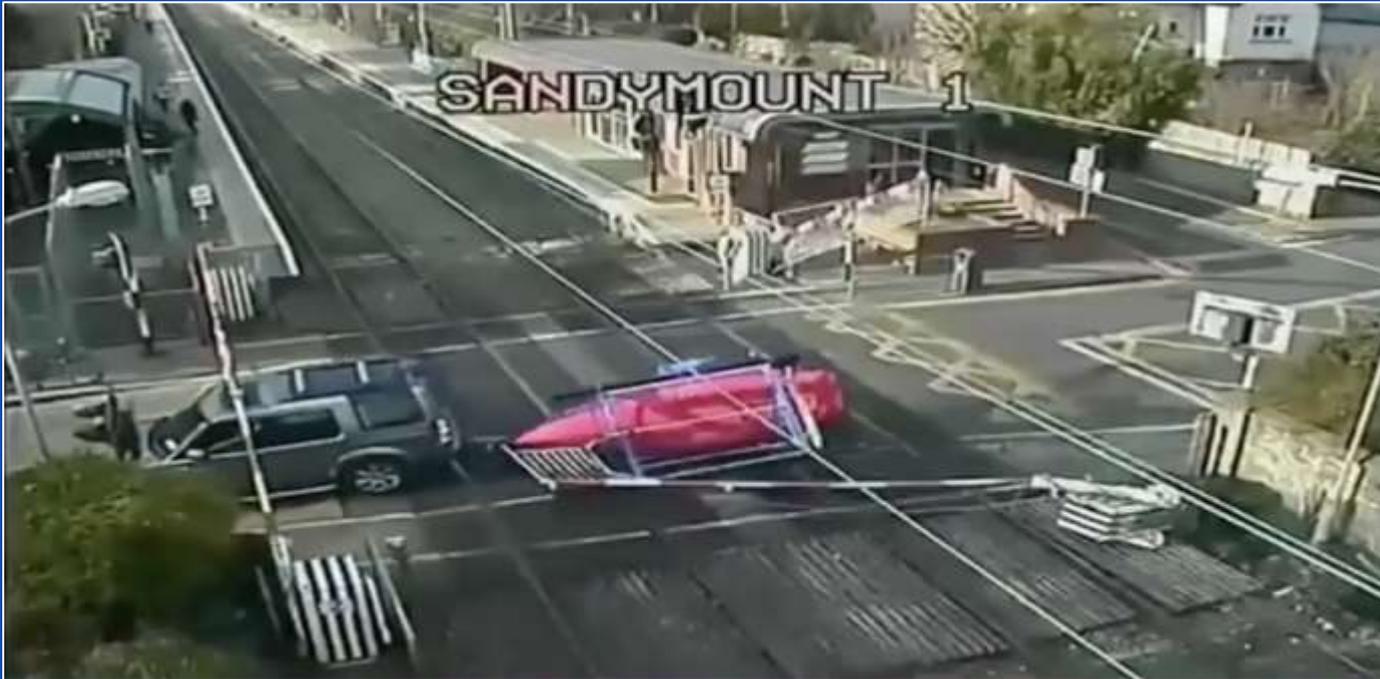
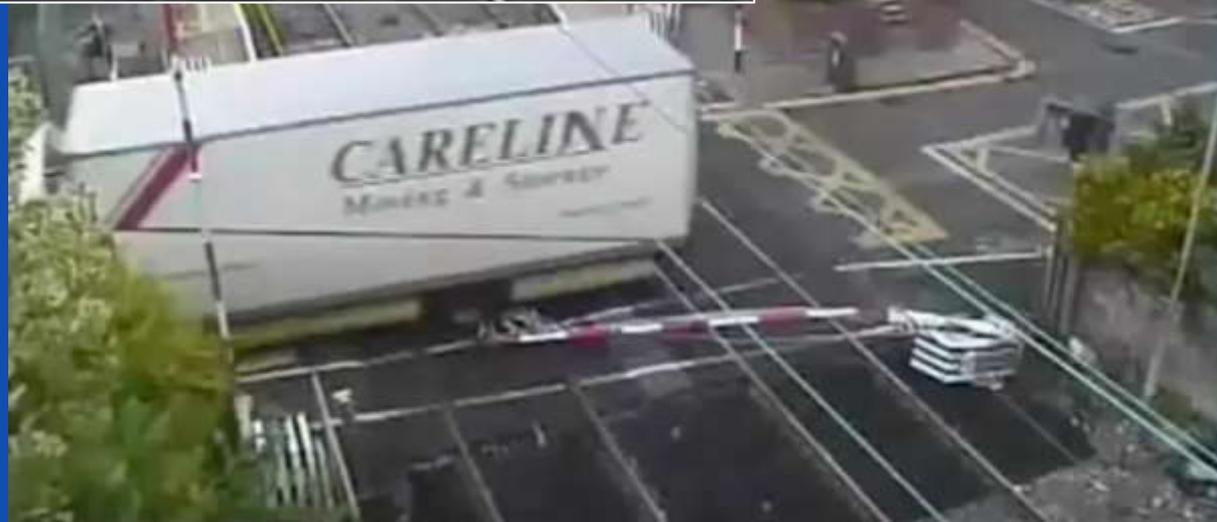
Truck strikes near gate  
Near gate swings and  
lands across both tracks

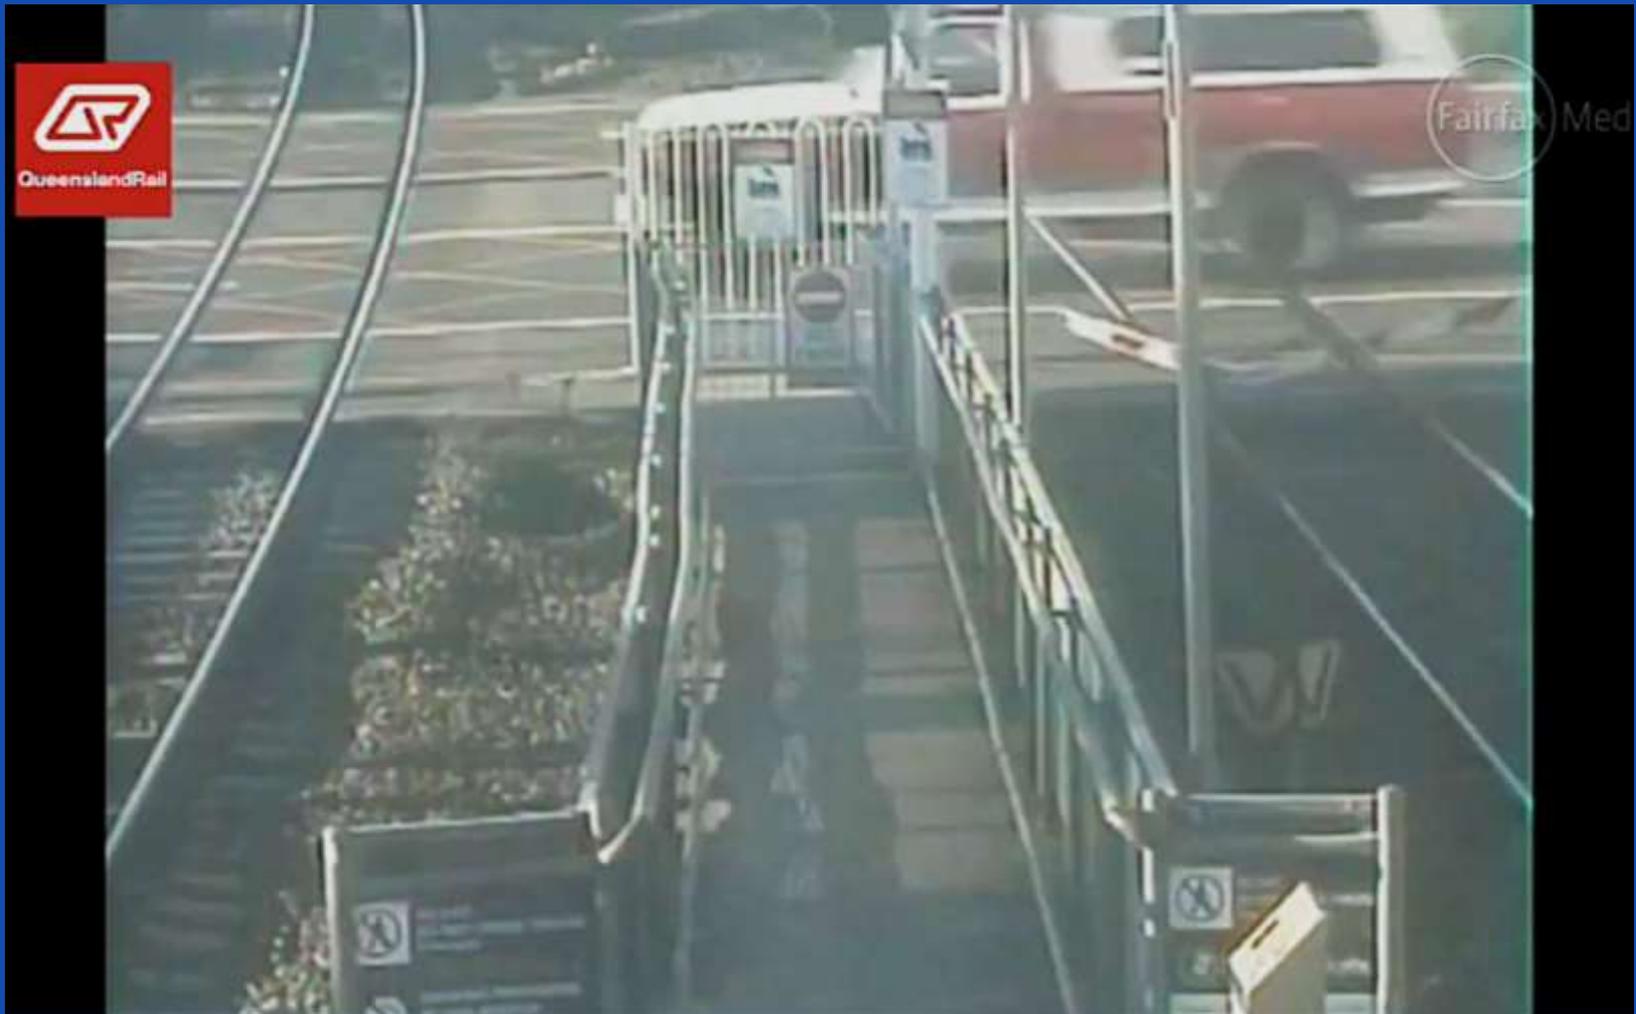
# Truck strikes near gate

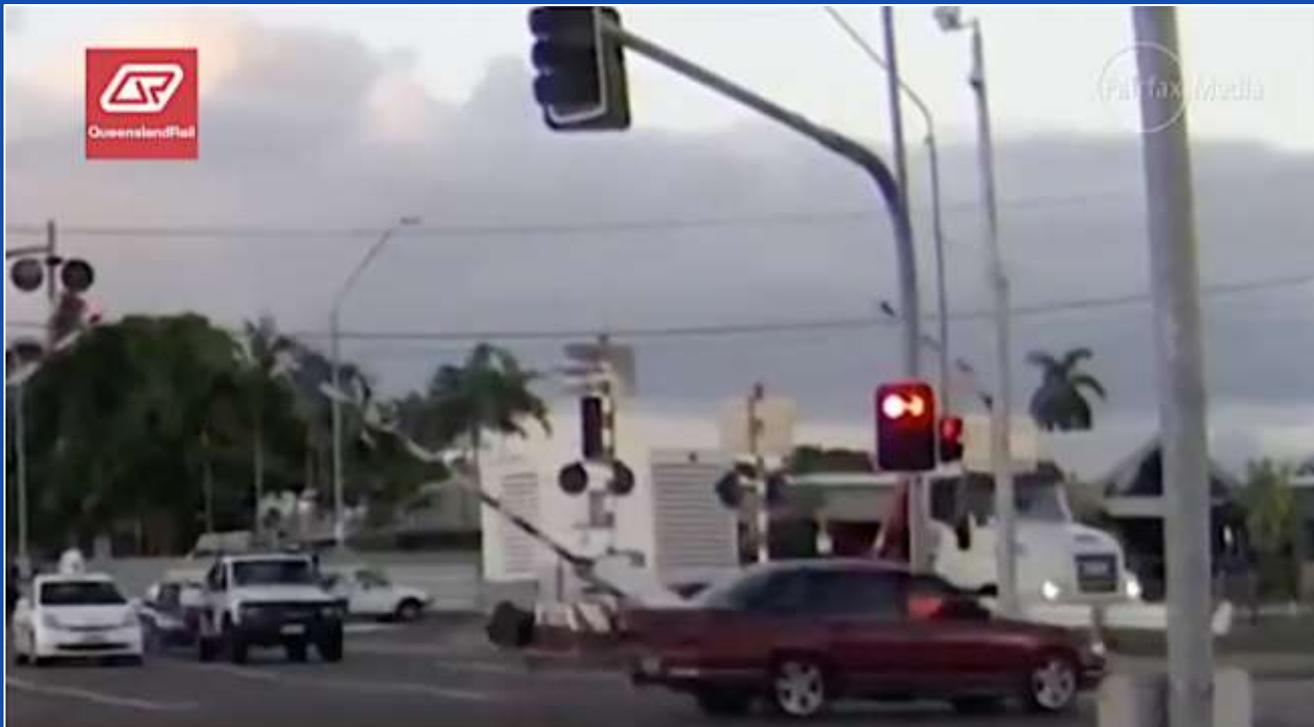
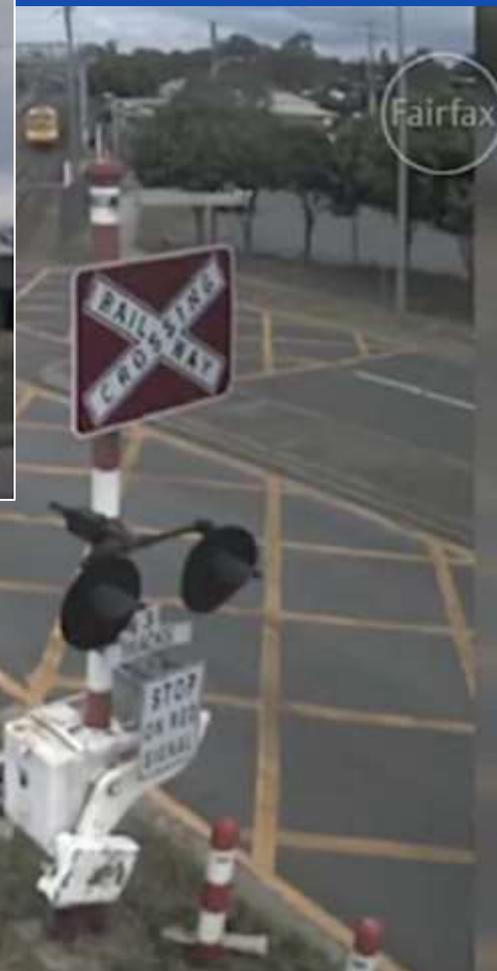
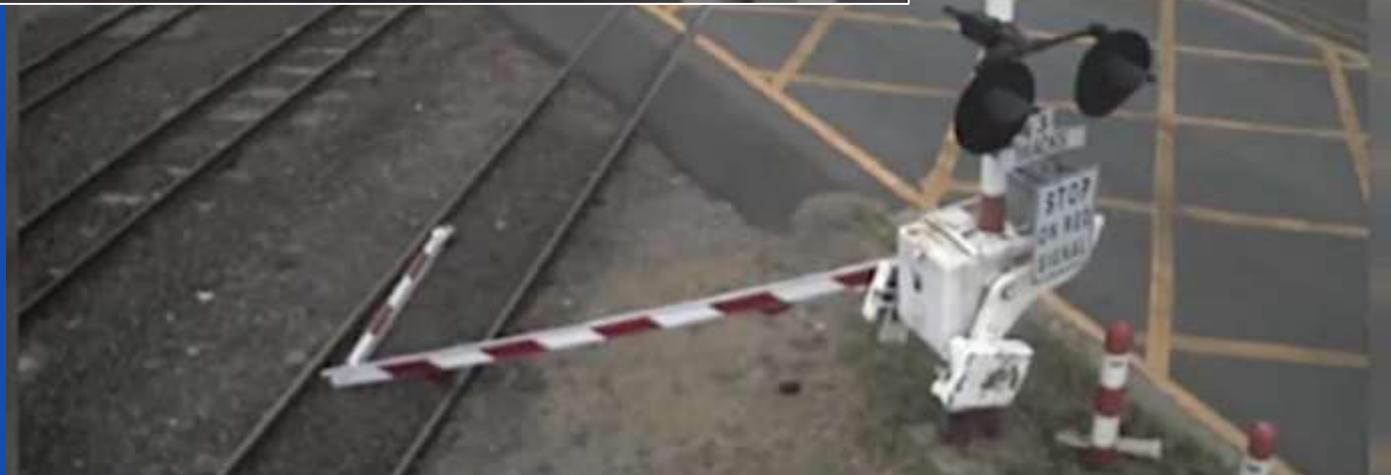
# Truck strikes far gate

Far gate swings and lands across tracks

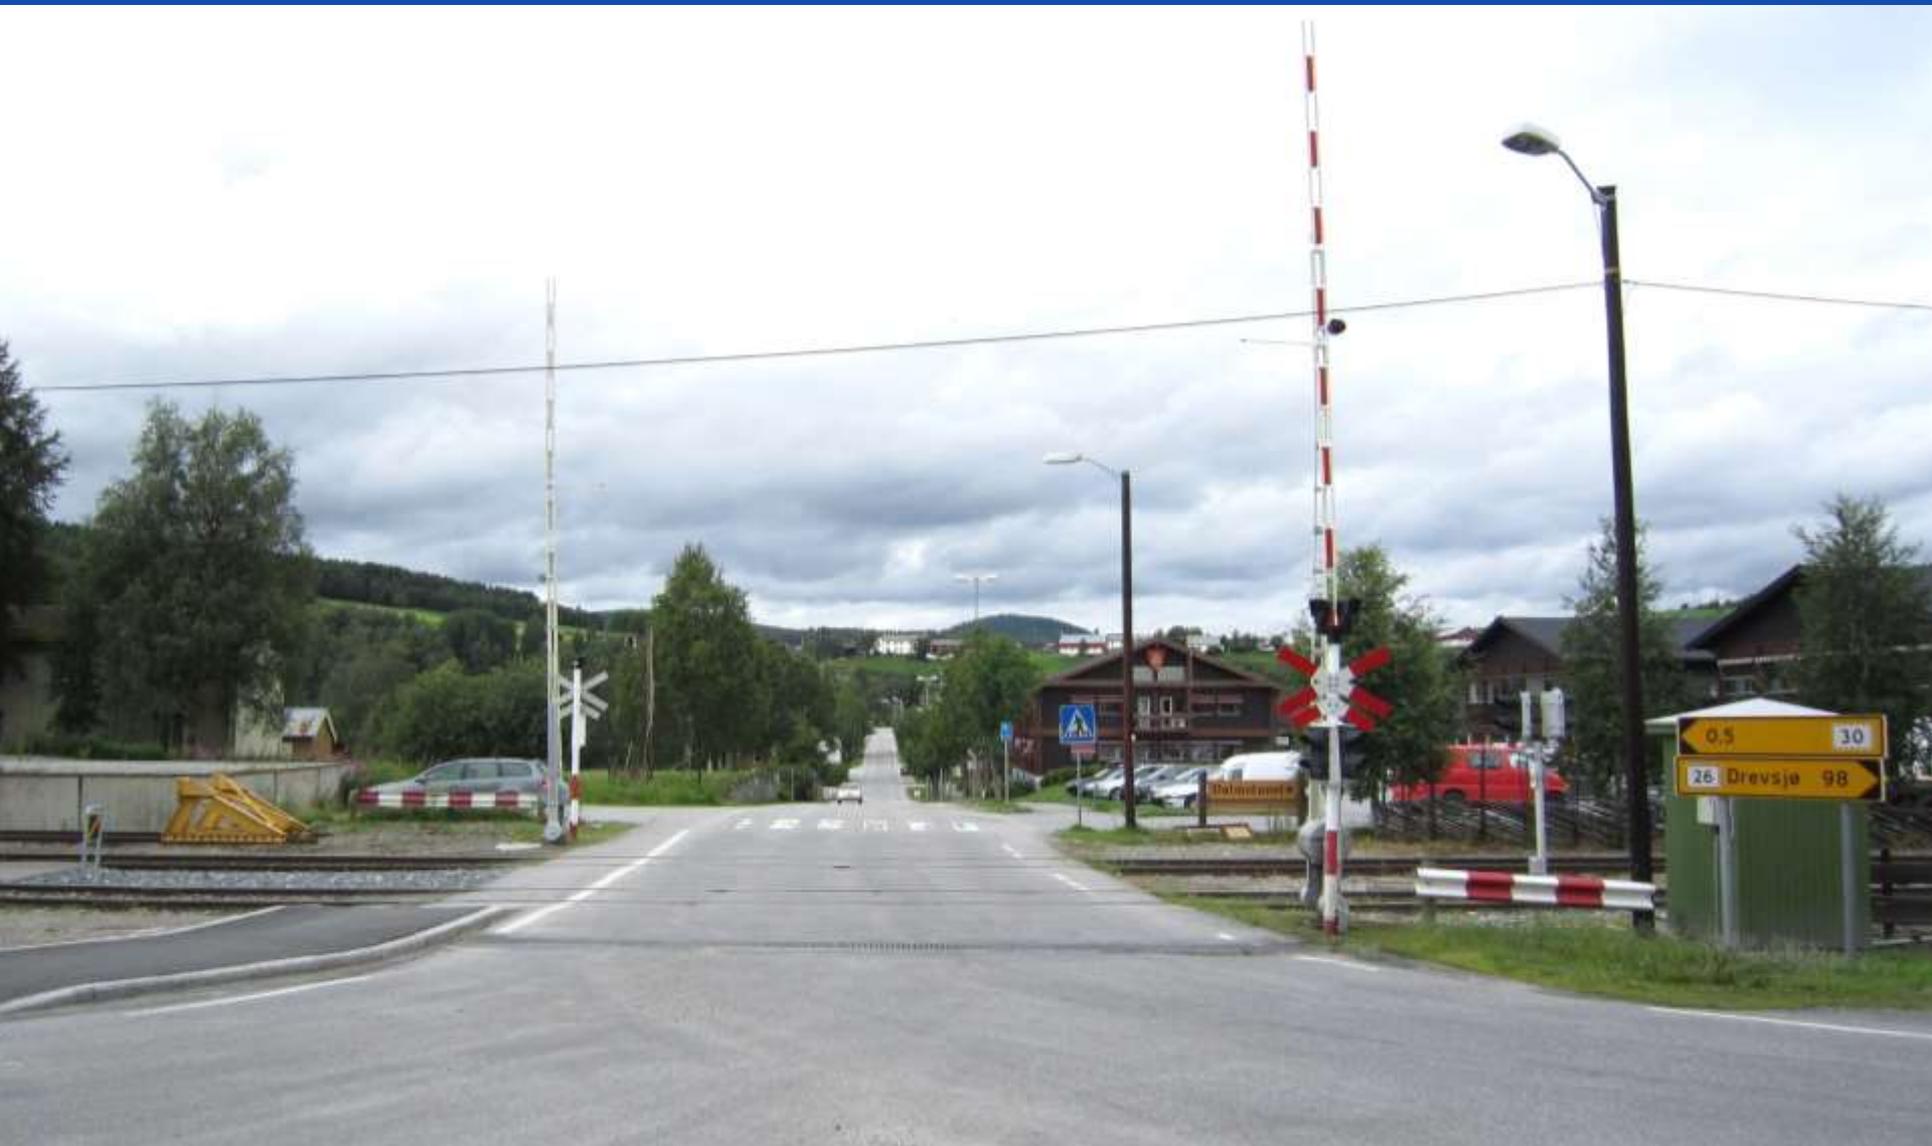
Note proximity to the far gate of pedestrian crossing and crossroad

The distance from the stop line to the gate appears to be about a meter and a half

It is possible for pedestrians to cross between the stop line and the gate

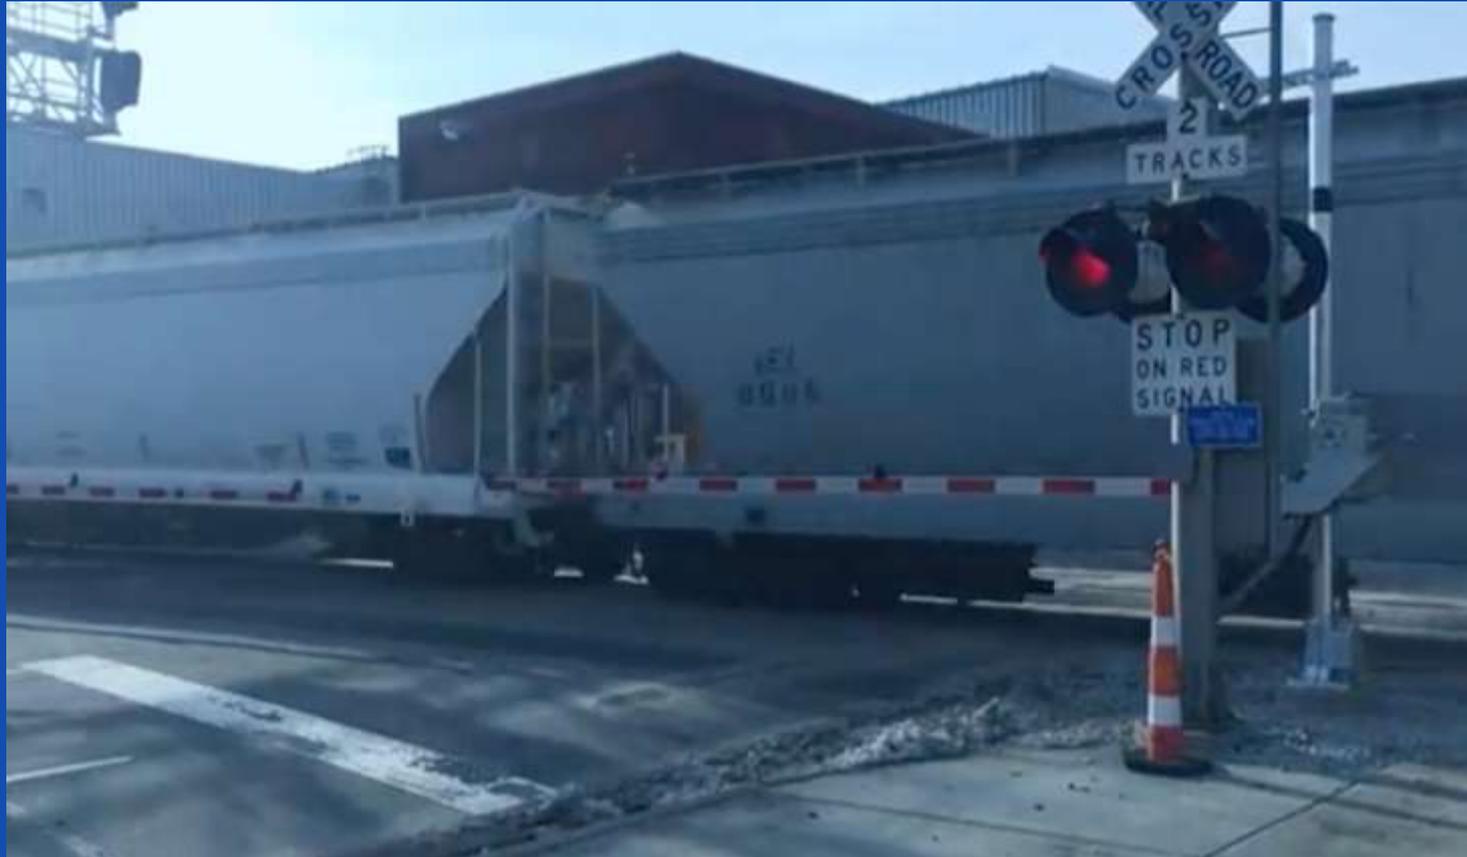
The road on the right is very near the gate, perhaps less than a passenger car length
