Test Report of FMVSS No. 201 Free-Motion Headform (49 CFR 572 Subpart L)

Used in Headform Test of ECE Reg. 43

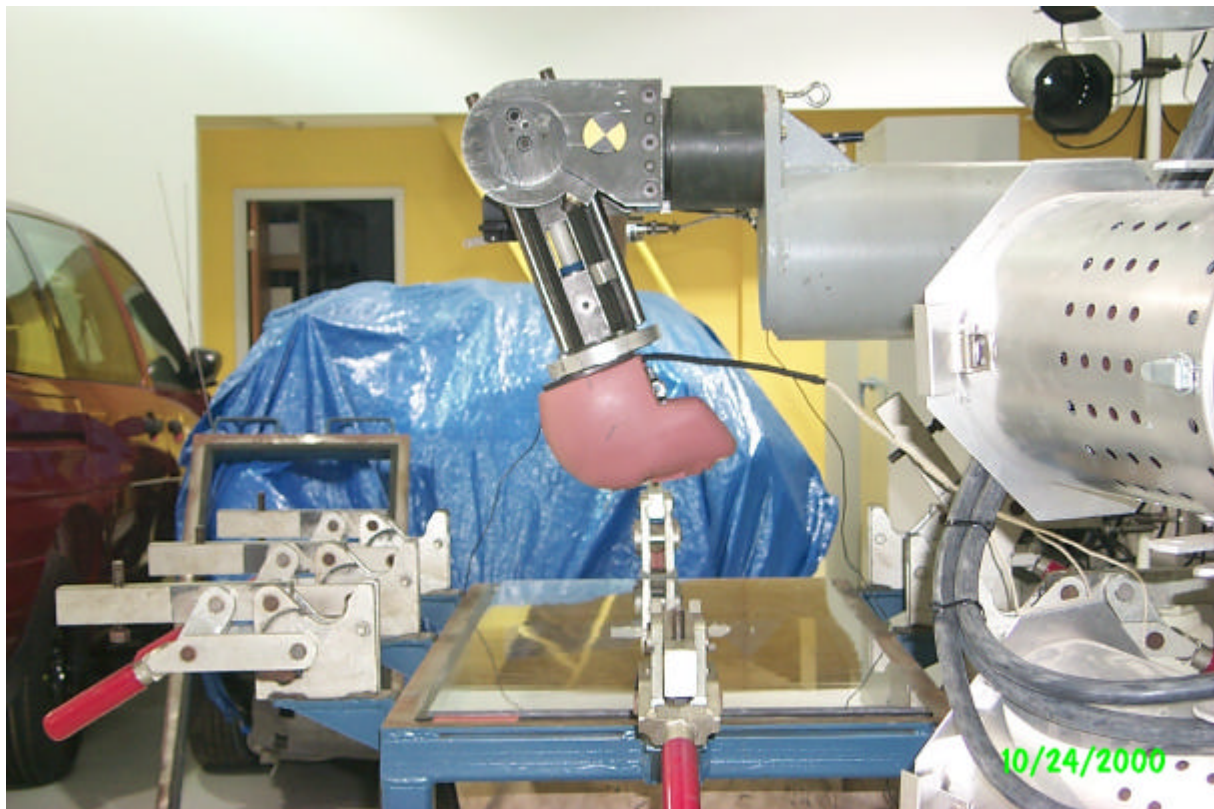
center of the forehead, just above the bridge of the nose. After positioning the impactor perpendicular to the plane of the test piece, it could be seen that contact would be made by other features on the face of the headform during dynamic testing. To avoid interference, the impactor was rotated 5 degrees backwards (See figure 1). Subsequent trial testing revealed that this shallow angle allowed for the rebounding headform to strike the impactor fixture, causing damage to the fixture and accelerometer data cables. Therefore, the impactor was rotated an additional 16 degrees (see figure 1).

Figure 1 -- Impact Angle of 21 degrees

It was determined that the direction of force imparted on the headform by the test piece should be at the
